Craigmillar Castle

Archaeological monitoring, April 2009

HS PIC Index number: 90129
Project code: HSCO-90129-2009-02

<u>Site</u>	Craigmillar Castle
<u>N.G.R</u>	NT 2893 7091
<u>Project Description</u>	Archaeological monitoring
<u>Project code</u>	HSCO-90129-2009-02

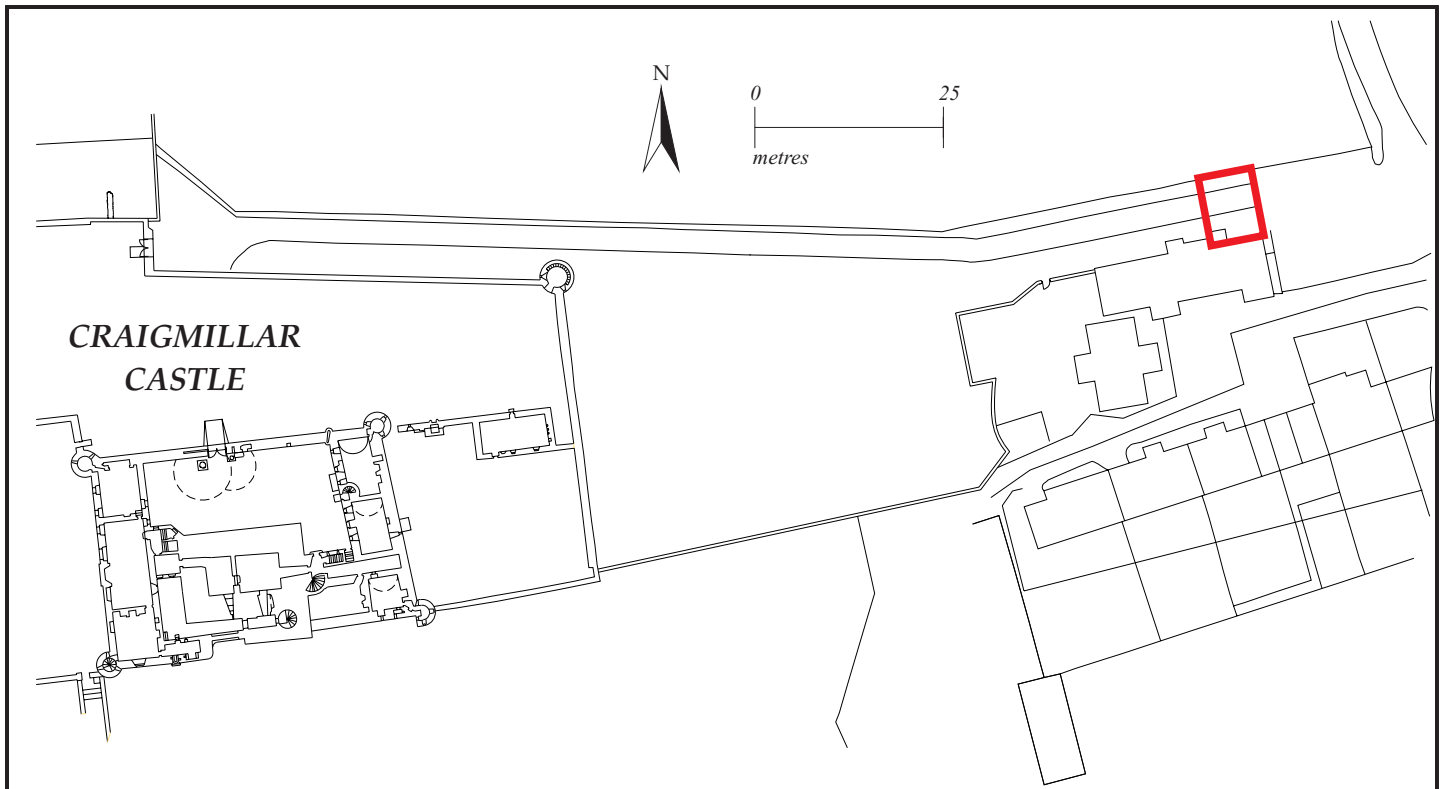
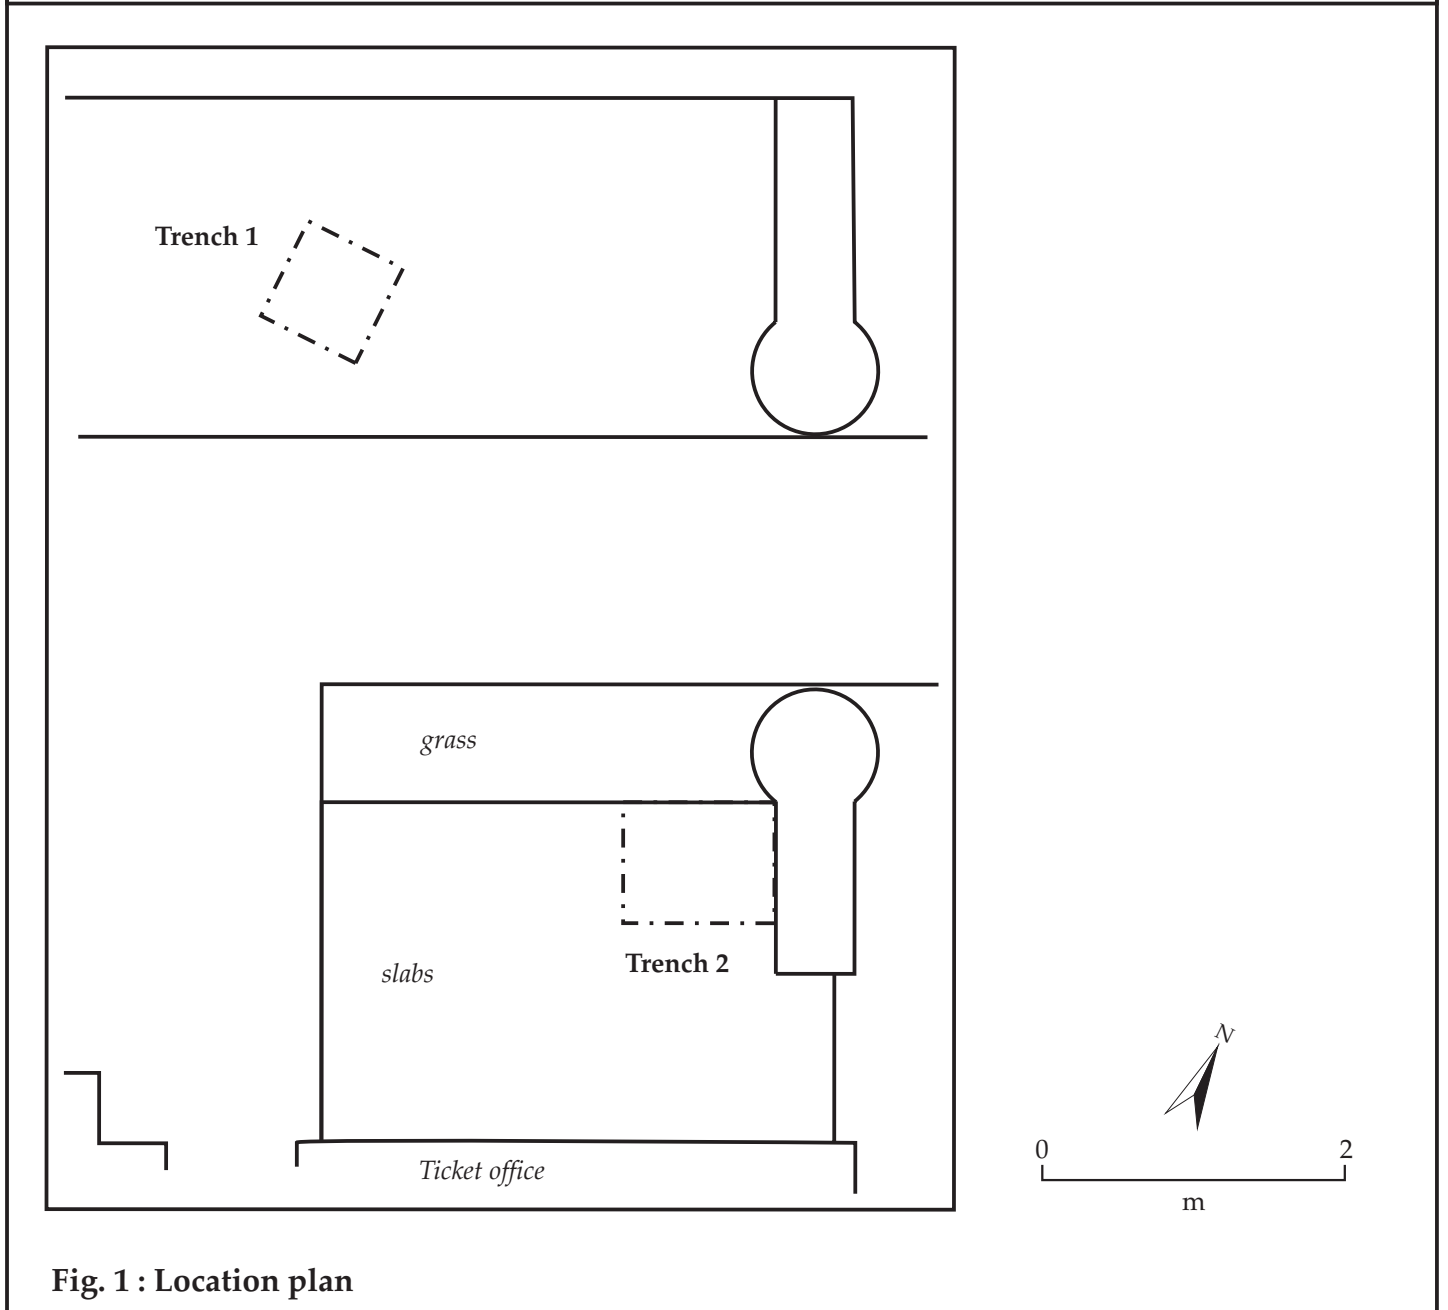
Fig. 1 : Location plan

Under the terms of its PIC call-off contract with Historic Scotland, Kirkdale Archaeology was asked to monitor the excavation of two trenches near the ticket office at Craigmillar Castle, Edinburgh. The trenches were for the installation of new signs either side of the access road, just N of the 18th-century building now used as the ticket office.

Trench 1 was located just to the N of the road up to the castle, measured 700 mm square and reached a depth of 400 mm. After the removal of 200 mm of fine dark brown slightly clayey silt topsoil a compact surface was exposed. This comprised small angular sandstone chips and small brick fragments over larger chunks of sandstone. This was cleaned up and photographed, and on its removal was found to be some 200 mm thick. The trench bottomed on compact pale brown sandy silt with charcoal, sandstone and some brick fragments throughout.

Trench 2 was to the S of the road, dug against the W face of the car park boundary wall. It measured 1.0 m E-W by 800 mm N-S, and was dug through stone slabs. These were removed using a breaker, and proved to be 60 mm thick, set in 40-50 mm of pale grey cement. This sealed 200-300 mm of dark grey slightly clayey silt, rich in coal, brick and sandstone fragments, which ran under the wall to the E. Below this
