Crichton Castle
HS Index No.90084

Project Code: CCNR08

Standing Building Recording
November/December 2008

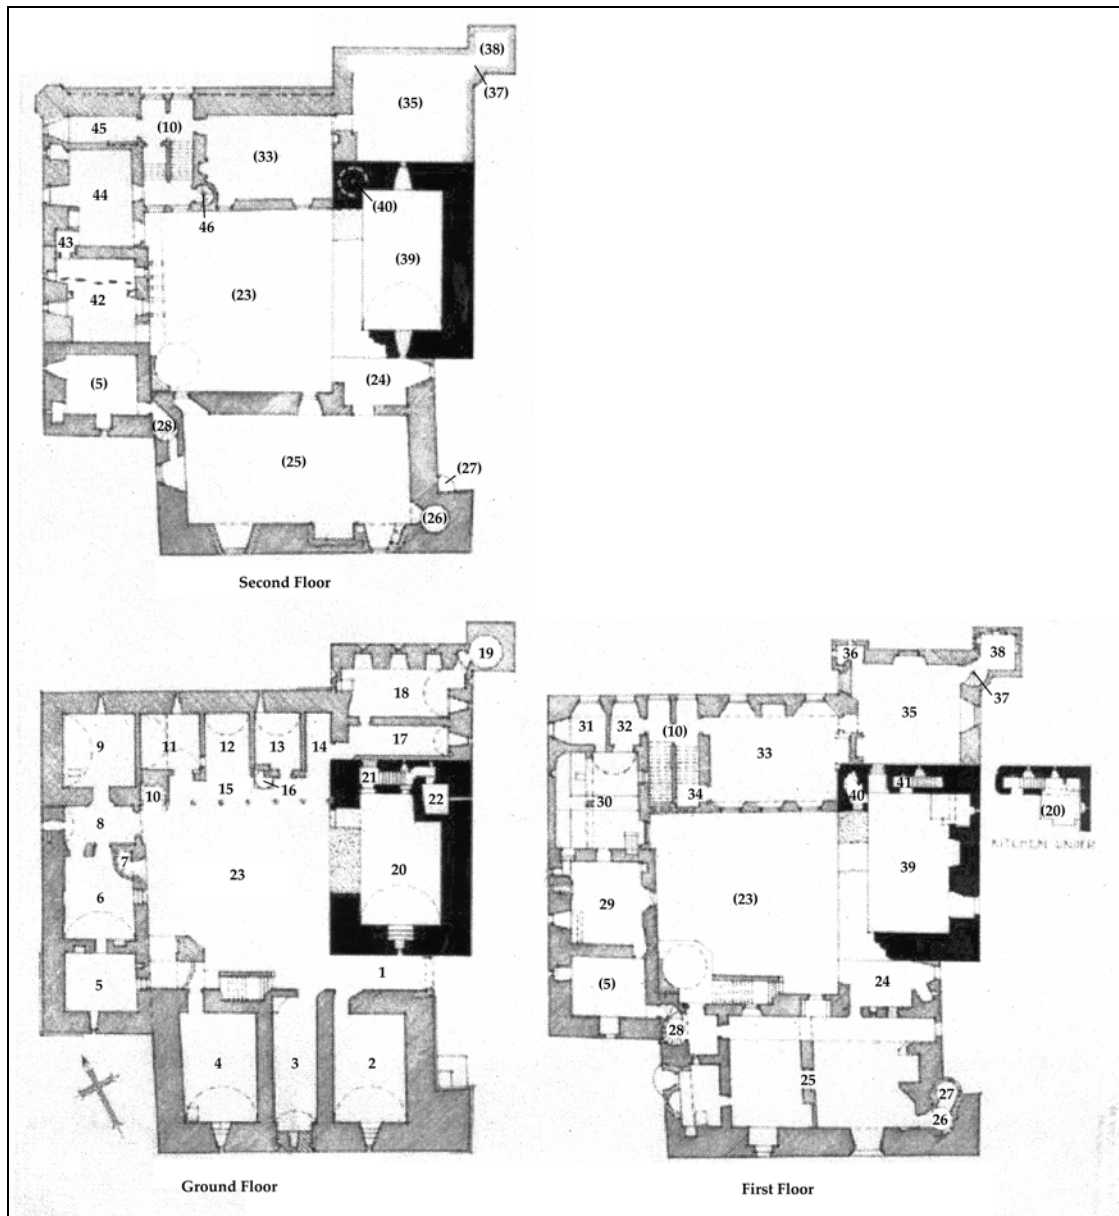
Figure 2: Location of internal components of Crichton Castle (based on a 1920 plan by CST Calder and held by the RCAHMS)

Work commenced with the identification of discrete components throughout the castle and each component was assigned a number. It was necessary to consider and number every space, even those which were out with the targeted standing building recording since any future work may extend into these areas and also so that reference could be made to any area of the castle during standing building recording. The component numbering system was based on the existing spaces rather than attempting to number floor levels and partitioned spaces that no longer exist since this would be interpretation in itself and potentially inaccurate. Work continued with the identification of five components, 10, 25, 42, 43 and 44 only accessible via the scaffolding. A further selection of six components 11, 12, 13, 14, 15 and 33 were selected in order to try to complete a section of the N range in order to understand the development of the N range from ground floor upwards. Each selected component was sketched and a running list of features was created per component (Appendix 1). Features were described and interpreted on pro forma context sheets. Detailed drawings of selected architectural mouldings within the scale-and-platte stair component 10 and a detailed drawing of the second floor fireplace in component 25 was created (Appendix 2). The drawings were labelled with the component feature numbers.
