Historic Scotland
Properties in Care
Minor Archaeological Works 2009

Doune Castle:
Archaeological monitoring,
September 2009

<u>Site</u>	Doune Castle
<u>N.G.R</u>	NN 7284 0112
<u>Project Description</u>	Archaeological monitoring
<u>Project code</u>	HSCO-90335-2009-01

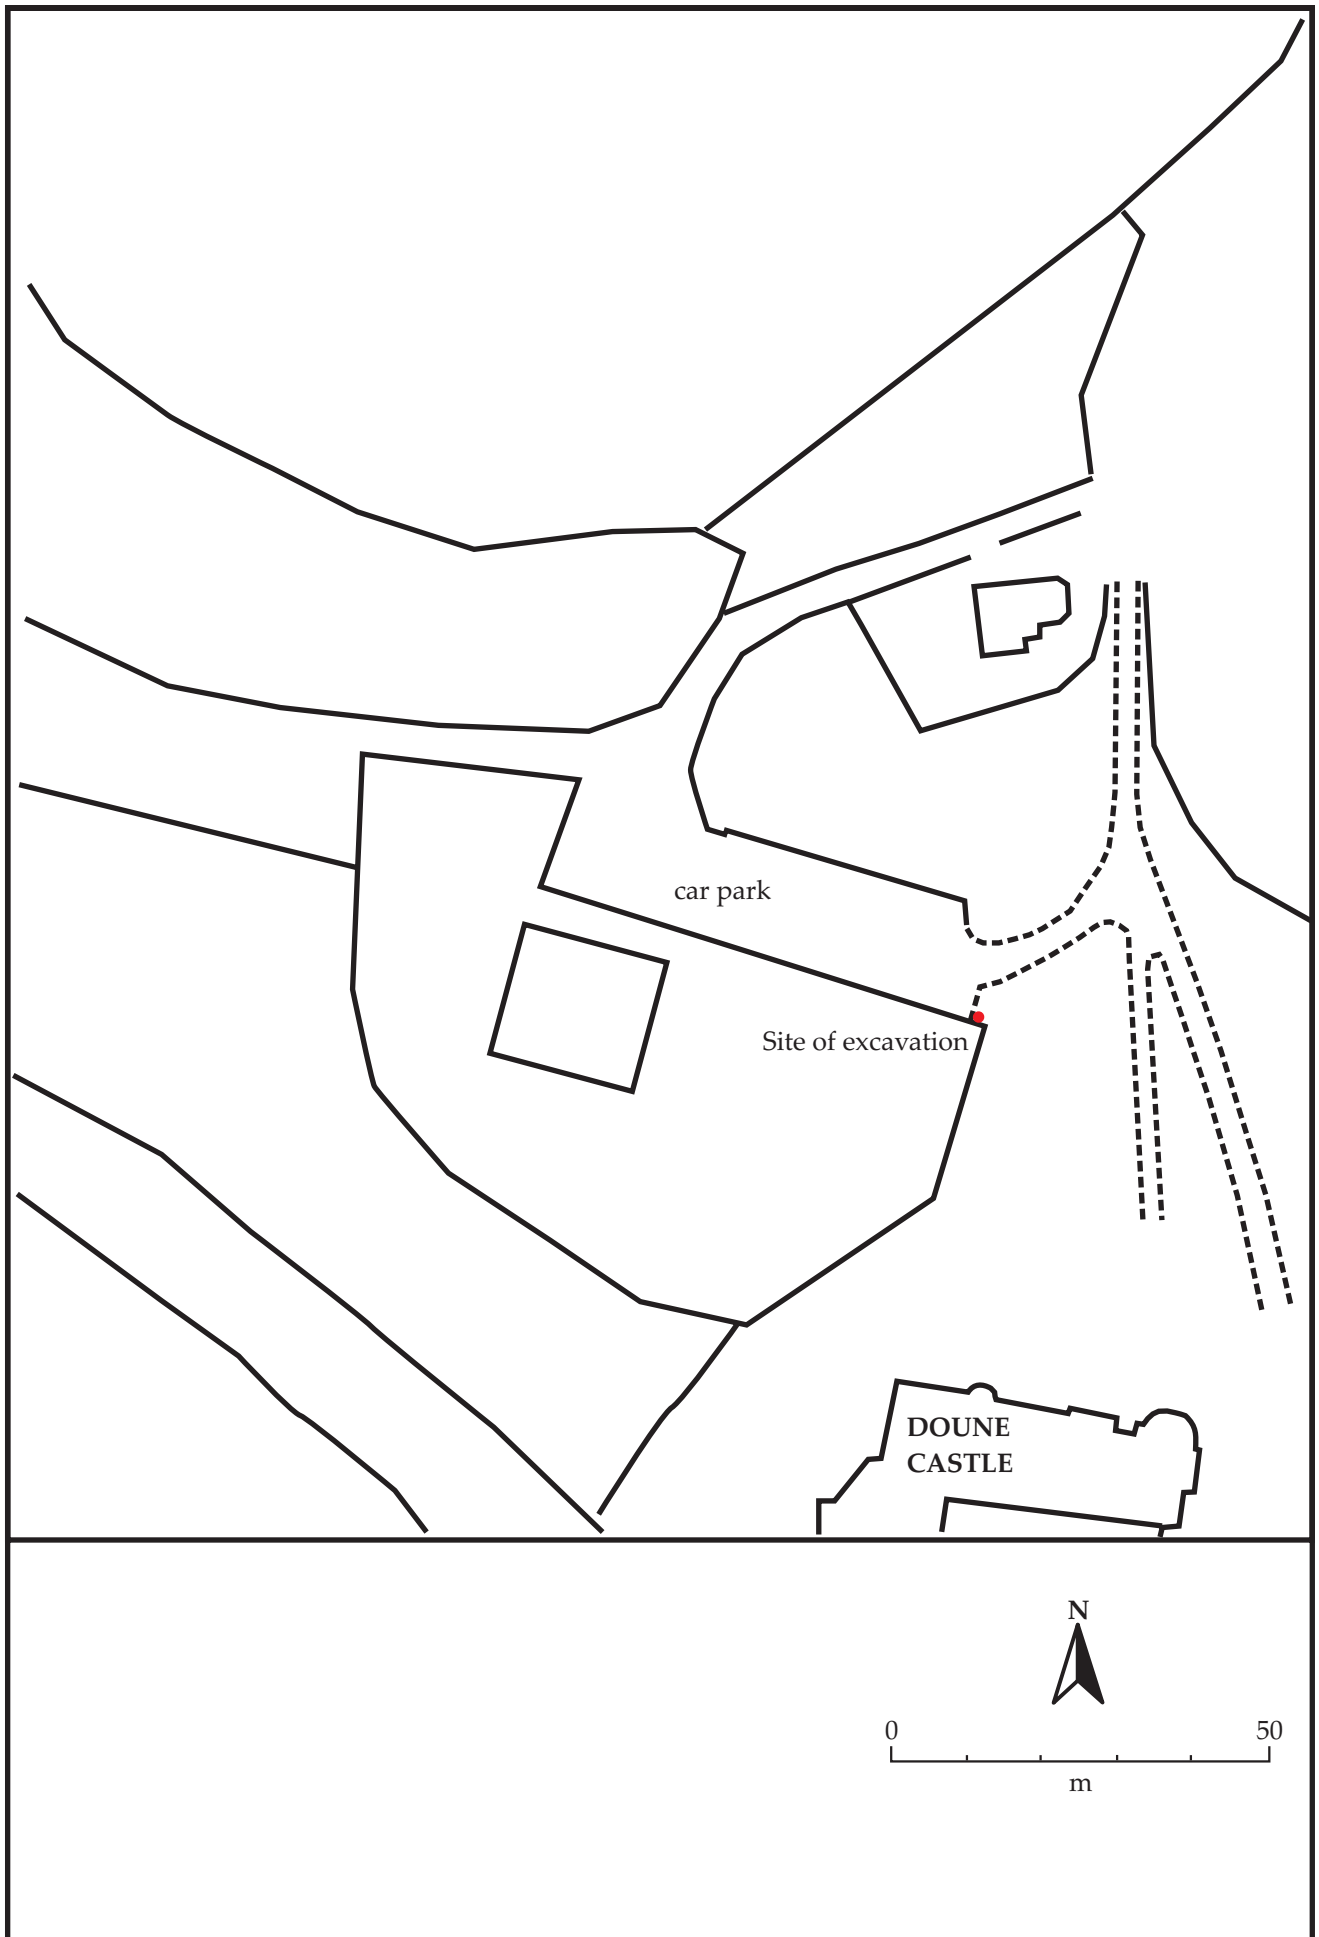
Fig. 1 : Plan (1:1000) showing location of excavation

Under the terms of its PIC call-off contract with Historic Scotland, Kirkdale Archaeology was asked to undertake an archaeological watching brief during the excavation of a trench to install a signpost near Doune Castle. The trench was located on the grassy area at the E end of the S side of the car park to the NW of the Castle.

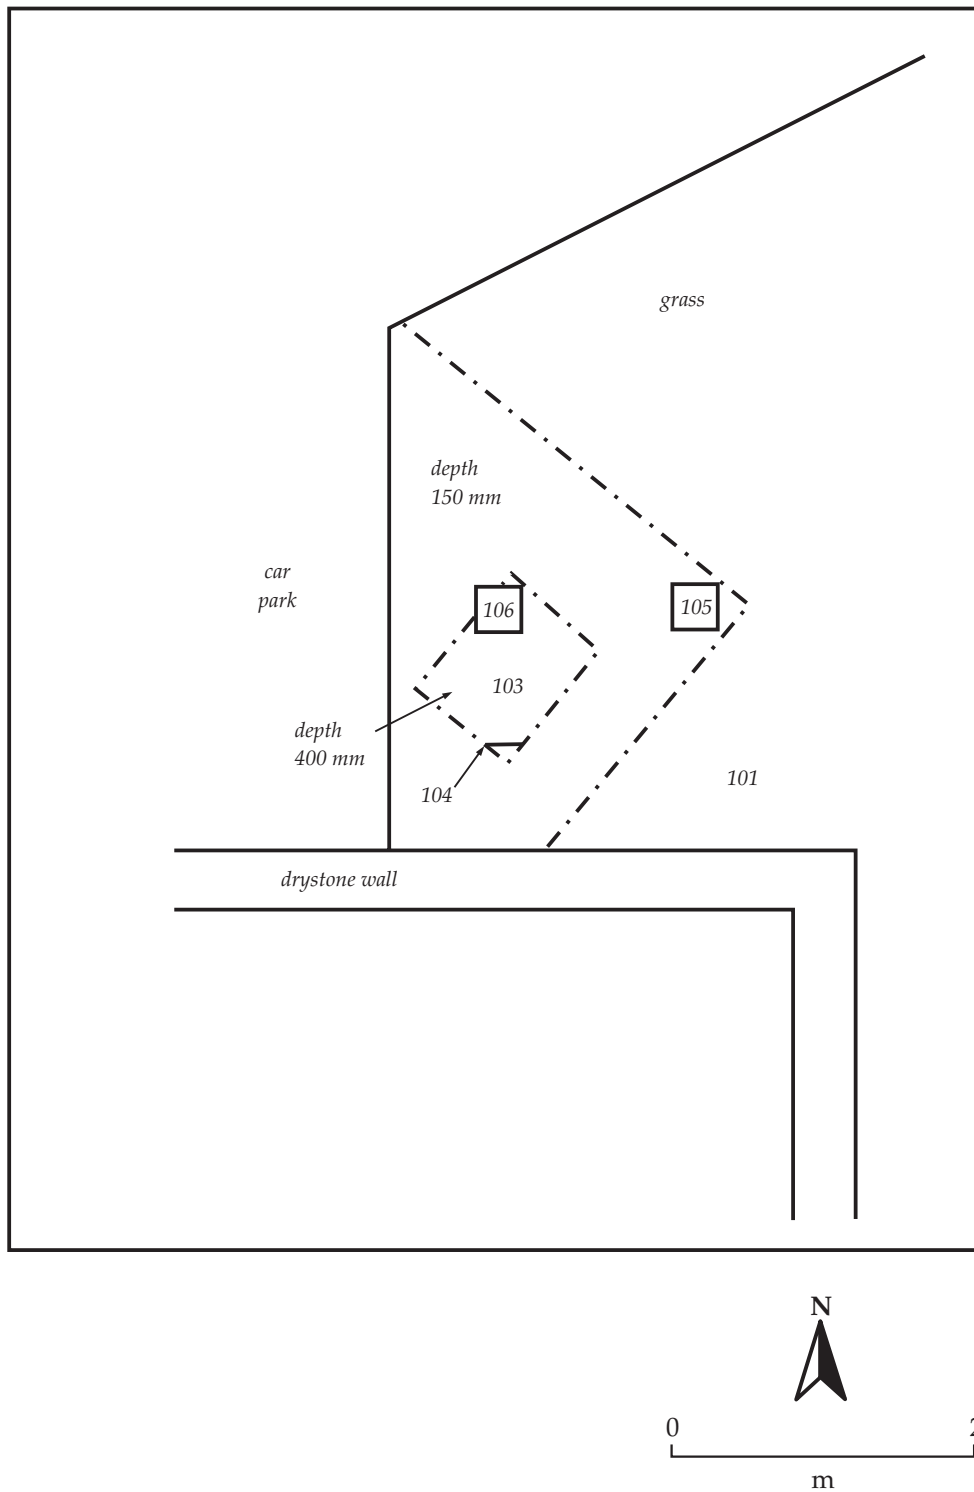
Fig. 2: Plan (1:50) of excavated area

The trench had an irregular shape and measured 3.5 m N-S by up to 2.3 m E-W. The central portion of the trench (to carry the found for the signpost) was 1.00 m NE-SW by 800 mm NW-SE and 400 mm deep. The rest of the trench was cut to a depth of 150 mm to allow 50 mm of bedding under the 100 mm thick grass bars which were to be installed. The grass bars would allow disabled access to the new information signpost. The trench was bounded to the S by a dry-stone wall running E-W.

At a depth of 120 mm, three features were noted. An electricity cable **104** was located running E-W 700 mm out from the N face of the dry-stone wall. At the same depth and 1.00 m apart were two concrete foundations of a demolished fence. The fence would have been aligned E-W and was composed of concrete foundations 1.00 m apart with central wooden uprights (the holes for which are on the upper face of the founds) probably linked with barbed wire (which was found in quantity throughout **102**). Its demolition was likely contemporaneous with the 20th-century landscaping. The E (**105**) and W (**106**) concrete foundations were 300 mm x 300 mm x at least 350 mm deep. On their upper faces was a square hole to carry the wooden upright 80 mm x 80 mm and containing the snapped remains of the post. It was decided that there was no need to remove either foundation.
