Historic Scotland
Properties in Care
Minor Archaeological Works 2009

Overbigging, near Maeshowe Chambered Cairn: Archaeological excavations, May 2009

Project code: HSCO-90209-2009-01

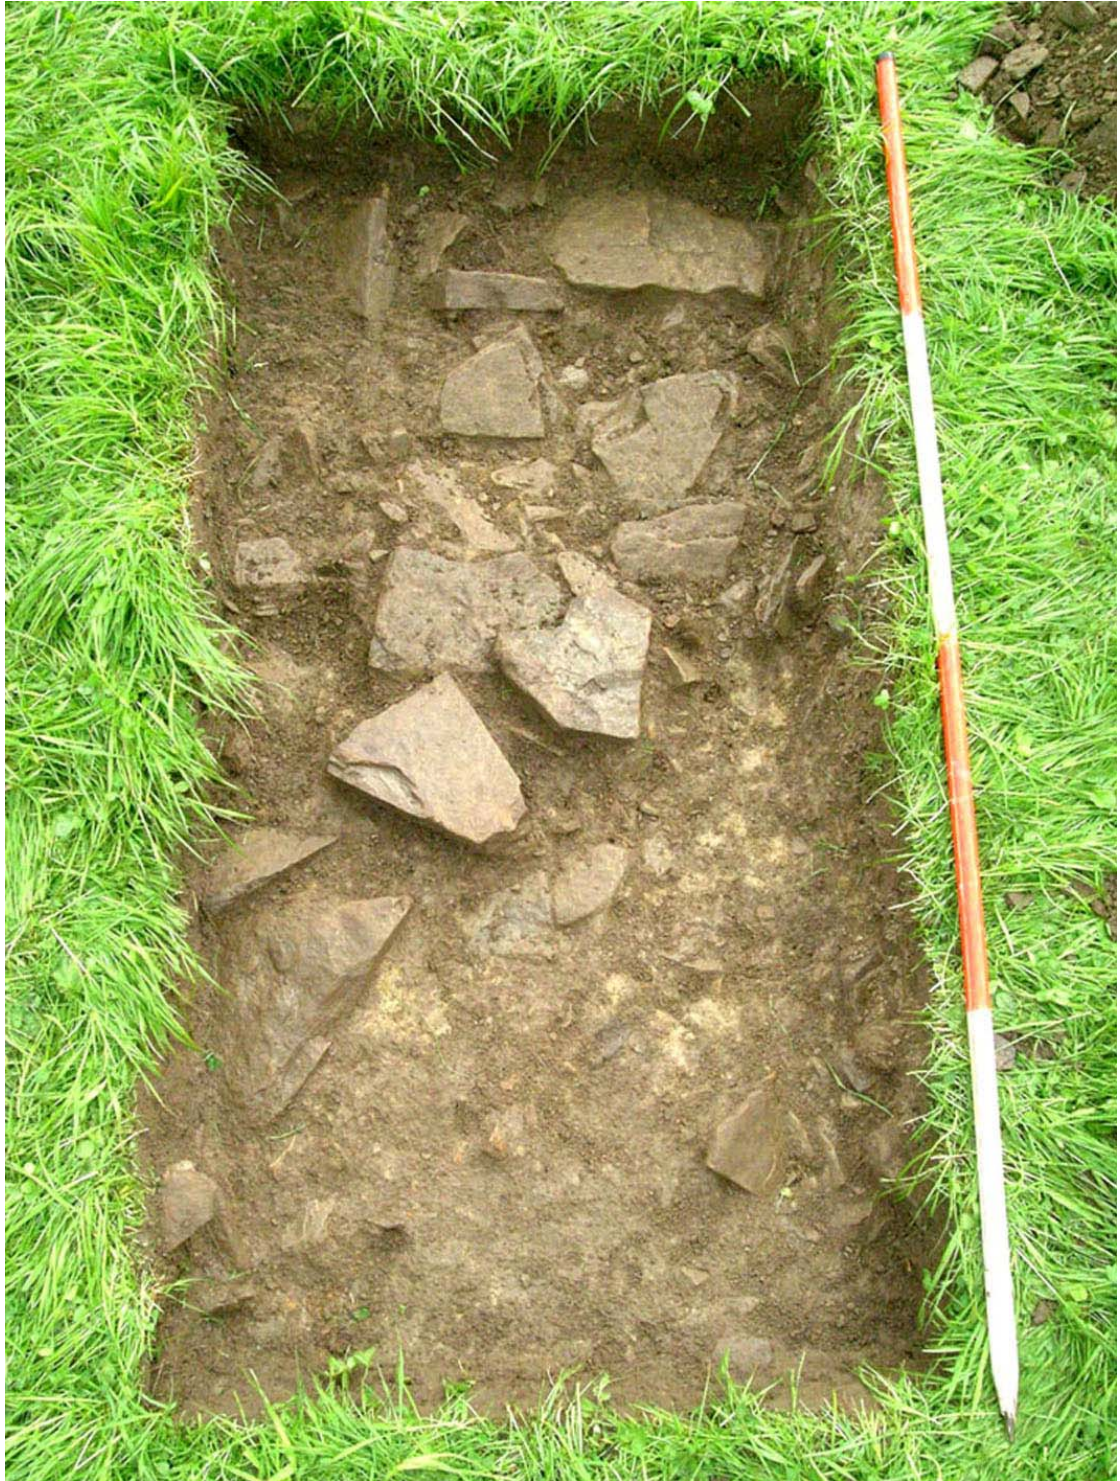
*Plate 1 : Test pit 6, after excavation, showing **F601**, taken from NE*

to medium sized angular flagstone fragments, mostly lying flat, with an apparent N edge running E-W across the trench. The trench was expanded by 1.0 m to the NE, and this action revealed more of this edge, indicating that this is a real archaeological feature. **F601** was not excavated and measured at least 1.80 m NE-SW and was at least 1.40 m E-W.

Test pit 6 showed evidence for a shallower plough-soil, with a spread of flat flagstones below it. This had a good N edge, and was so out of character from the occasional flagstone fragments seen elsewhere that it is almost certainly a man-made feature. It was not excavated, so its date is unknown and its function is far from clear, however it should be noted that the first edition OS map shows a road or track

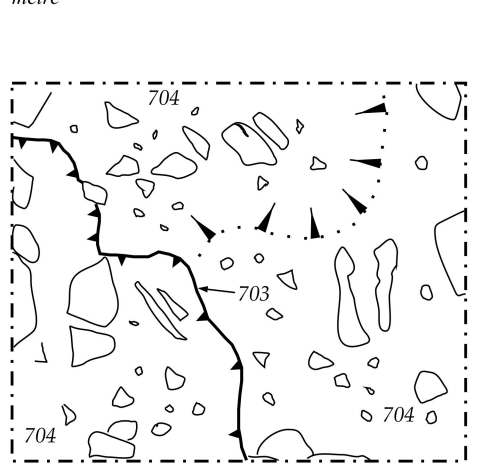
Test pit 7 - plan

Excavation started with test pit 7 in the SW corner of the S field. This was orientated N-S and was located towards the NW side of the base of a low mound. Topsoil **F700** was compact mid brown silty clay 70-80 mm thick. Below this 250-300 mm of **F701** was recorded, pale brown silty clay with patches of very pale grey and orange silty clay throughout. Beneath this most of the trench was covered by **F704**, compact pale orange silty clay with frequent chunks of decaying flagstone throughout. In the SW corner of the trench however an area of compact dark brown silty clay rich in stone, **F702** was noted. On excavation this seemed to sit in a possible shallow curving cut **F703**. This had fairly steep sides and a flat base and was up to 130 mm thick. After the excavation of this feature within the trench the W section, running through **F703** was drawn. The trench was then expanded 200 mm to the W, to attempt to prove if this was a shallow feature, or merely a stone-hole. In the event little further was added, with only part of the curving NE side of the feature exposed. It measured at least 850 mm N-S by at least 600 mm E-W

Test pit 7 produced a good depth of probable plough-soil, with traces of the subsoil ploughed up and re-deposited throughout it. Below this a possible shallow cut feature was noted in its SW corner, only part exposed in spite of extending the trench. This was only 130 mm deep, but had reasonable sides and a flat base, and its fill seemed different from the overlying plough-soil. This seems to indicate that this was a real, albeit truncated feature, but only further excavation could demonstrate this.
