Historic Scotland
SCPP Archaeological Works
2008

Stirling Castle Palace
U31 Plaster Stripping

Standing Building Recording
September 2008

Project Description Standing Building Recording following the removal of plaster from the top of the S end of the E wall in U31.

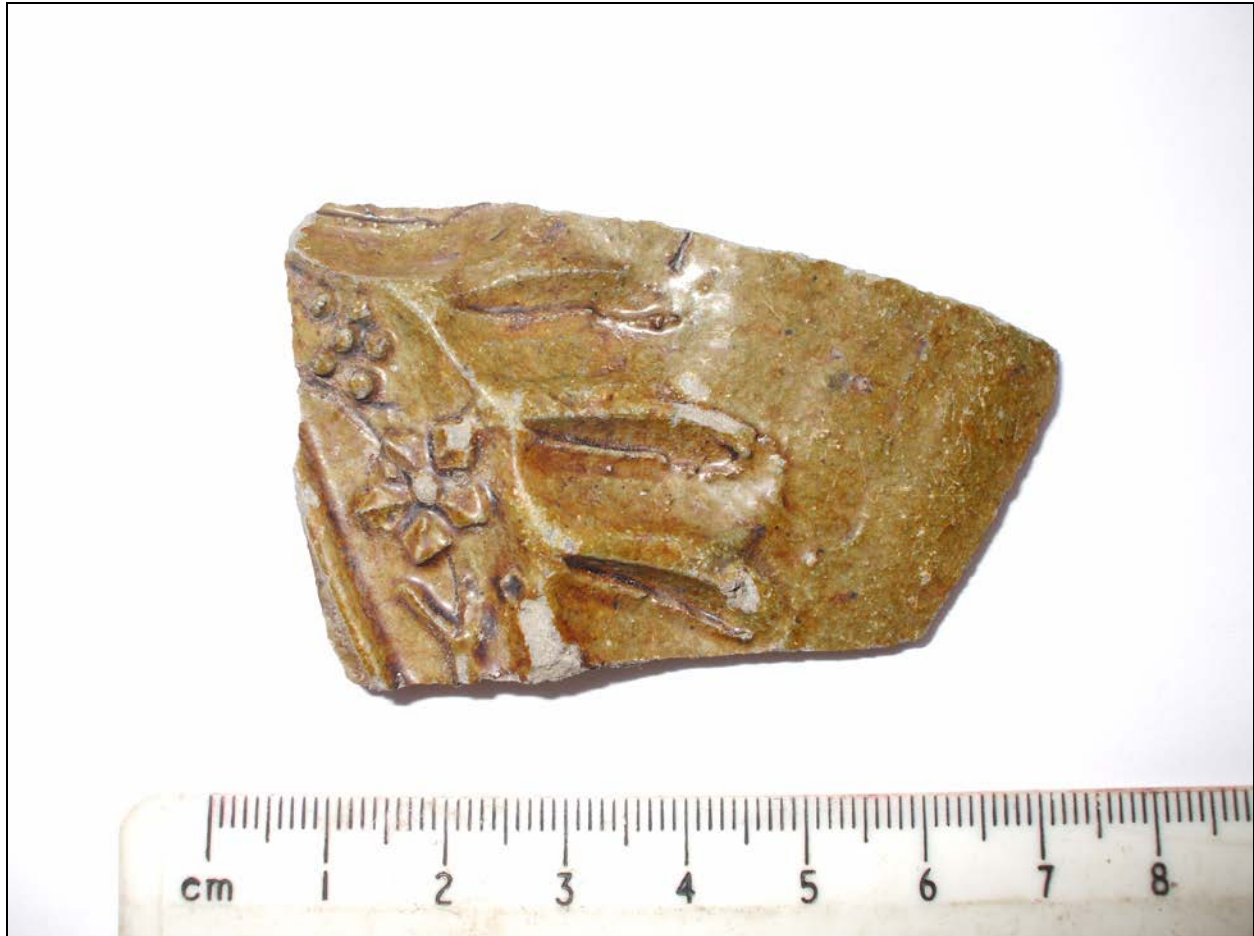
Figure 2: Decorated pot sherd (1255-026)

One item of note, although not an import, is the decorated body sherd from F058 (figure 2) which appears to be from a propaganda or heraldic decorated vessel (1255-026). Similar motifs have been found in mid-16th century contexts at Eyemouth fort and more recently at Cadzow Castle. The symbols in this instance a fragment of the Scottish saltire alongside a 5 pointed star or mullet, and then a floriet design comprising 5 small circular pellets. The iconography of this represents the nation (the saltire), the mullet is most typically used to refer to the 3rd son in the hierarchy of siblings, while the 5 pellet image is part of the Hamilton arms. The combination of the saltire and the pellet design was noted on floor tiles at Cadzow Castle, the significance of the mullet is not apparent at this stage except that it refers to a Knight. Further specialist comment could confirm whether this is a hamilton vessel associated with a particular 16th century figure but at the very least this vessel is a further example of the use of emblematic decoration for clear statements of allegiance, both personal and political.

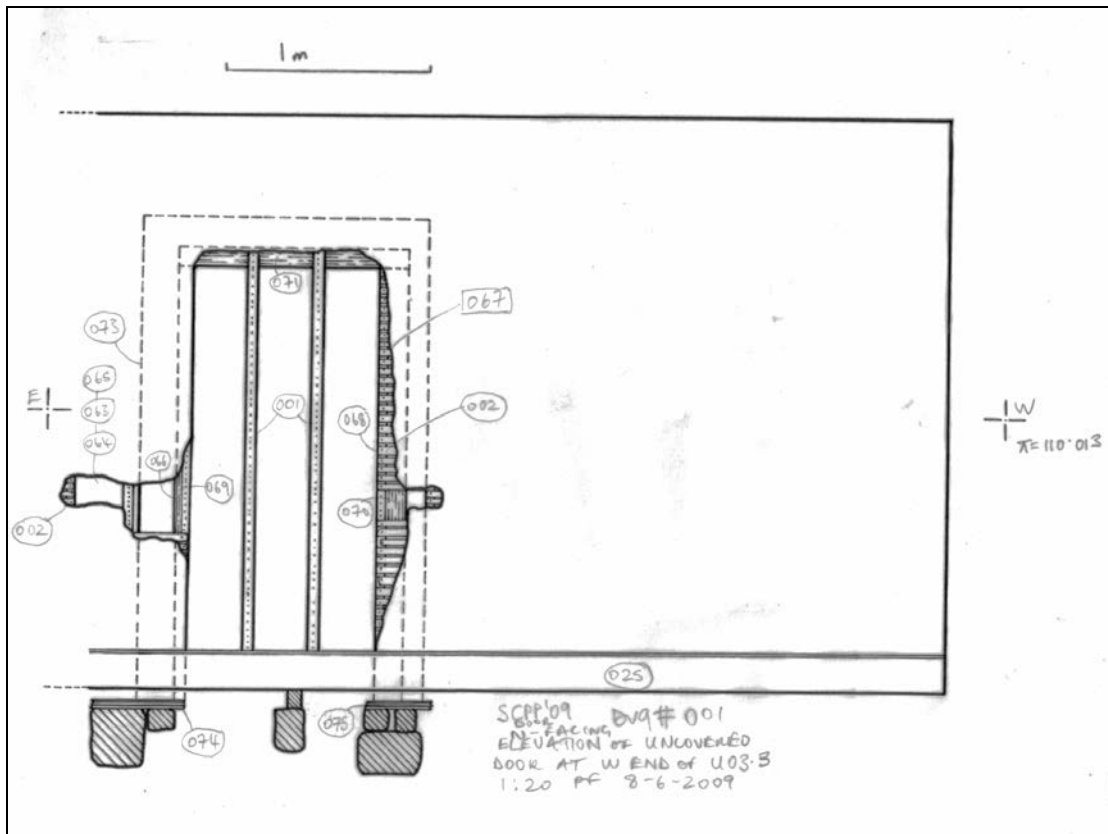
Figure 2: U03.3 Elevation of unblocked door (Drawing 1)

Scans of the field drawings are presented below (figs 2 & 3). These have been converted to CAD which is supplied on the CD

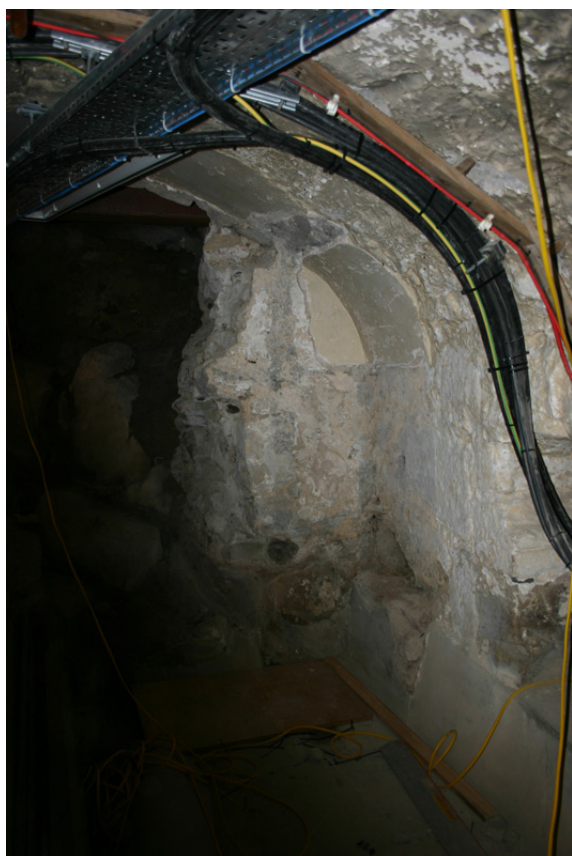
4.1.2 West-Range & North-Range, V19 [Annotated numbers 2-11]

The careful execution of springers, slots and relieving arch suggest a deliberate construction of the aperture in one consistent building operation. The original purpose of the opening is unknown but it may be speculated that the slots originally received timber rails either for fixing wooden boards or for operating a sort of drawer. The original base of the aperture cannot be ascertained due to the existence of the C20 concrete apron but it may well have extended to the current floor-level of V19, resulting in a floor-to-vertex height of approximately 120 cm

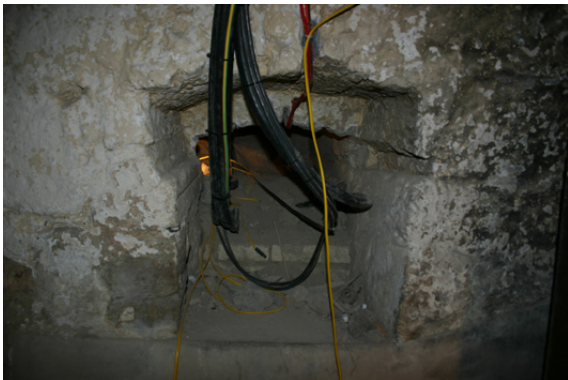
4.1.3 *West-Range & North-Range, V19 [Annotated numbers 4-10]*

The non-matching appearance of both parts of the relieving arch possibly points to the employment of reused material that was utilised in the construction of the aperture. The only important common elements are the slots carved at a corresponding height into the lateral faces of the aperture, suggesting deliberate arrangement of the slots at a height of ca. 81 cm above current floor-level

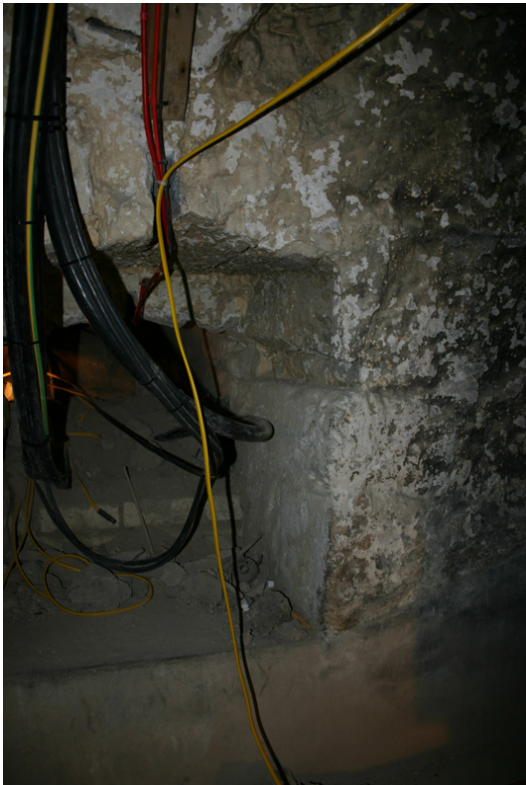
4.1.4 West-Range & North-Range, V20 [Annotated numbers 12-14]

The west wall of V20 and the immediately adjoining base of the southern wall represent one construction phase. The remaining part of the south-wall, as well as the entire shaft above lintel-level, must have been erected in a second step

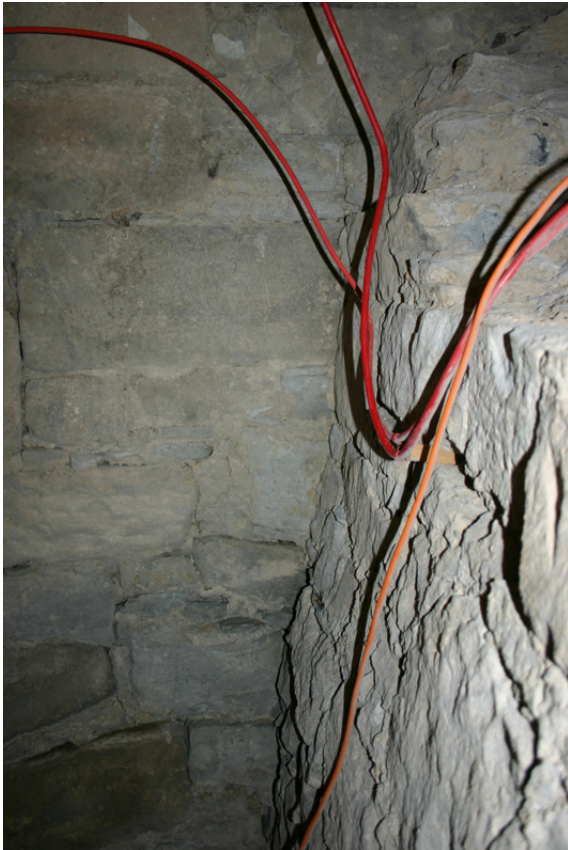
4.1.6 *West-Range & North-Range, V20 [Annotated number 15]*

The particular distribution of brown rubble in corresponding parts of the adjoining walls suggests contemporary erection of this part of the south and west walls of V20.

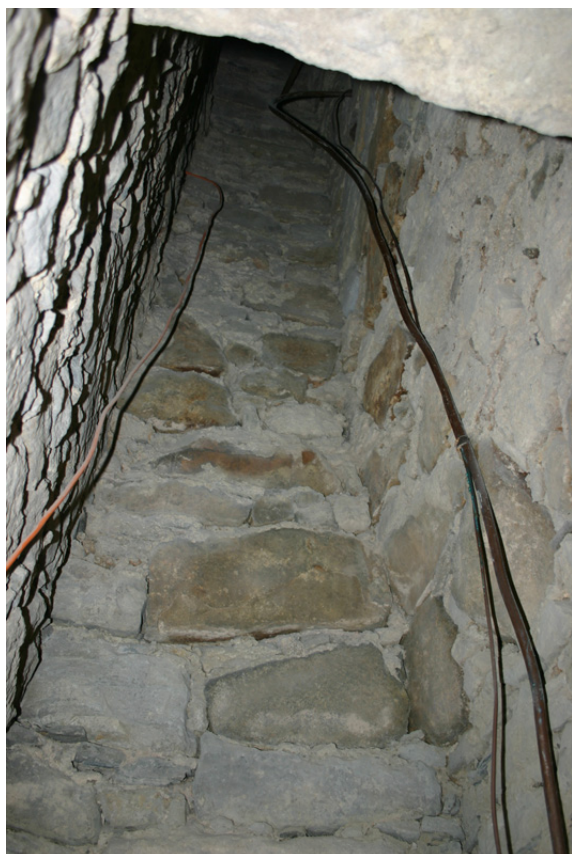
4.1.7 *West-Range & North-Range, V20 [Annotated number 16]*

The opening must be integral with the surrounding wall. This assessment, however, does not prove that wall and aperture are contemporary as the opening could have been inserted into existing masonry. The bottom parts of the south-wall (roughly up to aperture level) and the west-wall (roughly up to lintel level) appear to be a single construction unit.

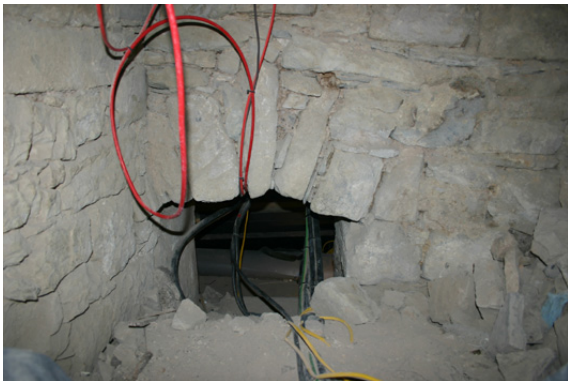
4.1.8 West-Range & North-Range, V20 [Annotated numbers 17 & 18]

It seems that the joint between the west and north walls was not created by butting one wall against the other but forms a structural entity.

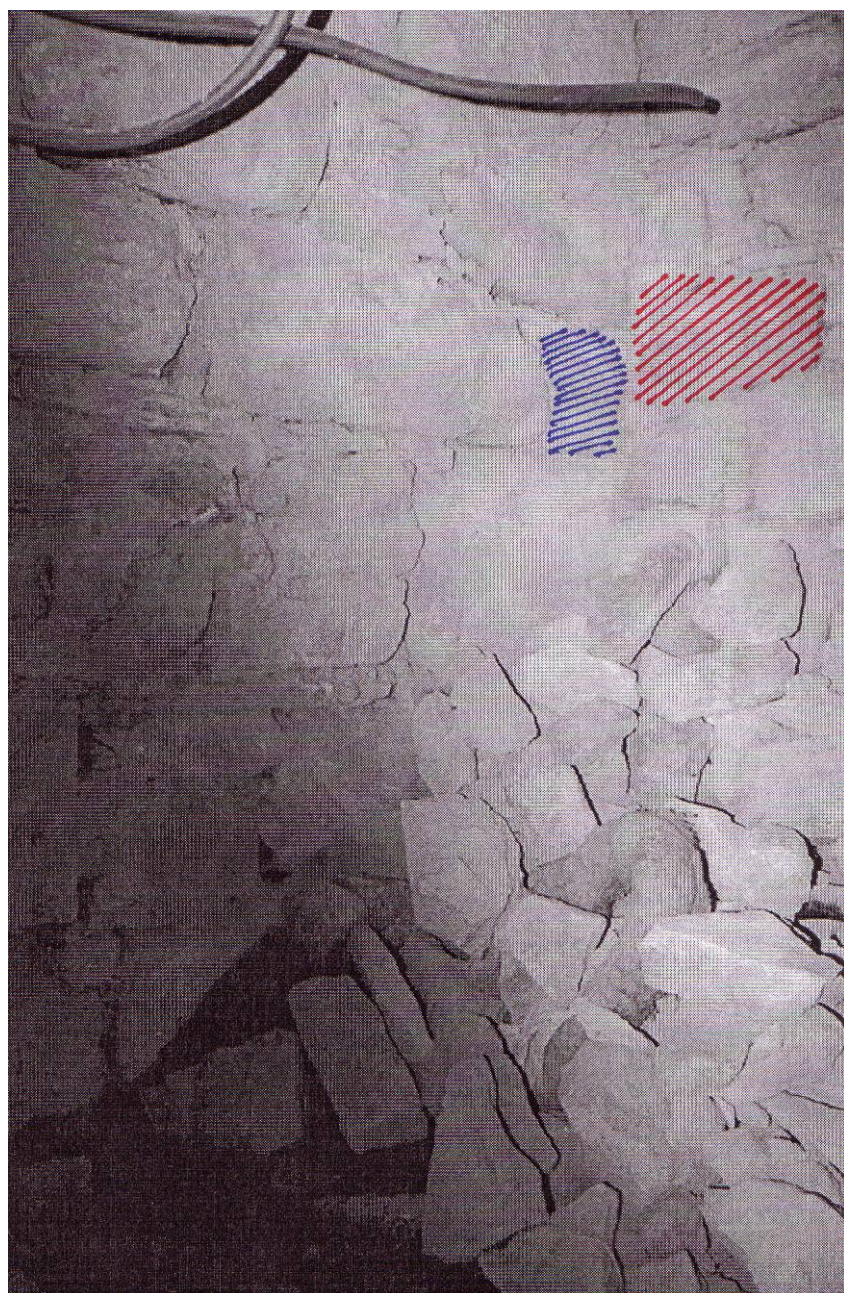
4.1.9 West-Range & North-Range, V20 [Annotated numbers 19 & 20]

It is very likely that the north and east walls have been created in one operation

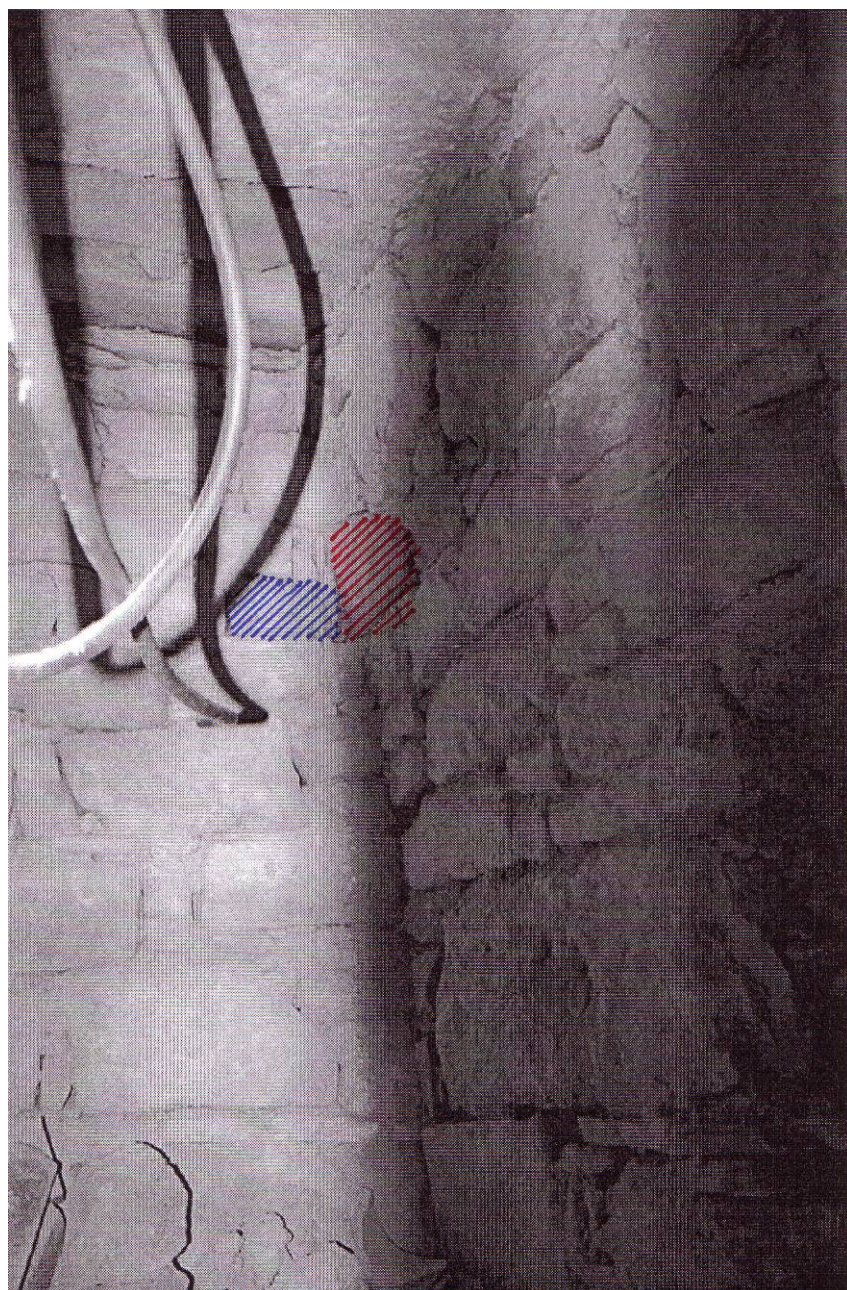
4.1.10 West-Range & North-Range, V20 [Annotated numbers 21-24]

The reduction of the sectional area of V20 at lintel-level suggests original usage of V20 either as service duct, chimney or garderobe. The appearance of similar stones immediately underneath the lintels in the west and north-walls strengthens the assumption that the shaft was created in one construction phase.

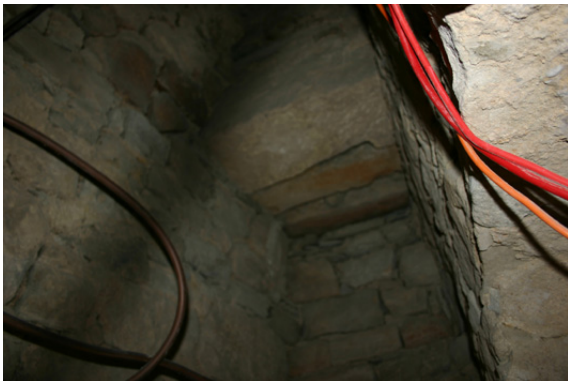
4.1.11 West-Range & North-Range, V20 [Annotated number 15]

The usage of matching material in all walls of the shaft suggests one construction phase. The absence of soot rules out any active former usage as a chimney stack

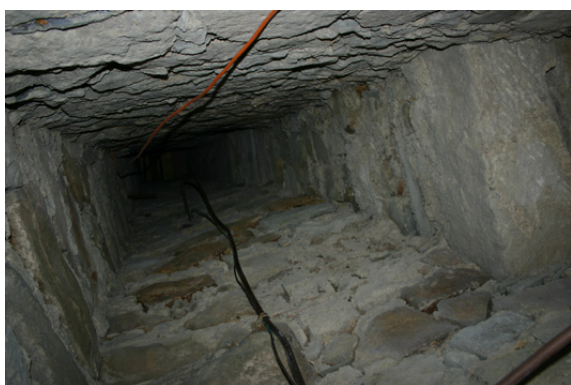
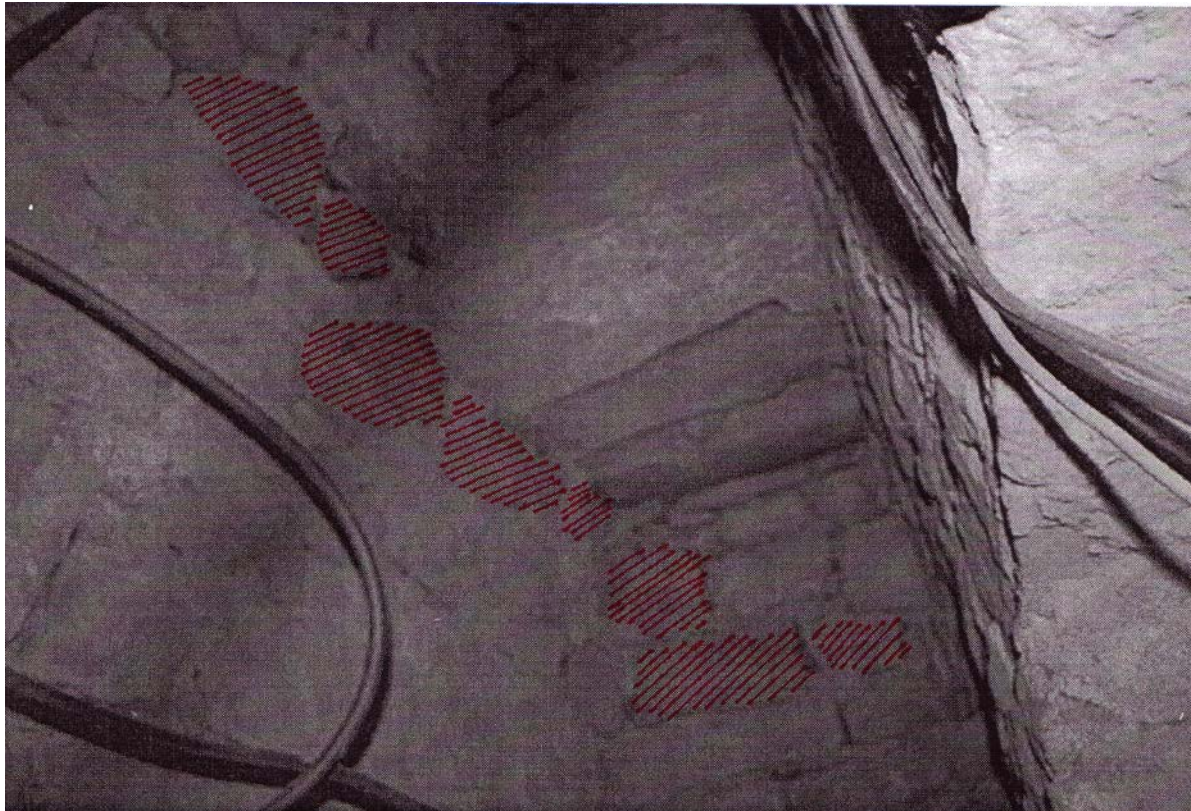
Interpretation:

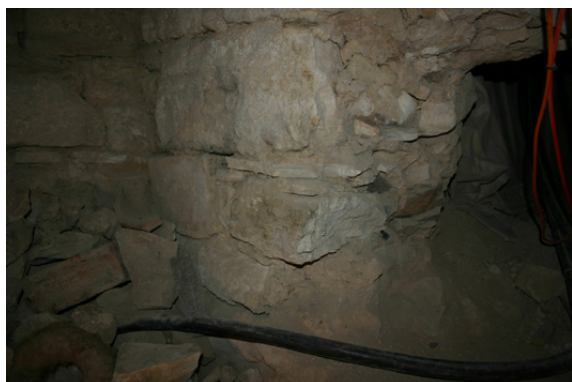
4.1.13 West-Range & North-Range, V20 [Annotated number 26]

Massive blocks of sandstones, probably sitting on a layer of bedrock, form the foundation of the wall between the King's Guard Hall and the West Range.

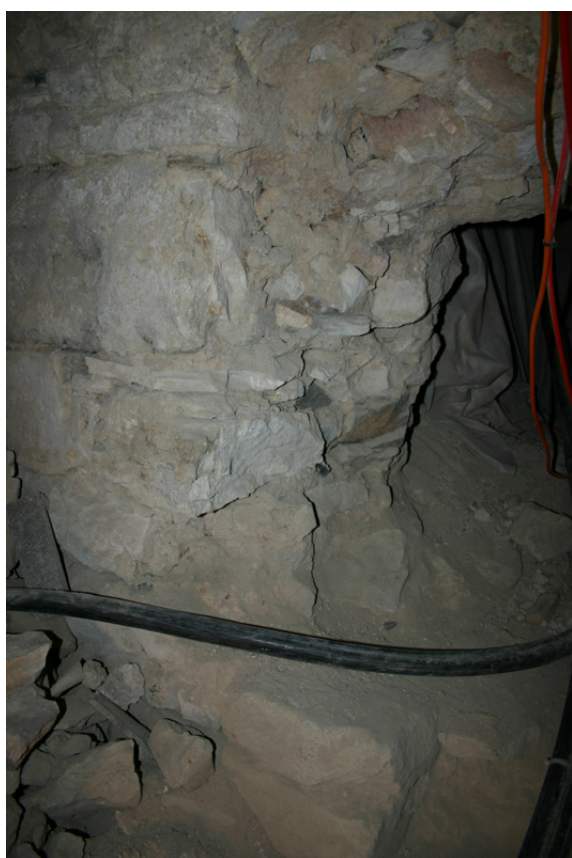
4.1.14 *West-Range & North-Range, V21 [Annotated number 27]*

The space, which is the result of a C19 or C20 intervention, did not serve any kind of distinguished architectural purpose. The void was driven into infill which adjoins the palace wall between P02 and West Range to the east below P02 floor-level.

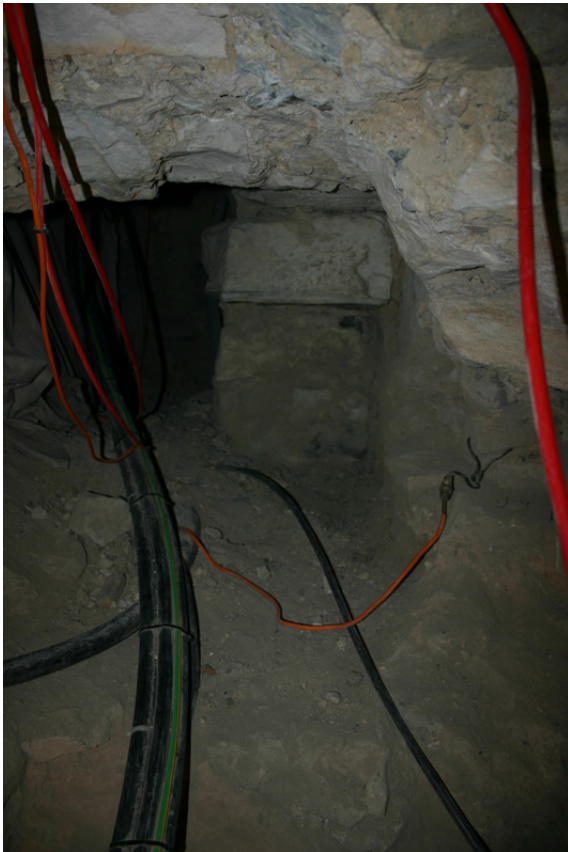
4.1.15 *West-Range & North-Range, V20 [Annotated numbers 28 & 29]*

These works most likely relate to the capping of this void after the asbestos removal works of 2005.

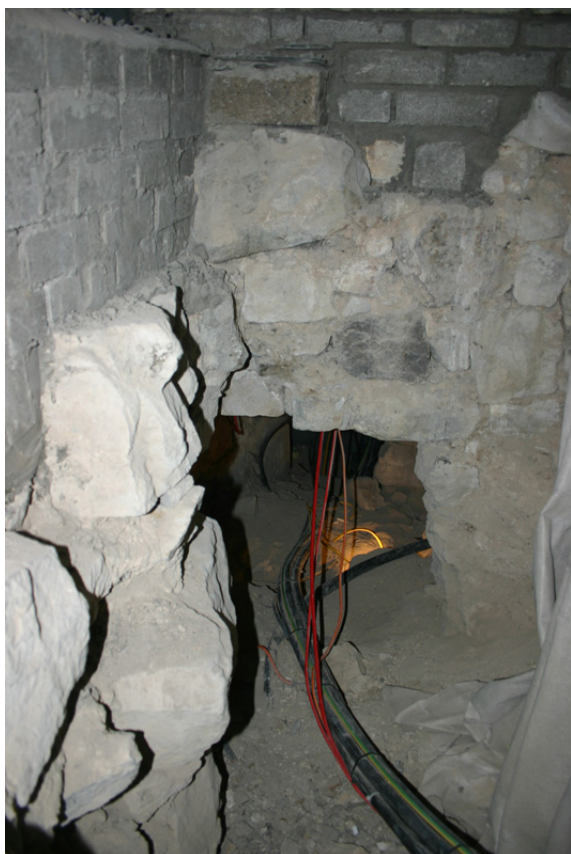
4.2.1 West-Range & North-Range, V20 & P12 [Annotated numbers 30 & 31]

The different architectural character may reflect the different function of both wall-parts. Alternatively it could suggest different erection dates of wall-surface and wall-core

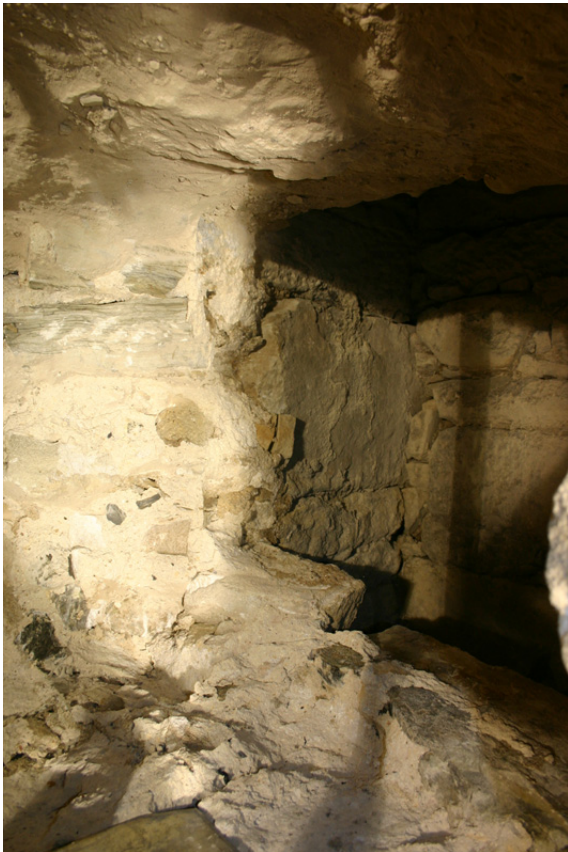
Interpretation:

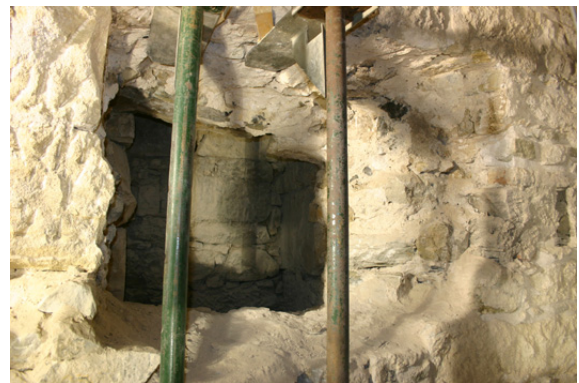
4.2.2 *West-Range & North-Range, V20 & P12 [Annotated number 32]*

The poor structural interlocking strengthens the impression that the wall between P01 and West Range comprises two construction stages, with the western surface being of more recent construction.

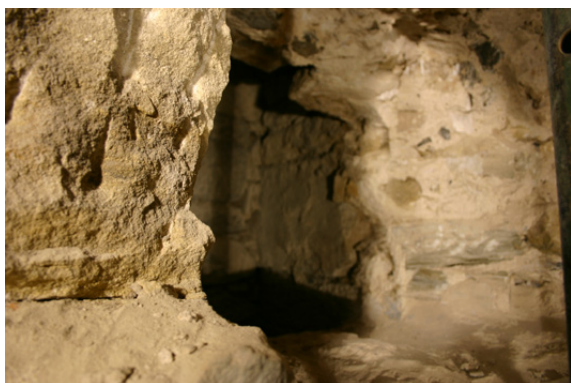
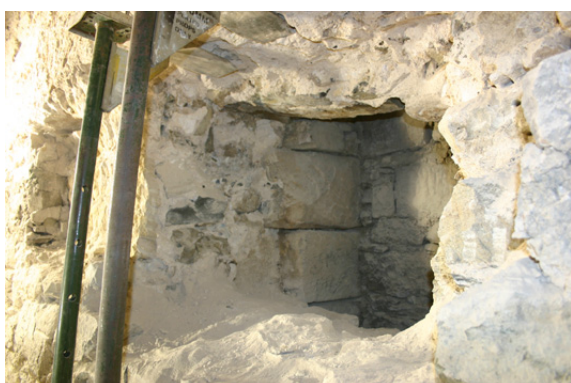
Interpretation:

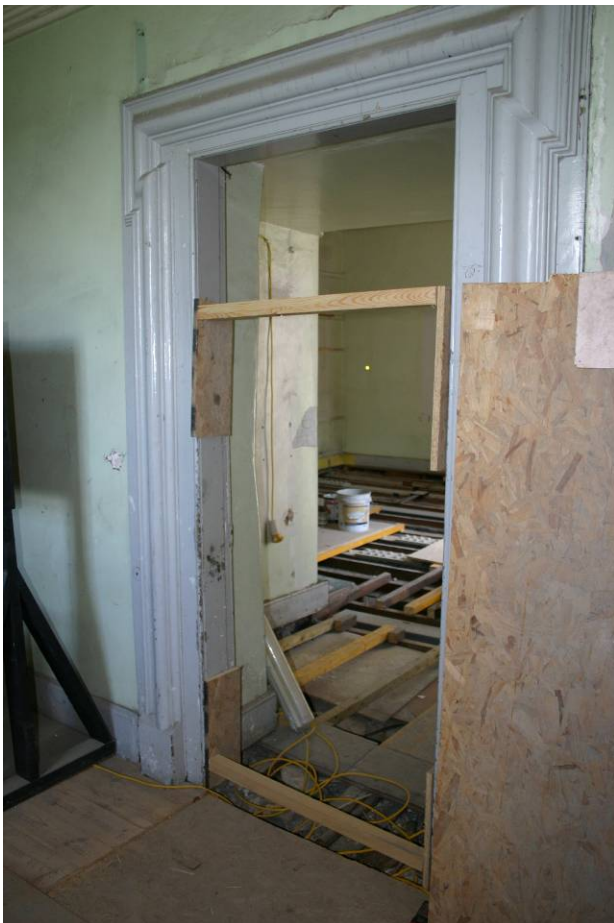
4.3.2 *West-Range & North-Range, V20 & U04 [Annotated number 33]*

This arrangement may point to an original function of V20 as a garderobe

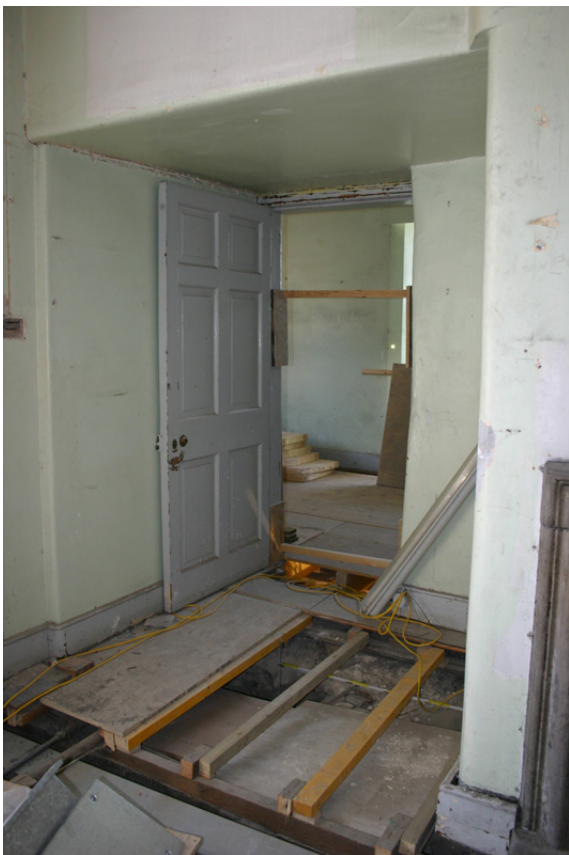
4.3.3 *West-Range & North-Range, V20 & U04 [Annotated number 34]*

The principal purpose of the lintels is to narrow the area of the chute in order to allow the creation of the platform at the upper floor level.

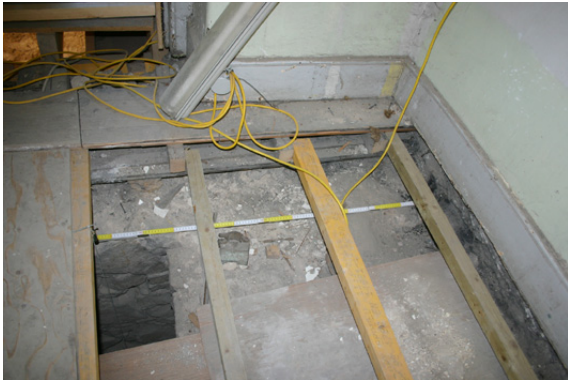
Interpretation:

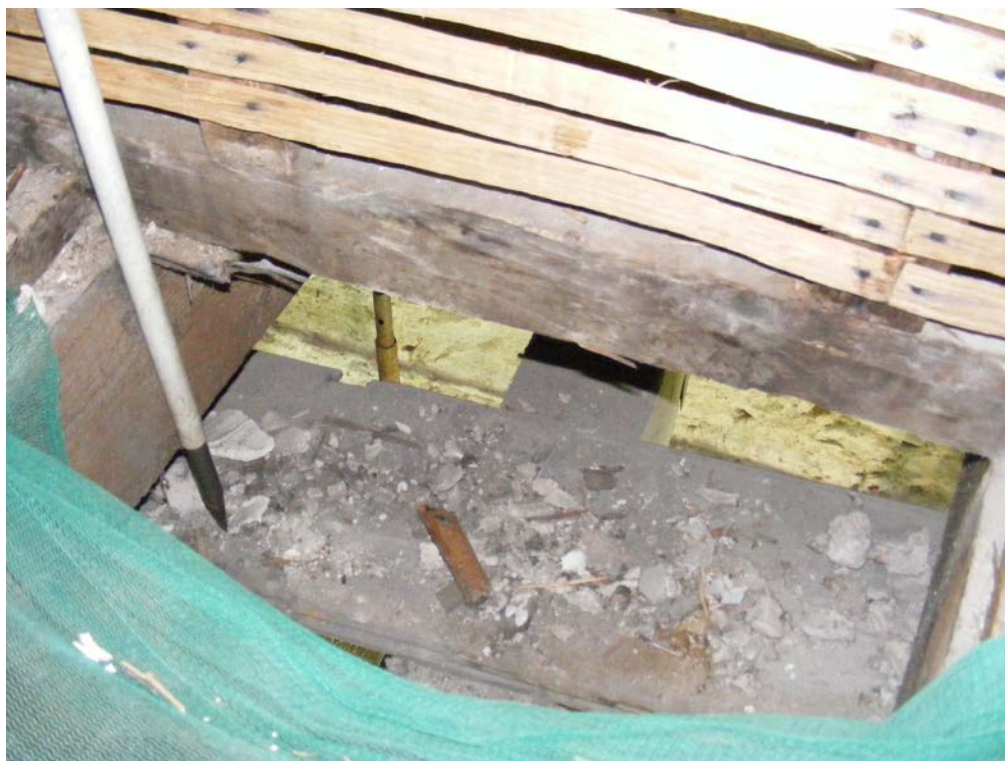
Figure 2: Location of the discovery (in the SW corner of U20)

On examining the find spot it was realised that this was an area where the lath and plaster had been removed, exposing the timber framework behind. This took the form of a horizontal sill beam on which rested three vertical members and one diagonal bracing beam. All were substantial squared timbers, and the bracing beam rose from the N side of the base of the S beam diagonally up to the N. The middle vertical member was sawn in two and attached to top and bottom of this diagonal beam, which ended against the S face of the most northerly vertical one.
