**Historic Scotland  
Properties in Care  
Minor Archaeological Works 2010**

**Burleigh Castle:  
East Gate Trenches  
September 2010**

**HS PIC Index Number: 90045  
Project Code: HSCO-90045-2010-01**

<b><u>Site</u></b>	Burleigh Castle, near Milnathort.
<b><u>N.G.R</u></b>	NO 12890 04597
<b><u>Project Description</u></b>	Archaeological watching brief on the excavation of two trenches to house the new E access gate to the castle.
<b><u>Project Code</u></b>	HSCO-90045-2010-01

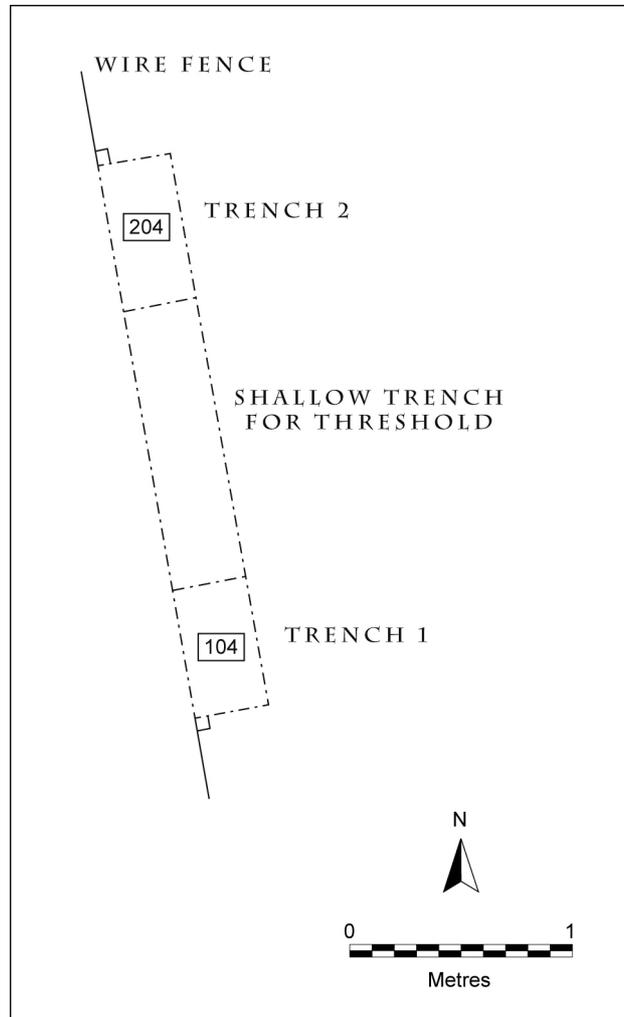
Figure 3: Plan of trenches 1 and 2.

Trench 1 (see Figure 3) was 600mm N/S x 350mm E/W x 800mm deep and was excavated to house the S gate post. The fills consisted of (101), a turf and mid-brown sandy silt 200mm thick over a moderately compact mixed mid-brown layer of silt flecked with mortar (102) some 300mm thick. Within this layer was an 1896 one penny coin SF101. Below (102) was a moderately compact layer of brown silt and smashed degraded reddish sandstone (103) up to 150mm thick. Layer (102), with a *terminus post quem* of 1896, shows that the platform (or at least this section of it) was a later formalisation of the ground surrounding the castle, perhaps due to issues of drainage or the visual landscaping of the site. Nothing was found within (103) so it was unclear as to whether it related to the later landscaping or whether it formed the pre-landscaping ground surface. Below (103) was a layer of compact reddish brown silty clay (104), excavated to a depth of 150mm (but not bottomed), which may have represented a buried or compacted topsoil/subsoil. The layer was flecked with charcoal and contained a single body sherd of a green-glaze pottery vessel SF102. The two possible scenarios that emerged from this were that either (104) was the original ground surface which was subsequently covered by a layer of stone and silt (103) (possibly due to water logging) and in the same way by (102), or that (103) represented the original ground surface

(strewn with remnants of the demolition debris of the ancillary courtyard buildings) which was then landscaped over by (102).

Trench 2 (see Figure 3) was 700 mm N-S x 350 mm E-W x 800 mm deep and was excavated to house the N gate post. The fills consisted of (201) a turf and mid-brown sandy silt 200mm thick over a moderately compact mixed mid-brown layer of silt flecked with mortar (202) 300mm thick. Below (202) was a moderately compact layer of brown silt and smashed and degraded reddish sandstone (203) up to 150mm thick. Below (203) was a layer of compact reddish brown silty clay (204), excavated to a depth of 150mm (but not bottomed) which again possibly represented a buried compacted

topsoil/subsoil. The layer was flecked with charcoal. All the layers were again consistent with those found in Trench 1 and the same interpretation could be applied to them.

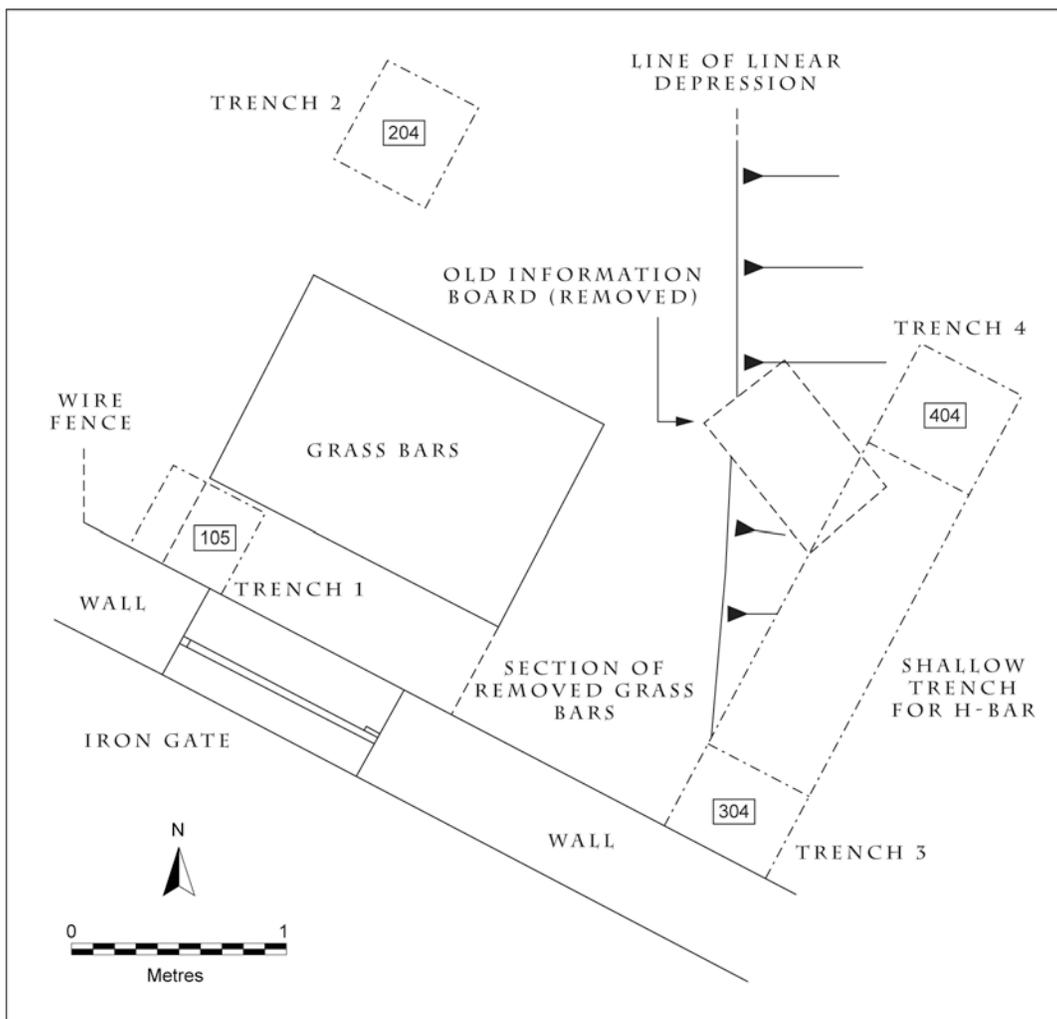
Figure 3: Plan of Trenches 1, 2, 3 and 4.

Trench 1 (see Figure 3) was 440mm N/S x 500mm E/W x 600mm deep and was excavated to house the SW gate post. The fills consisted of (101), a turf and mid-brown sandy silt 60mm thick over a moderately compact mixed mid-brown layer of silt flecked with mortar (102), 200mm thick. Below (102) was a moderately compact layer of gritty sand and brown silt (103) up to 200mm thick. Below (103) was a layer of moderately compact brown silt (104), sealing a layer of smashed degraded angular pieces of red sandstone (105). This layer was exposed, but not bottomed, to a depth of 40mm. Context (102) contained modern glass and pottery while the interface between (104) and (105) contained a piece of clay pipe stem and an animal tooth. Layer (103) was truncated to the S by a sloping cut (106) 150mm deep x 100mm N/S, intended for the insertion of the modern mortar-bonded sandstone S boundary wall (109). This wall sat on a concrete foundation (108) 50mm thick. The cut (106) was backfilled with a mixed fill of sand, mortar and silt (107).

It appeared that (101) and (102) were modern levelling layers introduced after the insertion of the S Boundary Wall (the cut for the wall did not continue up through (102) and (103)) while (103), (104) and (105) were likely to be older, albeit still indicating landscaping. Dating the clay pipe stem could provide a date for this activity.

Trench 2 (see Figure 3) was 540mm N/S x 500mm E/W x 600mm deep and was excavated to house the NW gate post. The fills consisted of (201), a turf and mid-brown sandy silt 100mm thick, over a moderately compact mixed mid-brown layer of silt flecked with mortar (202) 250mm thick. Below (202) was a layer of smashed and degraded angular pieces of red sandstone in a matrix of mid-brown silt (203) some 150mm thick. This sat over a layer of moderately compact mid-brown silt containing numerous small sub-rounded pebbles (204) that was excavated (but not bottomed) to a depth of 100mm. Within (202) were three heavily corroded iron nails; nothing was recovered from (203) or (204).

Trench 3 (see Figure 3) was 440mm N/S x 540mm E/W x 800mm deep (max.), and was excavated to house the SE gate post. The fills consisted of (301), a turf and mid-brown sandy silt 80mm thick over a moderately compact mixed mid-brown layer of silt flecked with mortar (302) that was 200mm thick. Below (302) was a moderately compact layer of gritty sand and brown silt (303) up to 300mm thick. Below (303) was a layer of angular pieces of sandstone rubble and fieldstones (304). This was exposed, but not bottomed, to a depth of 200mm. Layer (304) contained modern white pottery sherds, showing that all the layers within the section could be attributed to modern landscaping.

Layer (303) was truncated to the S by a sloping cut (305) 150mm deep x 200mm N/S related to the insertion of the modern mortar-bonded sandstone S boundary wall (308). The wall sat on a concrete foundation (307), some 50mm thick. The cut (305) was backfilled with a mixed fill of sand, mortar and silt (306).

Trench 4 (see Figure 3) was 540mm N/S x 540mm E/W x 600mm deep (max.) and was excavated to house the NE gate post. The fills consisted of (401), a turf and mid-brown sandy silt 100mm thick, which lay over a moderately compact mixed mid-brown layer of silt flecked with mortar (402) 100 mm thick. Below (402) was a layer of small sub-rounded stones in a silty matrix containing lots of coal and modern pottery (403), some 300mm thick. This sat over a further layer of moderately compact mid-brown silt containing numerous small sub-rounded pebbles (404), excavated but not bottomed to a depth of 100mm. Within (404) two clay pipe stems were recovered, along with modern pottery - showing that the various fills of the trench could be attributed to relatively modern landscaping.
