**HISTORIC SCOTLAND PROPERTIES IN CARE  
MINOR ARCHAEOLOGICAL WORKS 2014/2015**

**Edinburgh Castle War Memorial • Excavation**

**DESCRIPTION:** Excavation prior to the construction of the new World War I Memorial.

**PROJECT CODE:** HSCO-90130-2014-03

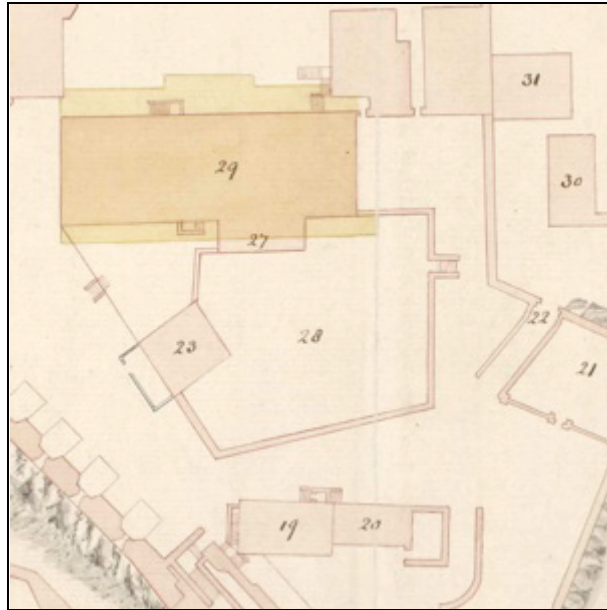
**Fig.5:** 1750 William Skinner and Stephen Fane *Plan of Edinburgh Castle*  
(23: The Main Guardhouse; 28: The Governor's Garden).

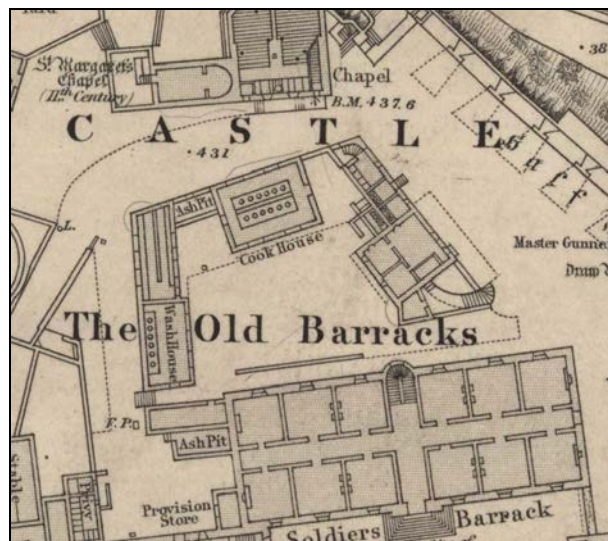
**Fig.6:** Detail from the 1st Edition Ordnance Survey plan of 1854.

The area of the Governor's Garden takes on a more utilitarian role following the erection of a new Governor's House in 1740-2. The footprint of the boundary wall is preserved but it becomes an area for service buildings such as the Cook House and Wash House, both seen on the 1<sup>st</sup> edition Ordnance Survey plan of 1854.

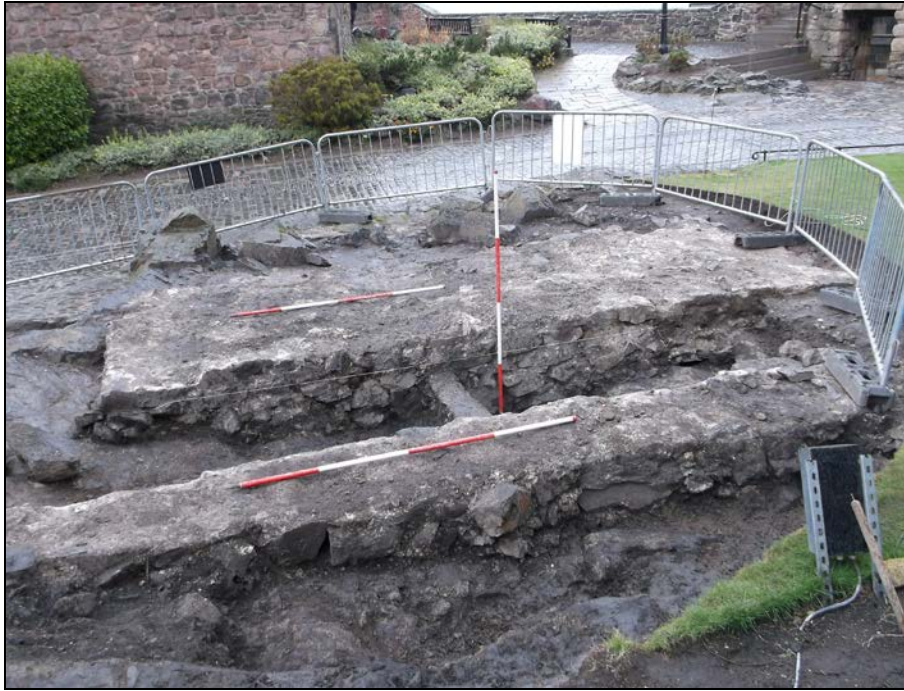
**Plate 1:** Site from the S, showing the S wall of the Cook House and central plinth.

It was notable that the fabric of all exposed masonry – walls and central plinth, was consistently of crude but very solid construction, comprising large (some massive) fragments of apparently locally quarried bedrock bonded with extremely hard lime mortar, directly over cleared/exposed bedrock. The demolition of the masonry eventually required use of a mechanical excavator.

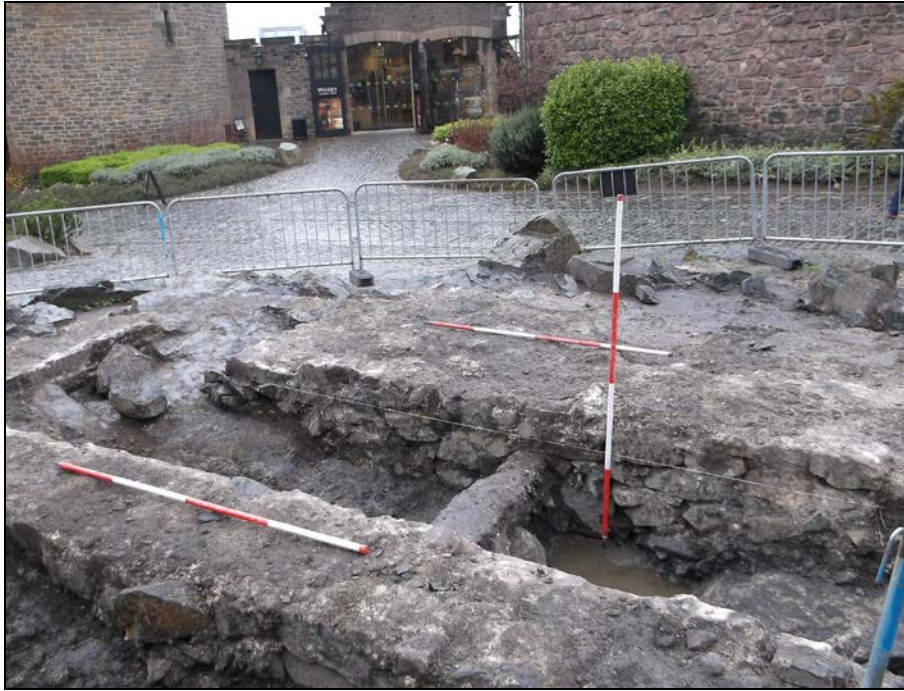
**Plate 2:** Site from the SE, showing the S wall and central plinth.

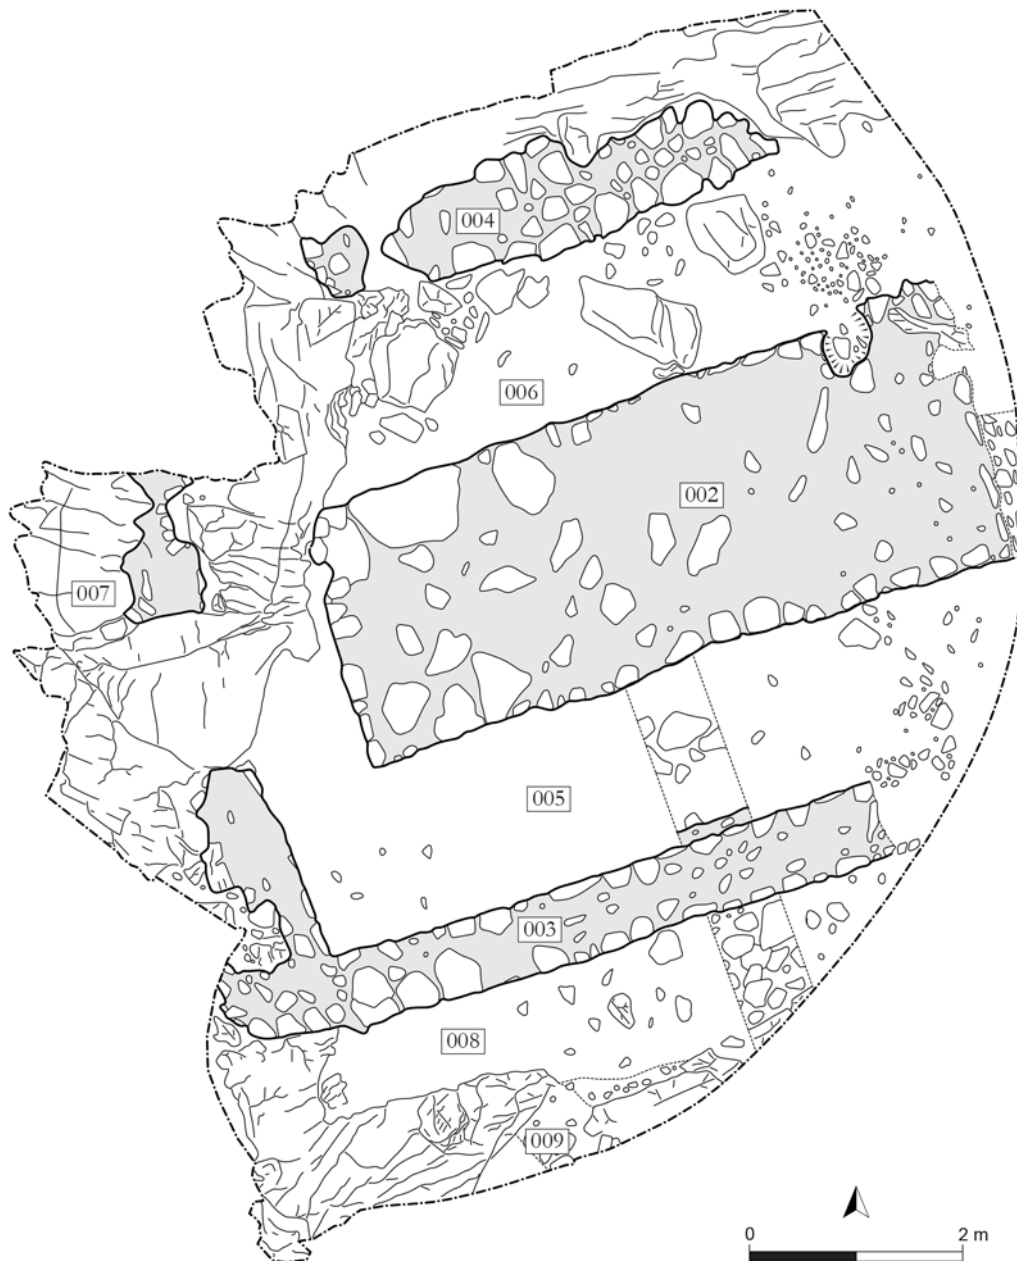
**Fig.8:** Post-excavation plan.

The site encompasses a natural declivity in the bedrock running roughly E/W with steep sides to the S and W, with more sloping sides to the NW, N and NE. Later quarrying associated with the construction of the Cook House and the National War Memorial work from 1923, have both truncated the highest bedrock outcrops and cut back the weathered edges of the depression. The natural bedding planes of the bedrock run roughly SE/NW and bedrock slabs were prised free by exploiting the natural ‘strike’. Greater effort was required to lower the bedrock head or to cut against the ‘strike’ – resulting in a characteristic ‘pecked’ effect on the stone. This is in contrast to the machine drilling of the rock head c.1923.

However, the depression itself is a natural feature and not the result of any quarrying – whether 16<sup>th</sup> century, 19<sup>th</sup> century or later. It may owe its survival by serving as a cistern - a water supply, predating and later augmenting the medieval rock cut wells, as was found at Dundonald Castle where a late Iron Age cistern was retained as part of the water supply alongside a 14<sup>th</sup> century well.

In addition, there are several examples of discrete areas where stone has been clearly dug/cut out creating a sunken feature with clear sides. They are of two basic types – large, irregular pits up to 0.7m wide and smaller, squarer cuts up to 0.3m wide. At this stage, their function is uncertain – potentially evidence of either quarrying large, individual blocks for building stone, or settings for earth fast posts.

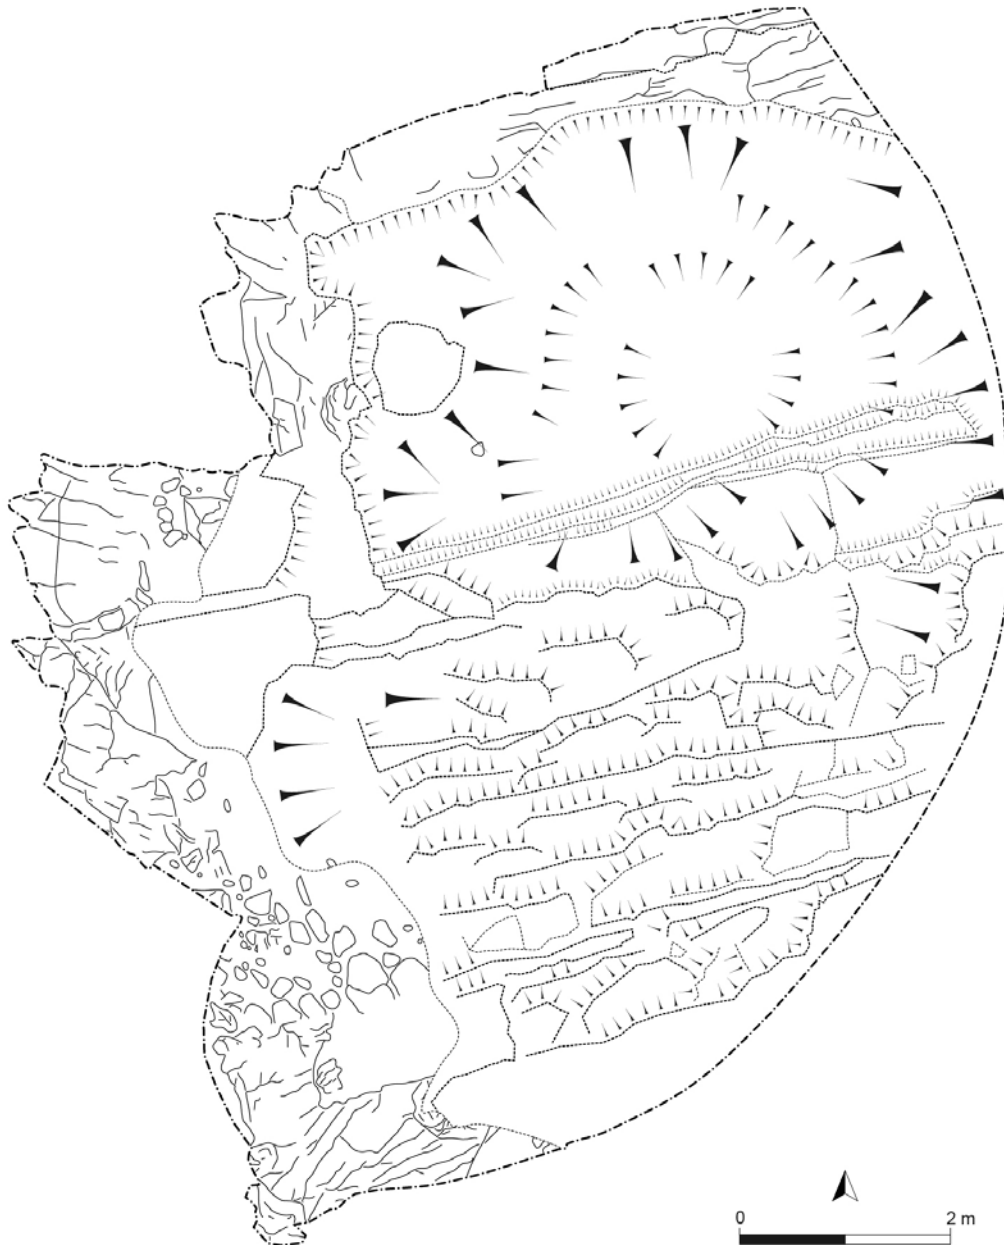
Fig.9: Post-excavation plan following the removal of contexts 002 - 006, 008 and 009.

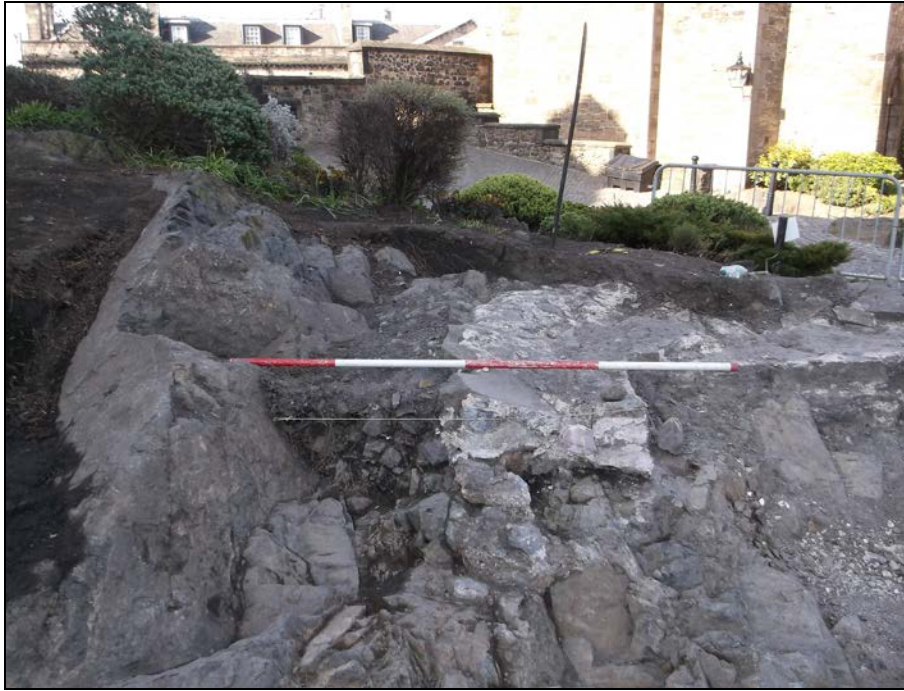
**Plate 3:** Fill between bedrock and S wall, as seen from the E.

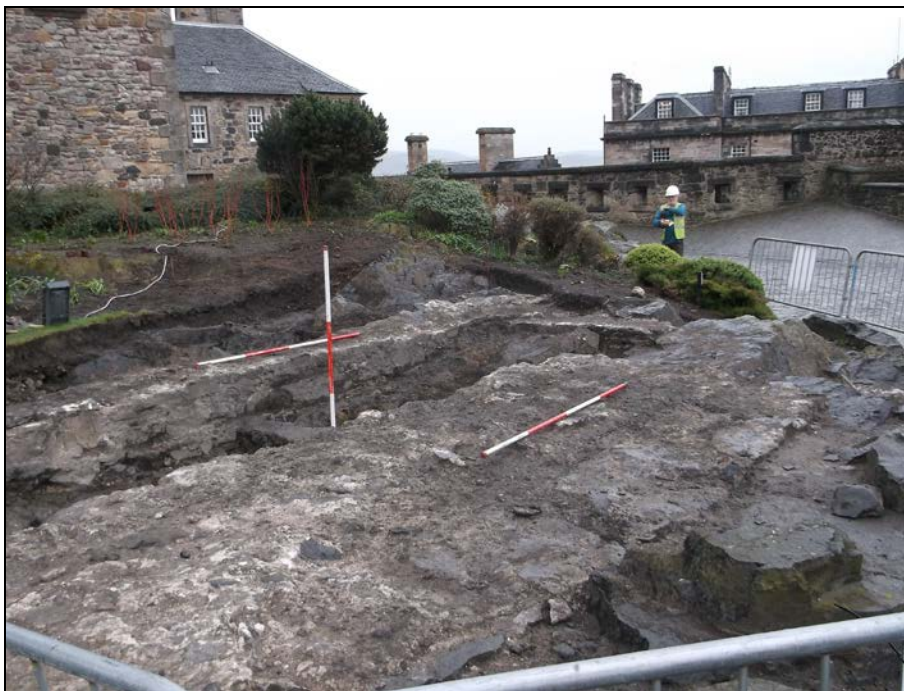
**Plate 4:** Site from the NE, showing bedrock and plinth in foreground.

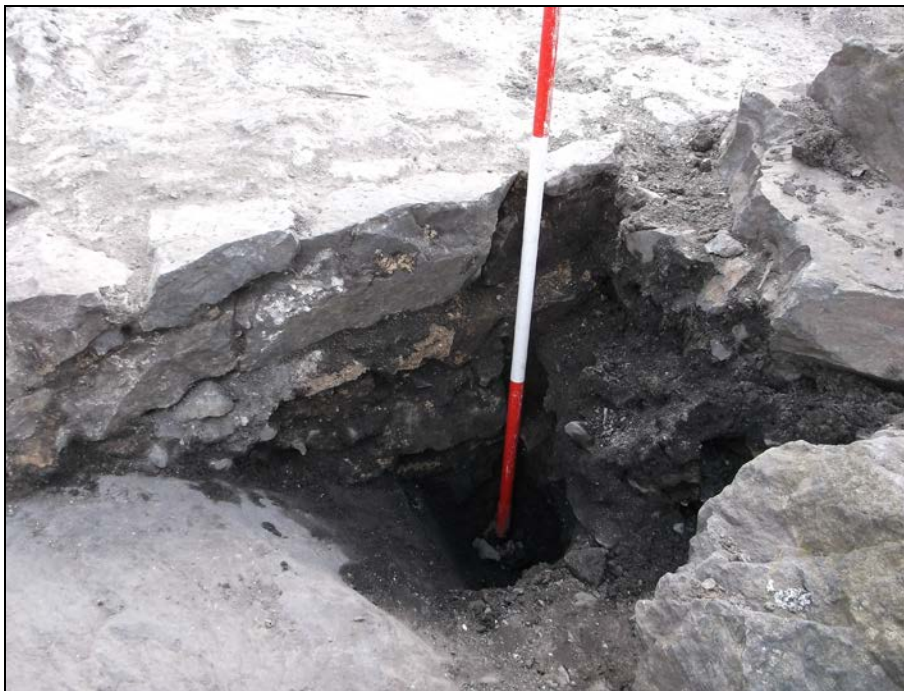
**Plate 5:** Plinth over bedrock depression with tipped fill between N wall and plinth, as seen from the NE.

Most of the intra-mural fills were removed to N and S of the central plinth, showing that they comprised a series of tipped deposits laid sequentially as the central plinth was built, in at least two stages. The latter were reflected by separate spreads of mortar extending from the face of the plinth, across part of the fill. This evidence suggests that the wall lines were built first, followed by the plinth with the fills added later. The plinth was built up from the deepest part of the bedrock depression, ultimately to create a level platform across the irregular surface of the bedrock.

The need for such a substantial footing for the 'boiler array' is a probably a reflection of:

- The very uneven surface of the underlying bedrock;
- The need to isolate any heat affect from the heat source(s) for the boilers, in order to minimise fire risk; and,
- The need to provide a stable platform for potentially hazardous activity involving hot liquids – avoiding spillage *etc.* in what was an early form of standardised mass catering for the garrison and other members of the extended castle community.
