<b>LOCAL AUTHORITY:</b>	Edinburgh, City of
<b>PROJECT TITLE/SITE NAME:</b>	Edinburgh Castle: Water Towers (near Foog's Gate)
<b>PROJECT CODE:</b>	HSCO-90130-2013-02
<b>PARISH:</b>	Edinburgh, City of
<b>NAME OF CONTRIBUTOR:</b>	Alan Radley
<b>NAME OF ORGANISATION:</b>	Kirkdale Archaeology
<b>TYPE(S) OF PROJECT:</b>	Minor excavation
<b>NMRS NO(S):</b>	NT27SE 1 (Edinburgh Castle); NT27SE 1.21 (Foog's Gate)
<b>SITE/MONUMENT TYPE(S):</b>	Castle
<b>SIGNIFICANT FINDS:</b>	None
<b>NGR</b> (2 letters, 8 or 10 figures)	NT 2512 7349
<b>START DATE</b> (this season)	4 November 2013
<b>END DATE</b> (this season)	25 November 2013
<b>PREVIOUS WORK</b> (incl. <i>DES</i> ref.)	
<b>MAIN (NARRATIVE) DESCRIPTION:</b> (May include information from other fields)	<p>An integrated programme of test trenching, standing building recording and survey over exposed areas of bedrock was completed at intervals between June and November 2013.</p> <p>The earliest features revealed were traces of eroded rock-cut features comprising slots and crudely-squared cuts thought to pre-date mid-16<sup>th</sup> century masonry. The masonry and other remnants of defensive features were thought to range from the mid-16<sup>th</

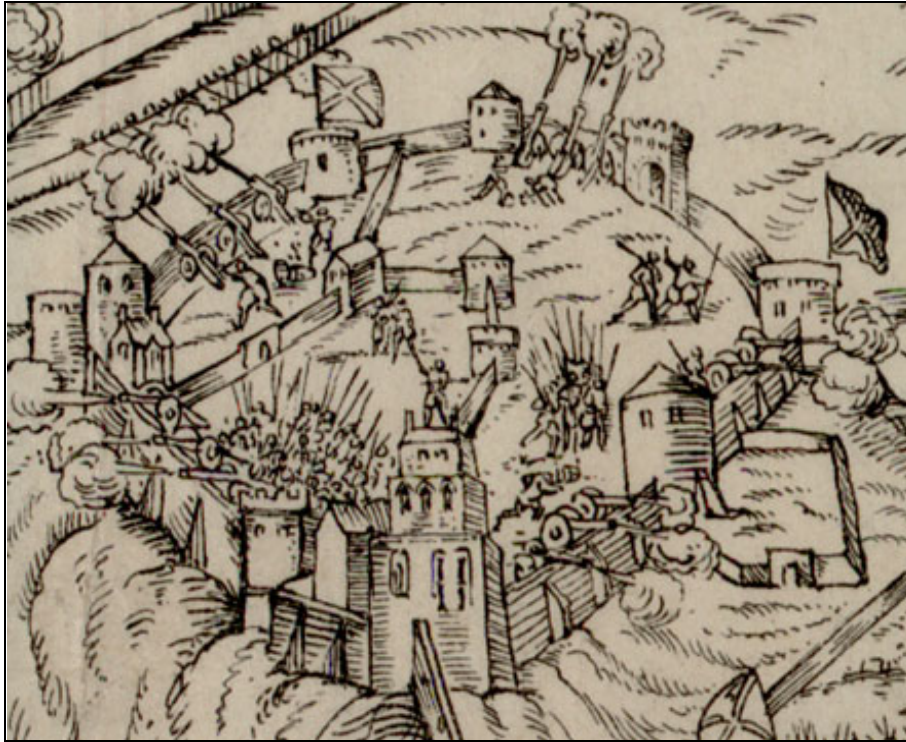
Fig.1: The siege of Edinburgh Castle, from Holinshed's Chronicles of England, Scotland and Ireland, 1577.

The present water tanks are bounded on their west side by a defensive wall, loop-holed for both artillery and muskets, which was erected in the 1670s. This is likely to have been a modification of an early enclosure. Holinshed's depiction of the siege of 1573 shows a stylised depiction of this defensive wall defended by towers. Foog's gate is shown. The building to its right, shown on the curtain wall, may be St Margaret's Chapel. The former wall is shown as what appears to be an earthwork on Gordon of Rothiemay's bird's eye view of 1647. This may not be, as it appears, a degrading of the defences, but rather the depiction of an earthwork strengthening an earlier wall line to create a better defence against artillery. Gordon of Rothiemay does not show Foog's Gate, which must have existed at that time as it is shown on the earlier drawings. Its omission demonstrates the limitations of drawings as evidence.

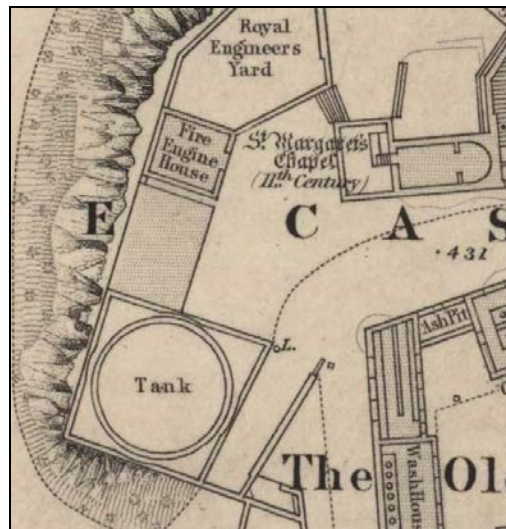
Fig.5: Ordnance Survey 1st edition Sheet 35, surveyed 1852

The Ordnance Survey 1st edition Sheet 35, surveyed 1852, published 1854 shows the new water tank with the fire-engine house on its north side. The tank was supplied on its western side by a 10 inch (0.25m) wide supply pipe, as shown on drawings of 1907. A 4 inch diameter pipe led out to the Lawnmarket and there was a 6inch (0.15m) emergency overflow pipe (HS 007-130-J-011).

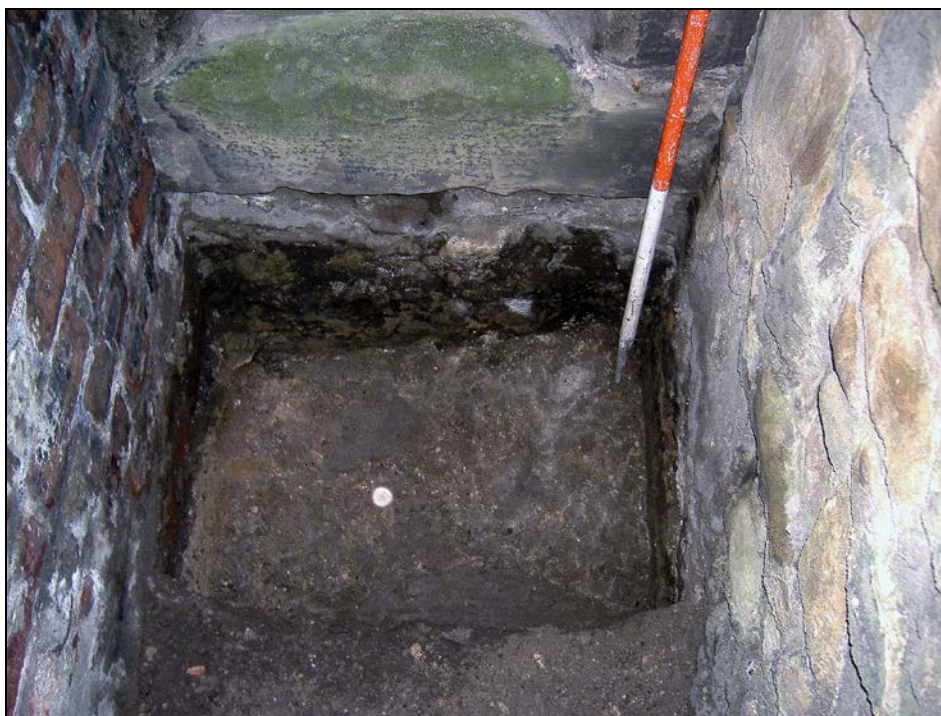
**Plate 1:** Trench 1N, showing the surface at the base of the excavation.

The excavation in this trench stopped on **122**, a surface of flat stone slabs with yellow/light brown mortar pointing between them.

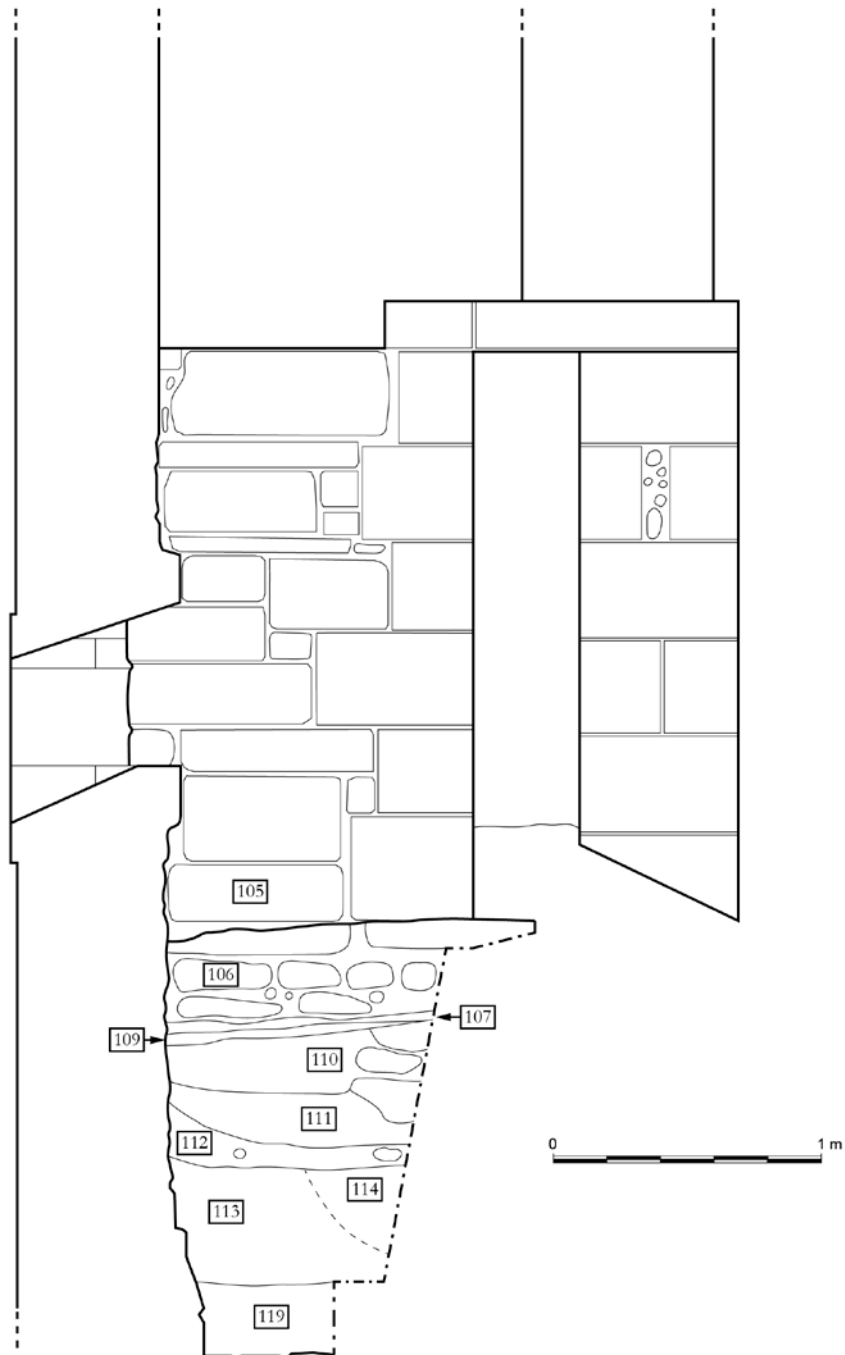
Fig. 13: S-facing section in Trench 1

Under the make-up for wall **105**, context **110** was a 0.3m thick deposit of fairly loose grey brown clayey silt and stones. Approximately 30% of the stones were mostly displaced chunks of bedrock measuring up to 0.3m x 0.25m x 0.25m.

Context **110** sealed **111**, a fairly loose mid-brown clayey silt containing approximately 20% chunks of displaced bedrock and some coal flecks. The stones in **111** measured up to 0.2m x 0.2m x 0.15m; the deposit was up to 0.25m thick.

Loose light brown mortar with occasional stone grits and charcoal flecks, **112**, was seen below **111**. Context **112** measured 0.1m in thickness at the N section but thickened to 0.2m at the edge of **103**, it was also noted to slope down to the S.

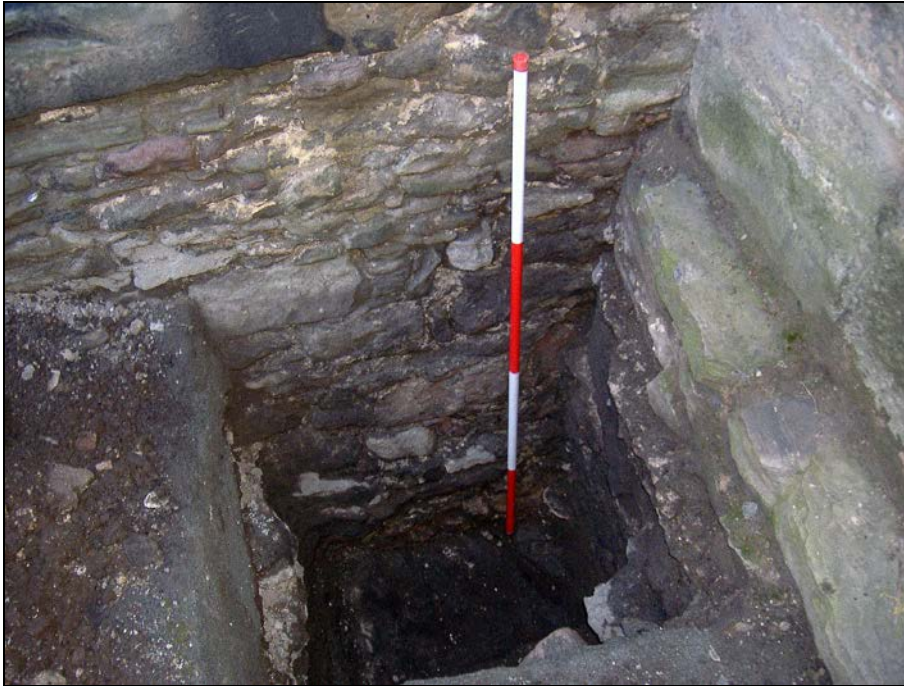
**Plate 2:** Trench 1, bottom part of wall 104 showing the trench excavated down to bedrock.

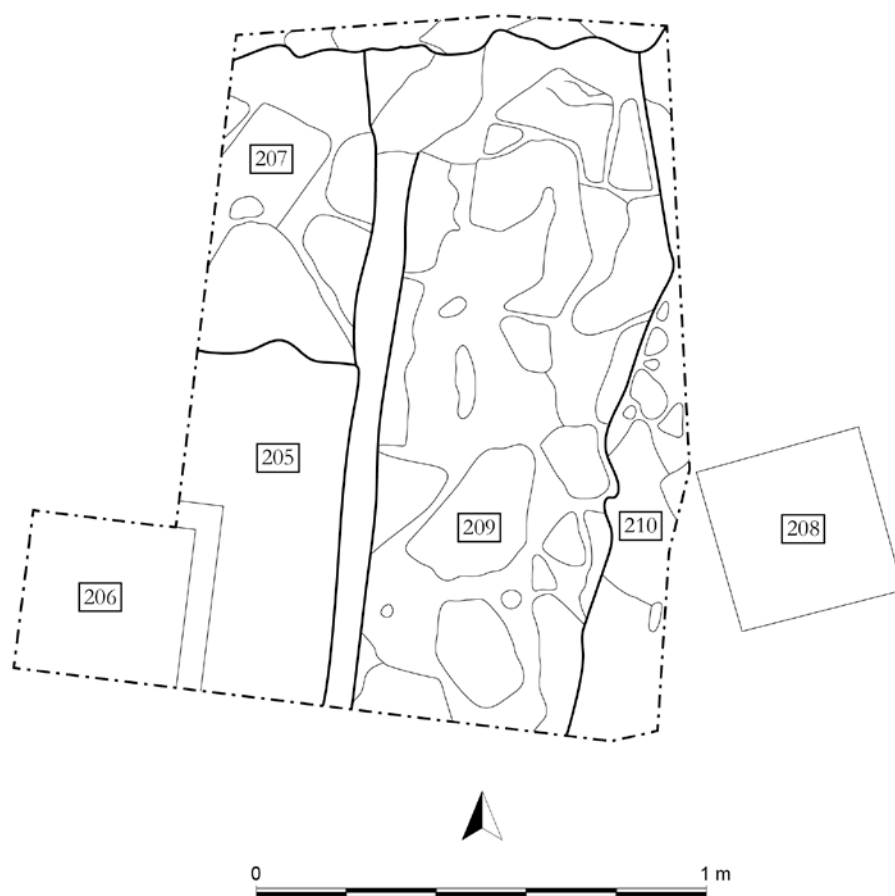
Fig. 14: Trench 2, post-excitation plan

Context **203** was against the N face of **206**, a brick pillar, measuring 0.35m x 0.35m, one of those currently supporting the water tank. The concrete base for **206**, context **205**, was only seen

directly under and N of the pillar. Context **206** measured 0.2m in thickness and extended 0.07m outside (to the N of) the N face of **205**.

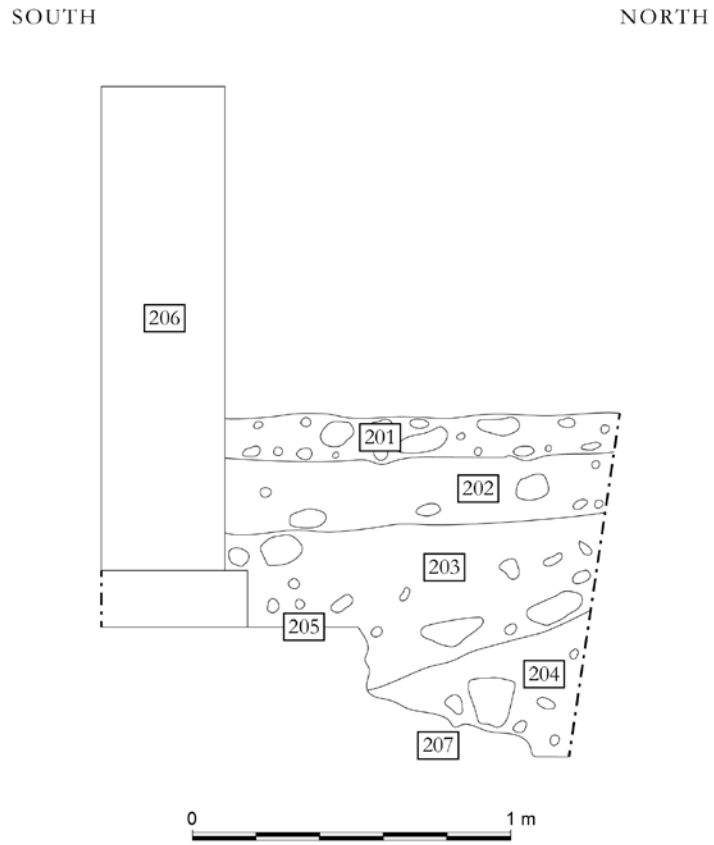
Fig. 15: Trench 2, E-facing section

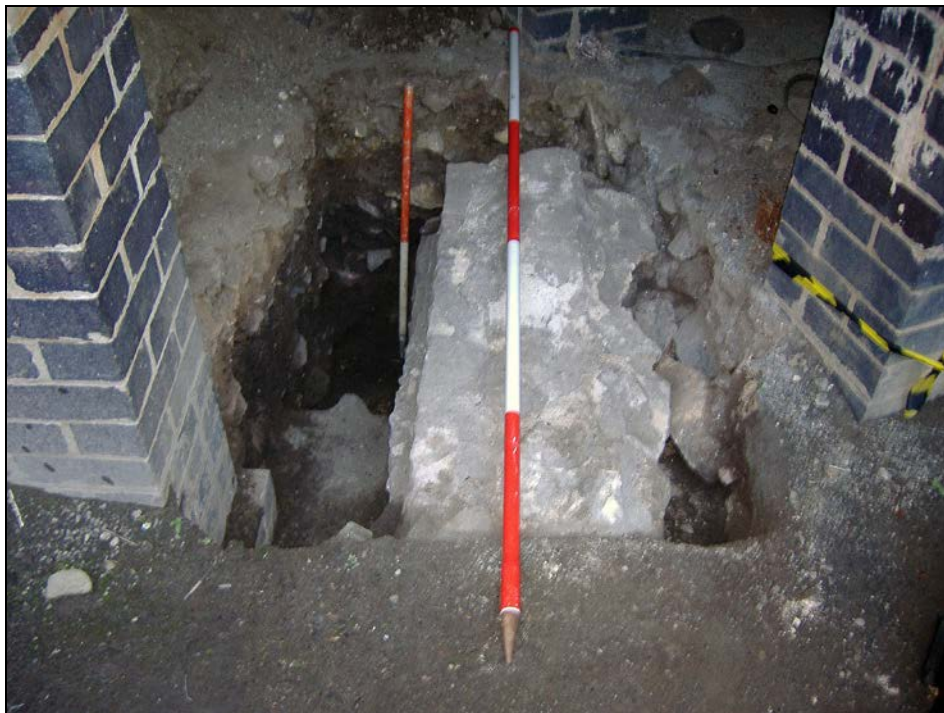
Plate 3: Trench 2, upper face of wall 209.

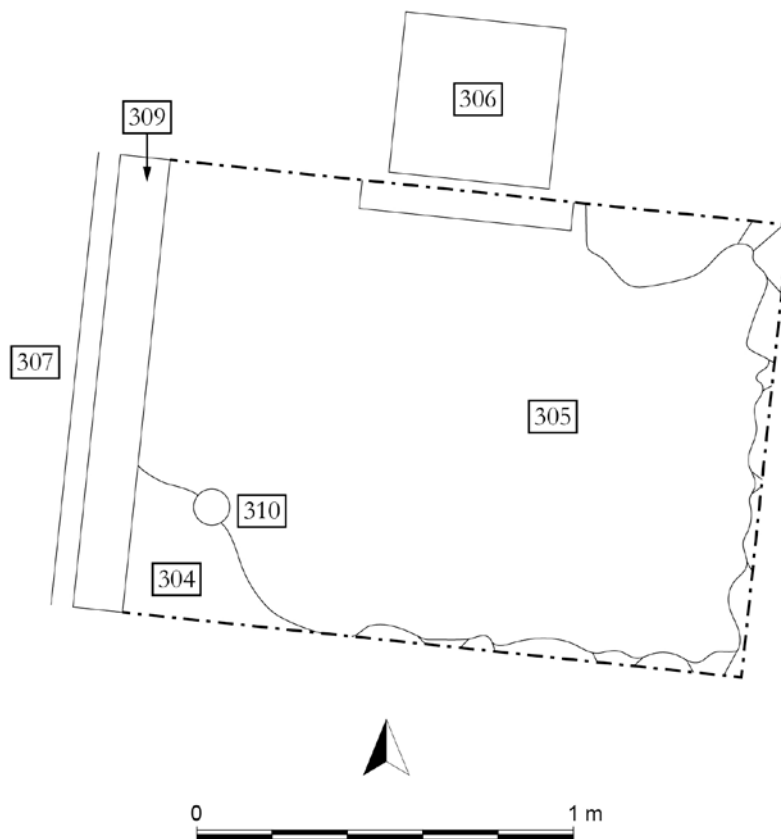
**Fig. 16:** Trench 3, post-excitation plan

The W wall from the top to 0.2m above the current ground level wall was formed with curving sandstone blocks, **307**. At the base of **307**, stepping 0.08m E from it, and continuing down 0.4m, context **308** was constructed with brick. The lowest construction seen, **309**, was also of brick. It stepped in (to the E) approximately 0.12m from **308**, and although it was seen to a height of 0.7m, the base of it remained uncovered.

At the base of the excavation there was a deposit of fairly compact pink brown clay, **305**. A maximum depth of 0.1m of **305** was excavated; it was not bottomed.

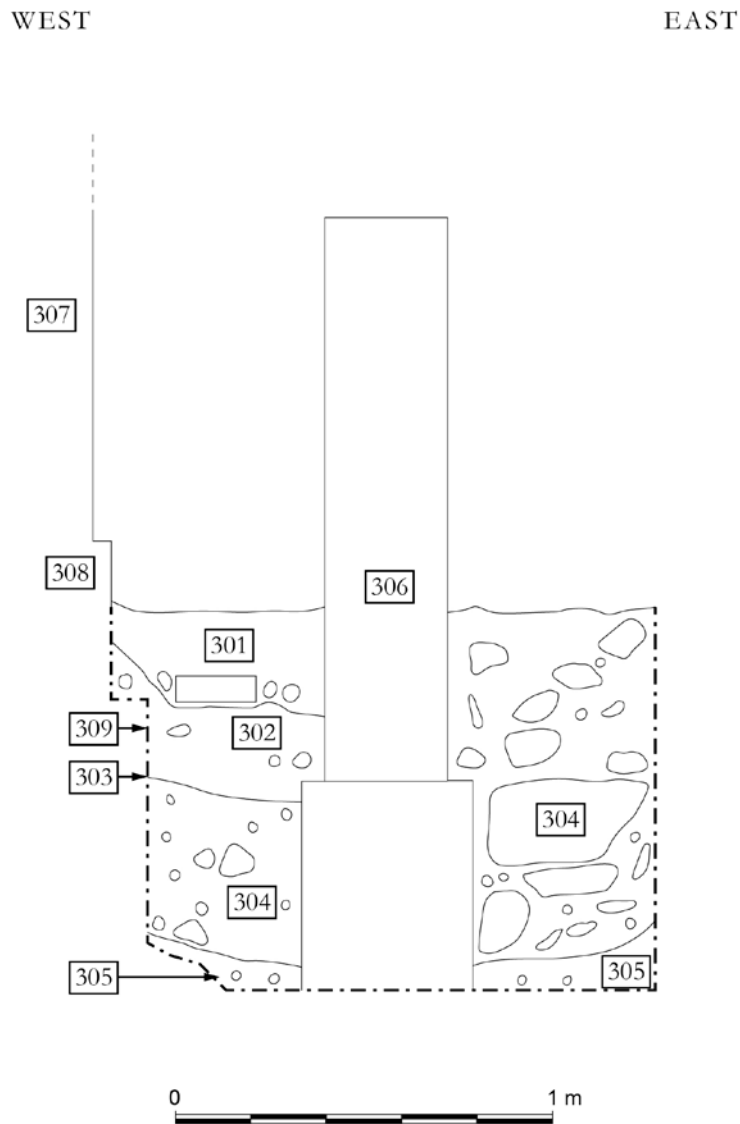
Fig. 17: Trench 3, S-facing section

Roughly half way along the N section, brick pillar **306** measured 0.32m x 0.32m square and 1.50m in height, roughly 0.5m of which was underground at the start of the excavation. The concrete base under **306**, context **311**, measured 0.45m E/W, and although it was seen to a height of 0.6m, the base of it was not uncovered.

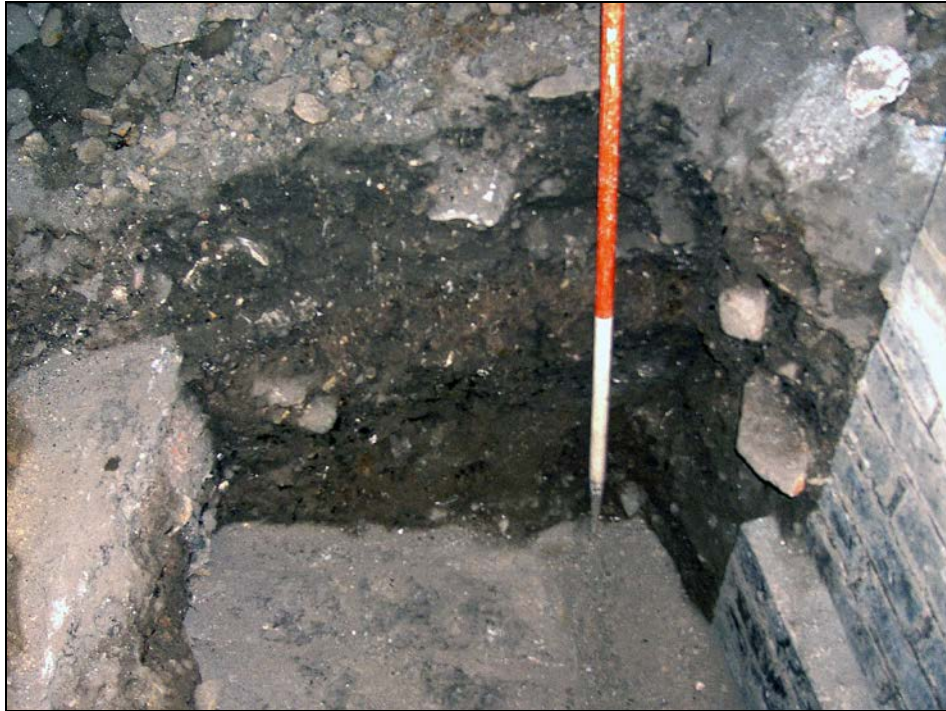
Plate 4: Trench 3, W section, post-excavation, showing contexts 412 - 415

The upper of these deposits, **412**, comprised 80% fine very dark grey silt and 20% small fragments of sandstone; there were charcoal flecks and oyster shell fragments throughout.

Context **412** was very compact and measured 0.15m in thickness. It sealed **413**, another very compact deposit. Context **413** was a 0.12m thick, mix of pale brown silty clay (60%), fine pale grey silt (30%) and small sandstone fragments (10%); there were oyster shell and charcoal fragments throughout.

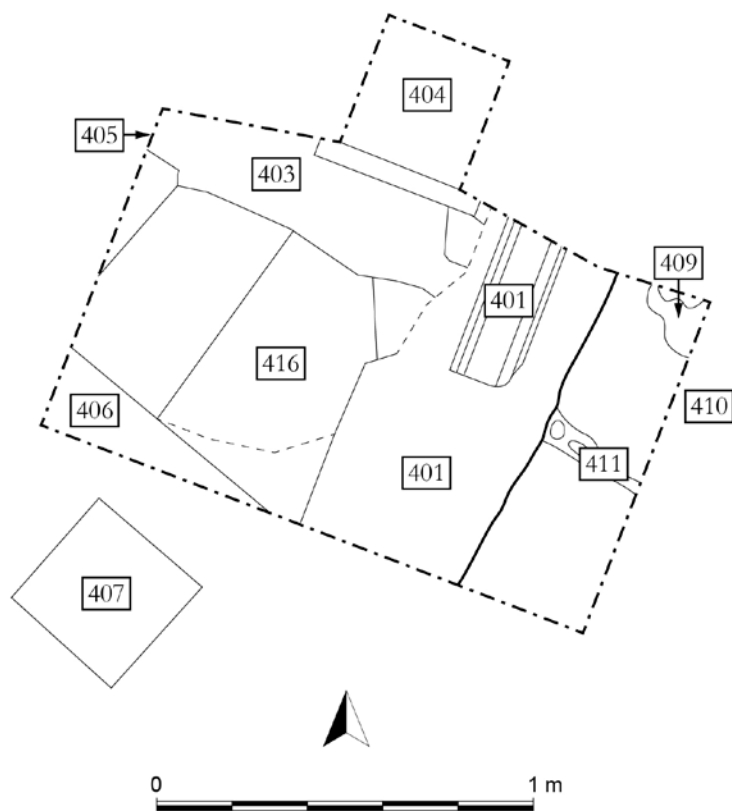
Fig. 19: Trench 4, post-excavation plan

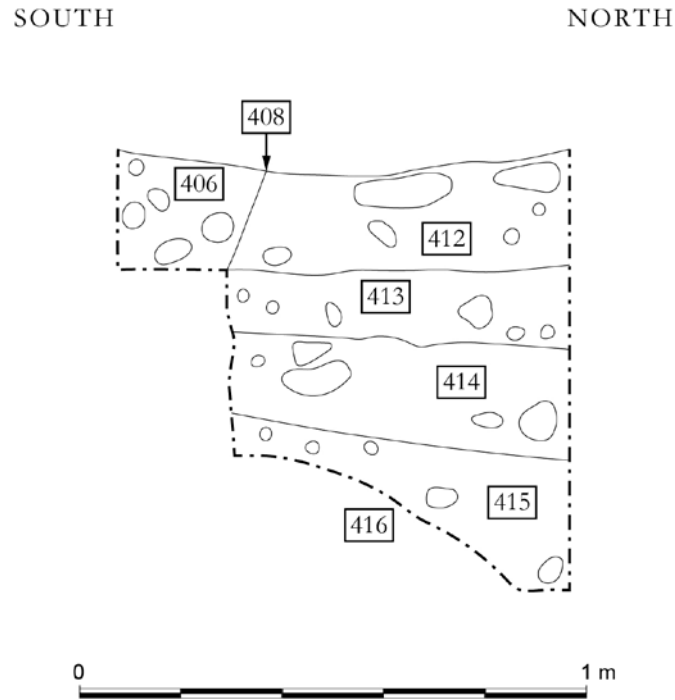
Fig. 20: Trench 4, E-facing section

The E wall of the N tower, **410**, was not recorded in detail as part of this work. The footings for **410**, context **411**, extended 0.3m E from **410** and the two large slabs visible both measured over 0.45m N/S (both continued outside the trench). There were small stones infilling between them.

Against **410**, over **411**, and cut by **402**, context **409** comprised 80% small-medium sized stone fragments and 20% dark grey silt and mortar chunks. There were both sandstone and dolomite fragments in **410** and it was seen N/S across the trench, extending 0.25m from **410**; it was up to 0.25m thick.

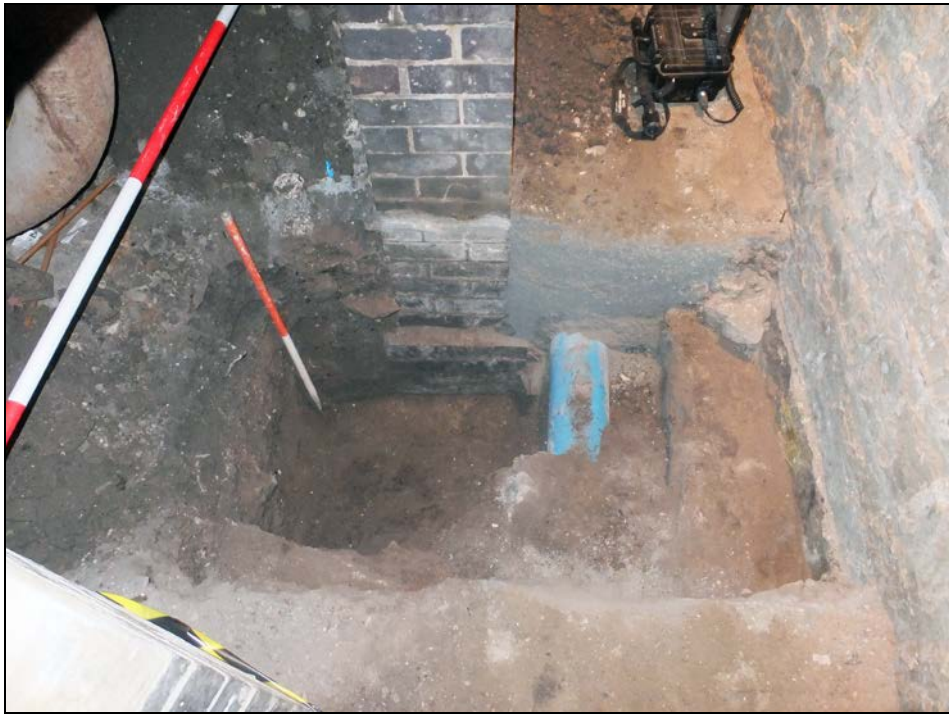
**Plate 5:** Trench 4, showing the pillar 404, cut 405 and the trench edges.

The upper deposit, **400**, comprised whin dust and rubble. It measured roughly 0.1m in depth. Running N/S through the trench, and cut against pillar base pillar **404** to the W and **410** to the E, context **402** was a steep sided cut measuring roughly 0.5m in depth. Cut **402** carried a blue plastic water pipe and was filled with whin dust, **401**.
