<b>LOCAL AUTHORITY:</b>	Edinburgh, City of
<b>PROJECT TITLE/SITE NAME:</b>	Edinburgh Castle: Governor's House (Governor's Yard)
<b>PROJECT CODE:</b>	HSCO-90130-2014-02
<b>PARISH:</b>	Edinburgh, City of
<b>NAME OF CONTRIBUTOR:</b>	David Murray
<b>NAME OF ORGANISATION:</b>	Kirkdale Archaeology
<b>TYPE(S) OF PROJECT:</b>	Minor excavation
<b>NMRS NO(S):</b>	NT27SE 1.35
<b>SITE/MONUMENT TYPE(S):</b>	House (18 <sup>th</sup> Century)
<b>SIGNIFICANT FINDS:</b>	None
<b>NGR (2 letters, 8 or 10 figures)</b>	NT 2508 7347
<b>START DATE (this season)</b>	2 December 2013
<b>END DATE (this season)</b>	15 January 2014
<b>PREVIOUS WORK (incl. <i>DES</i> ref.)</b>	
<b>MAIN (NARRATIVE) DESCRIPTION:</b> (May include information from other fields)	<p>Archaeological excavations were carried out in the Governor's Yard, just to the rear (west) of the mid-18<sup>th</sup>-century Governor's House, itself just west of the winding approach road leading up to Foog's Gate and the upper citadel of the castle.</p> <p>The bedrock showed only limited evidence for modification within the area of the trenches. Examination of the space under the tunnel accessing the Yard from the east showed substantial areas of bedroc

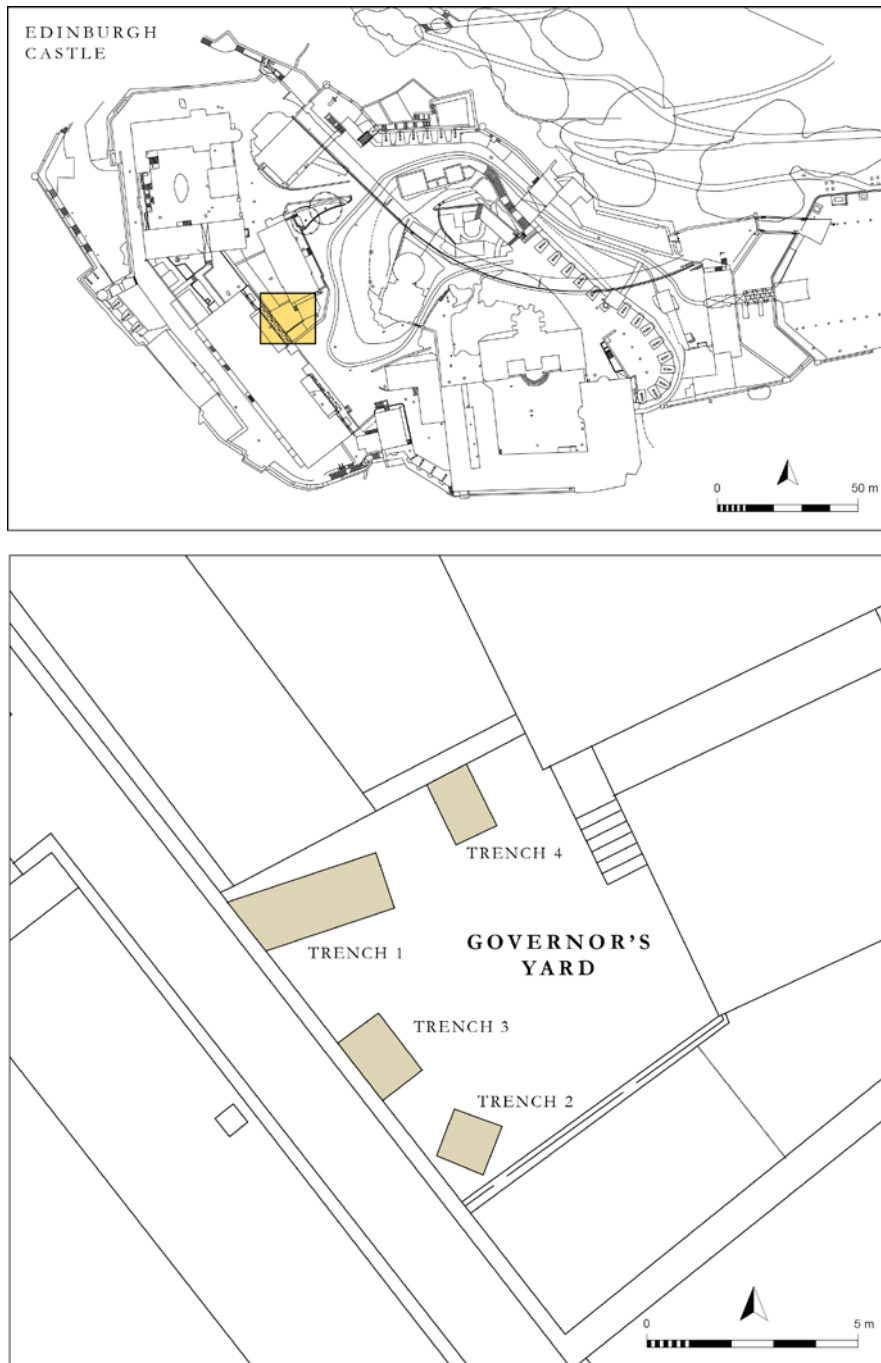
Figure 1: Location plan of the four trenches

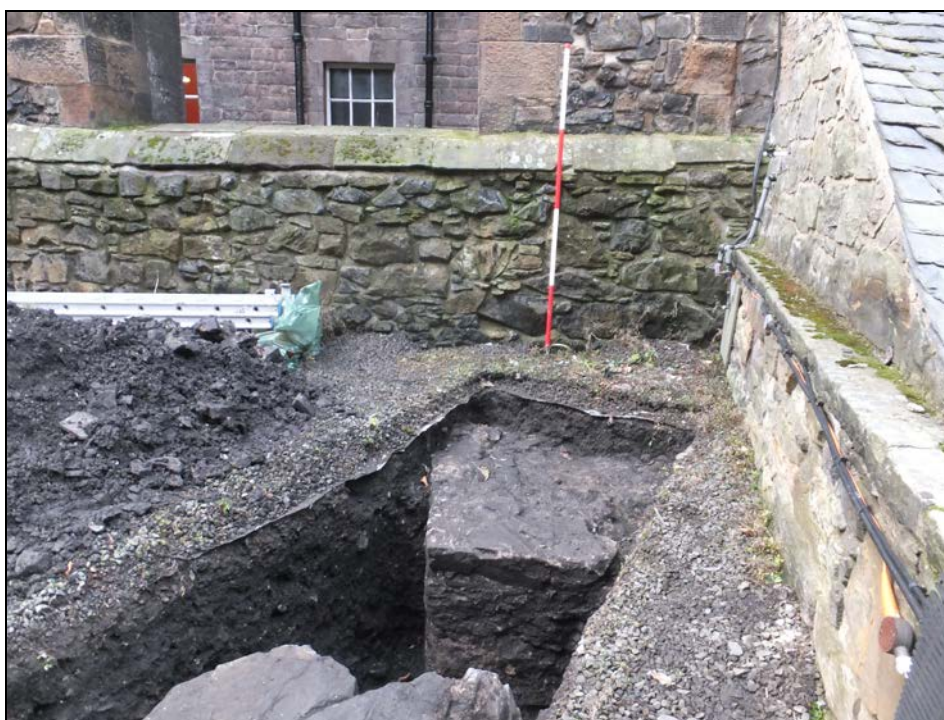
**Plate 1:** Trench 1, from the NE

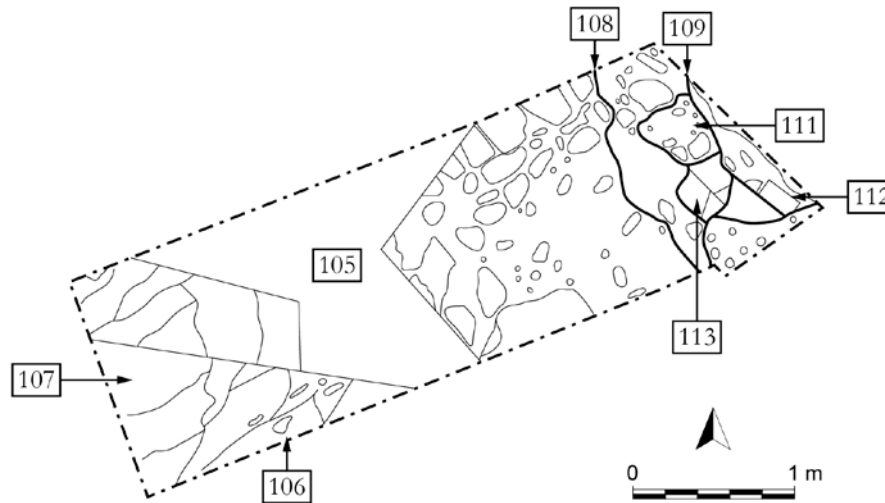
The earliest feature over the top of **105** was **113**, a setting of four well-dressed sandstone slabs laid to form a channel running N/S. Two slabs formed each side and were pitched to make a 'V' shape 30cm deep and 40cm wide, whose base dropped fairly steeply to the N. These continued N under wall **109**, but stopped dead to the S at an area of poorly laid dolerite and sandstone chunks **111** roughly 40cm square.

Figure 2: Trench 1, post-excavation plan

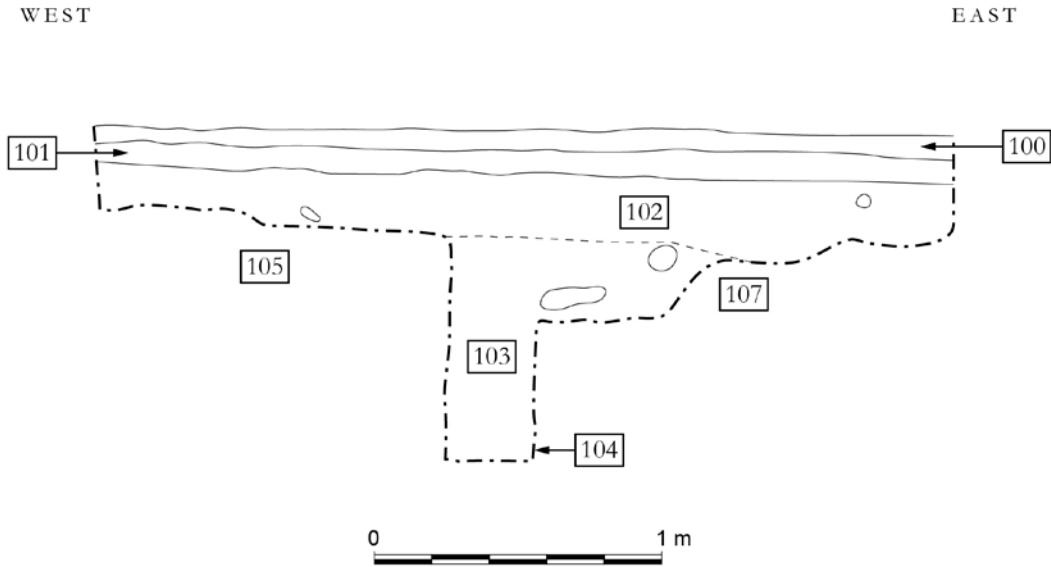
At the extreme E end of the trench, bedrock **107** was separated from all other features by **103**. Most of its upper surface was smooth, but it dropped down to the S, where blobs of mortar **106** overlay it. Its W edge was a 'Z' shape in plan and near vertical, standing at least 1.1m high. Damage along the top of this side indicated that this was at least partly an artificial cut, attributed to **104**, the modern cut for **103**. Splashes of mortar **106** over this damage hinted that there may be an older cut here, probably associated with the construction of wall **105**.

Figure 3: Trench 1, S-facing section

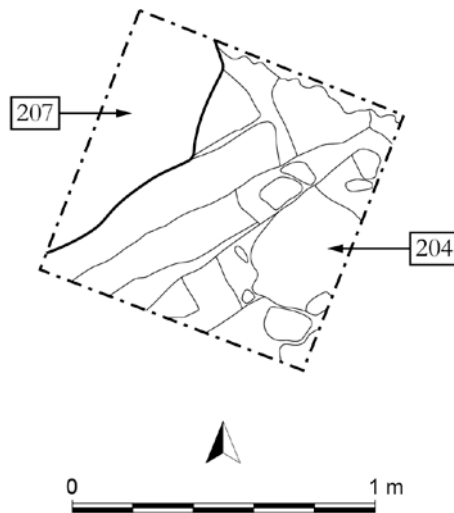
Figure 4: Trench 2, post-excitation plan

Bedrock **204** ran along the S side of the trench. There was a slight flat shelf at the top of the bedrock along this S edge of the trench, after which it dropped in height rapidly to the N. At the

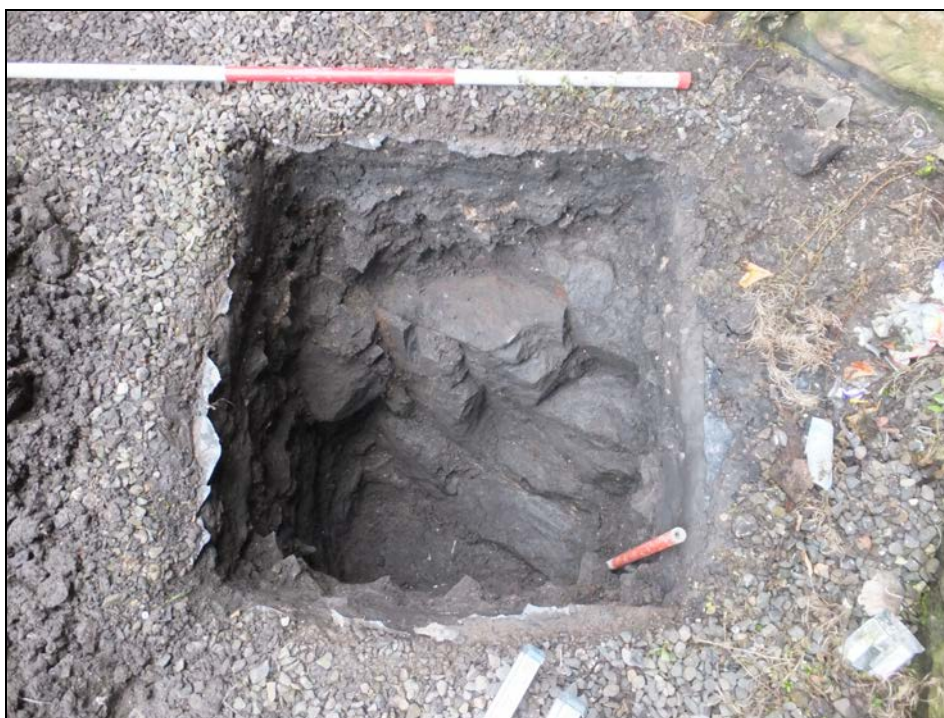
Plate 2: Trench 2, from the N

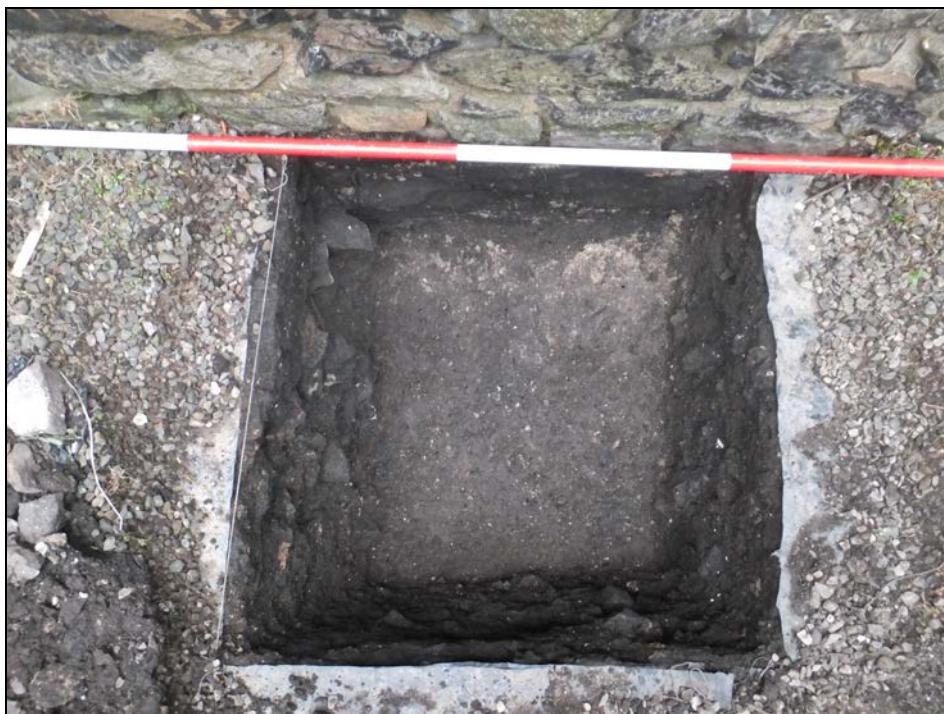
Below **303** was a thin lens of fine pale yellow sandy mortar **304** of varying extent, never more than a few cm thick. In the NW and SW corners of the trench it banked up against wall **308**, sloping away to the S and E from here.

Plate 3: Trench 3, from the E

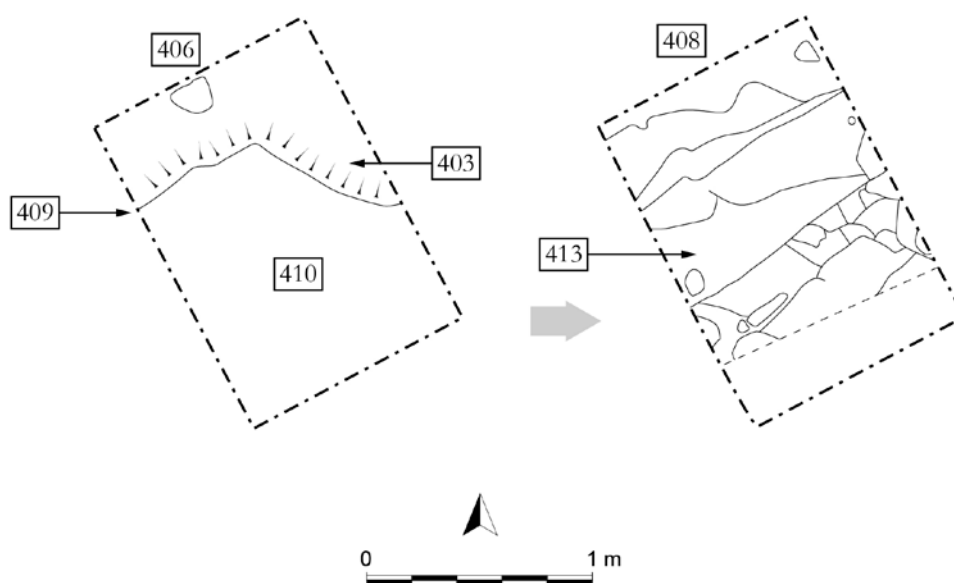
The familiar sequence of two gravel surfaces (**400** and **401**) covered **405**, a layer of black silt up to 25cm thick that contained modern finds. The removal of **405** exposed **402**, an area of rubble and dark grey silt in the NE corner of the trench. This proved to be the fill of a cut, **403**, whose side ran in a curve away from wall **406** to the SE before running out the trench, making it at least 1m N/S x 0.5m E/W. Its steep sides (vertical against **406**) went down 80cm, and its fill **402** was full of rubble, including handmade bricks and smashed sections of ceramic drainpipe, as well as modern plastic.

Figure 5: Trench 4, post-excitation plans (earlier one on the left)

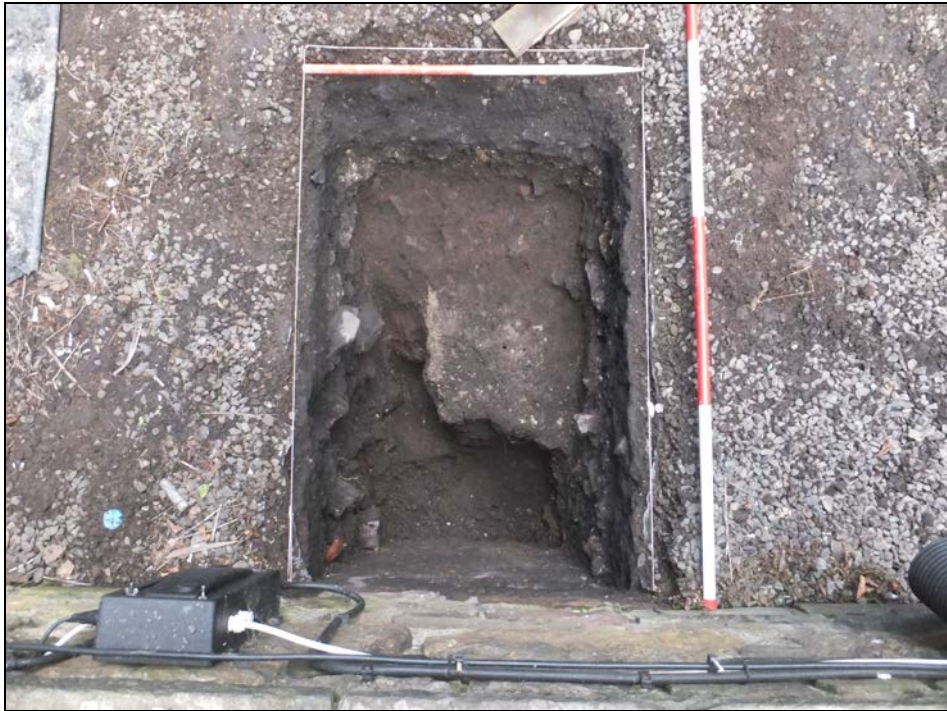
Plate 4: Trench 4, from the W

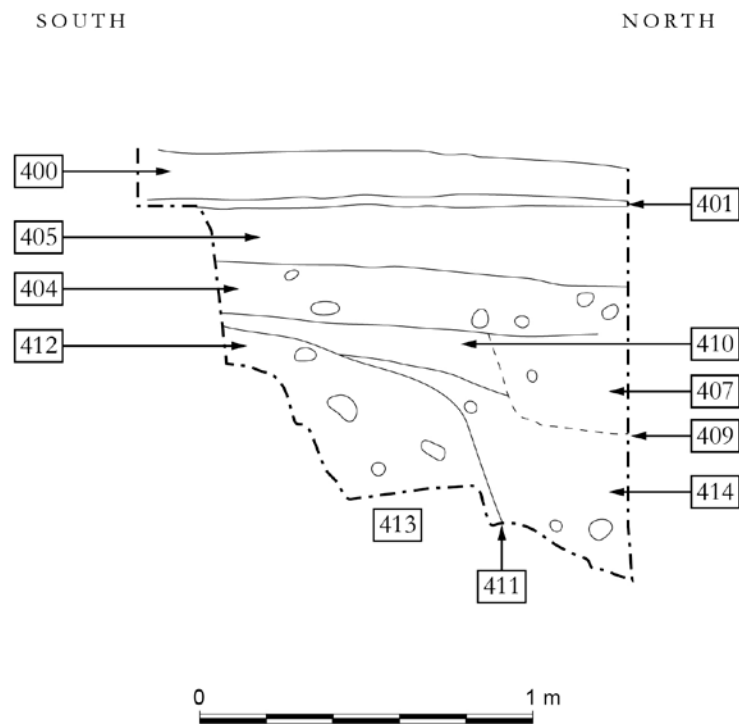
Figure 6: Trench 4, E-facing section

Context **410** then sealed a loose, occasionally voided mix of pale grey silty clay and sandstone rubble and mortar flecks and chunks, **414**. This filled cut **411**, spilling out over its top slightly to the S. Context **411** ran along the S side of wall **406** seeming to survive below the base of cut **403** in the NE corner of the trench. It was 55cm wide at its top, with steep sides, the lower part of which was against the bedrock **413**, possibly having actually cut through this rock in places. Context **411** was at least 50cm deep, although it was not bottomed; with stones mortared onto the base of the wall to its N that were left *in situ* within **411**.

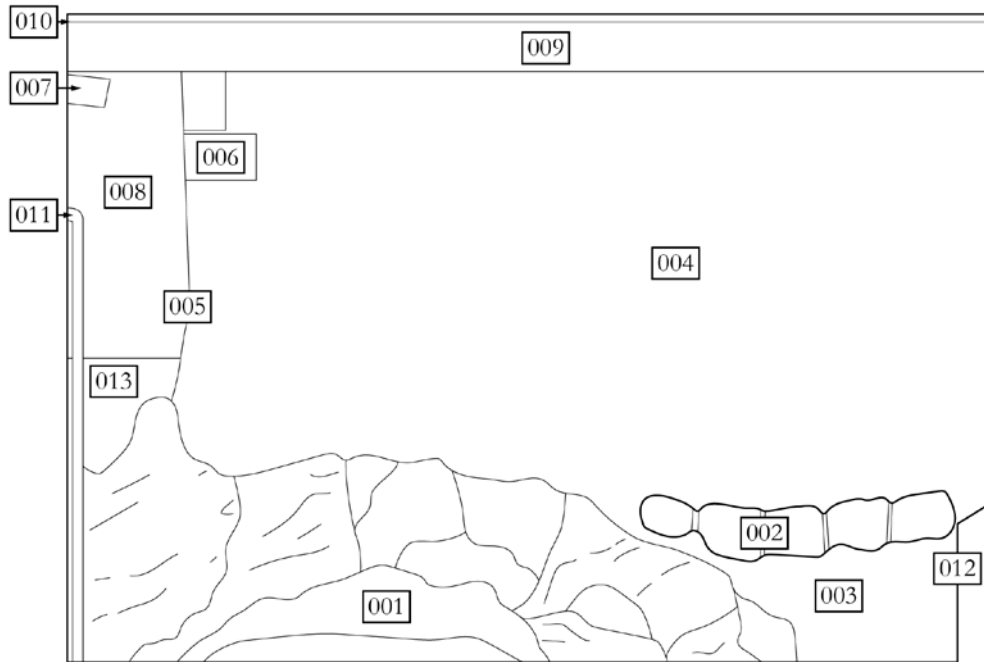
Figure 9: The N-facing elevation of the Governor's yard (not to scale)

**001-** Truncated dolerite bedrock. To the E, it crops to current ground level +2.20m; centrally it crops to current ground level +1.50/1.60m, falls sharply to the W. The bedrock has been cut back to the N to form the current level of the yard.

**010-** Cope stones over build 009 made from horizontal sandstone slabs.

**011-** Cast iron down-pipe.

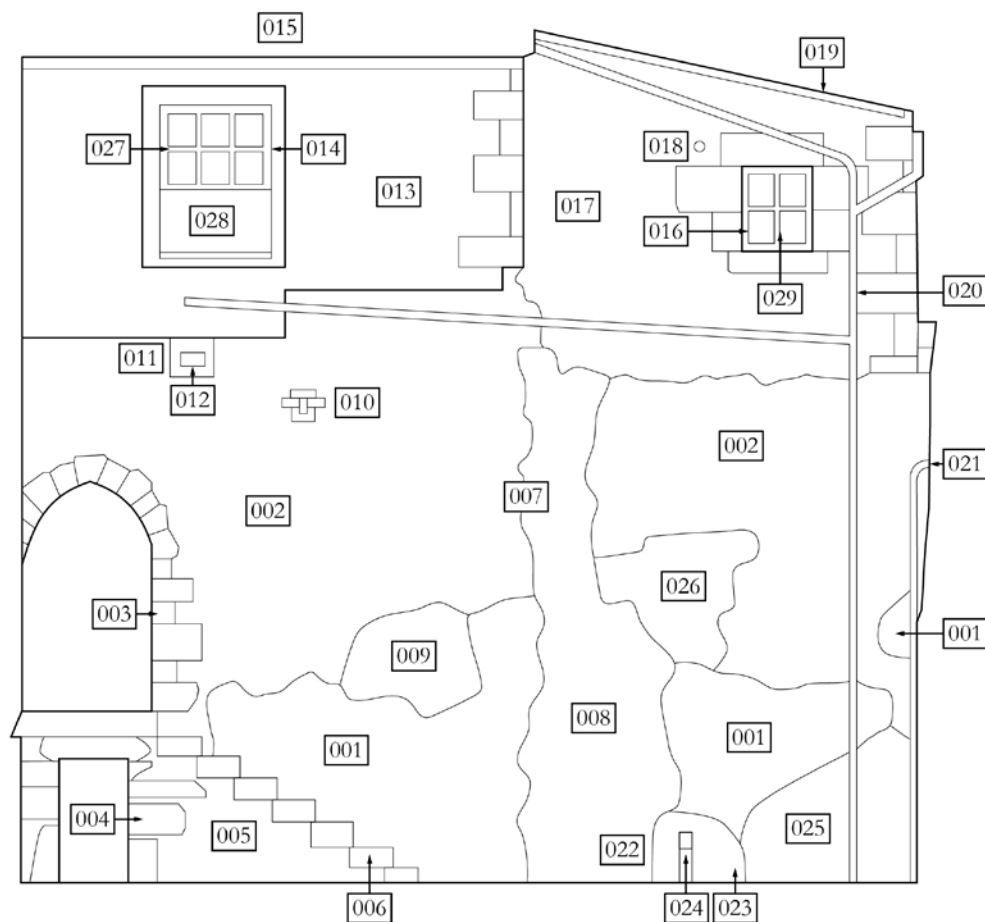
Figure 10: The W-facing elevation of the Governor's yard (not to scale)

**001-** Truncated dolerite bedrock. To the S, it crops to current ground level +2.55m; centrally it crops to current ground level +2.50m. The bedrock has been cut back to the W to form the current level of the yard; this has left some portions of the bedrock clefted and overhanging.

**010-** Drainage spout, square aperture with curved water channel. Sandstone lintel, sill and sides. The spout sill is broken/clawed back. Sits within and is integral to build 002. Likely to have been drainage for the mid-18<sup>th</sup> century Storekeeper's garden.

**013-** Upper N wall build of roughly-coursed dressed yellow sandstone blocks, mainly with a rusticated finish. Edge quoins to S have hatched linear tooling. Build 017 abuts to the S. Build 013 contains window aperture 014.
