**HISTORIC SCOTLAND PROPERTIES IN CARE
MINOR ARCHAEOLOGICAL WORKS 2014/2015**

Kirkmadrine Church • Monitoring • January 2014

SITE: Kirkmadrine Church, Dumfries and Galloway

DESCRIPTION: Watching Brief during the removal of an existing concrete floor

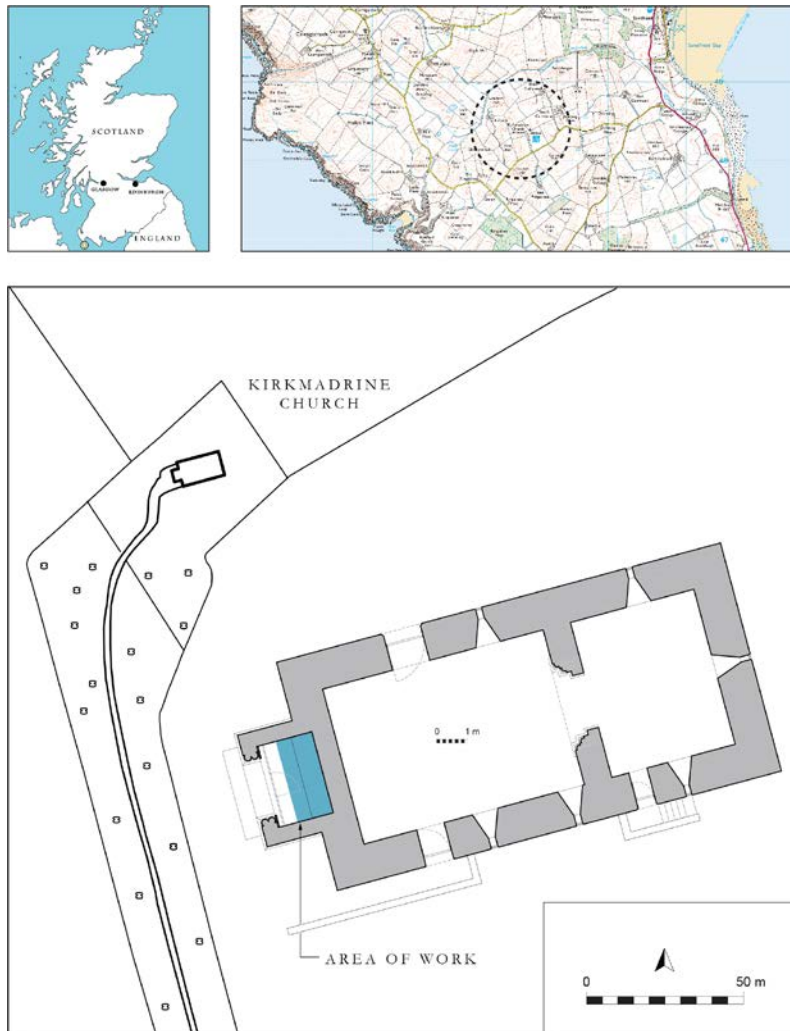
Figure 1: Plan showing the location of the present work.
Inset No. 2 © Crown copyright. All rights reserved 2014. Licence number 100036933.

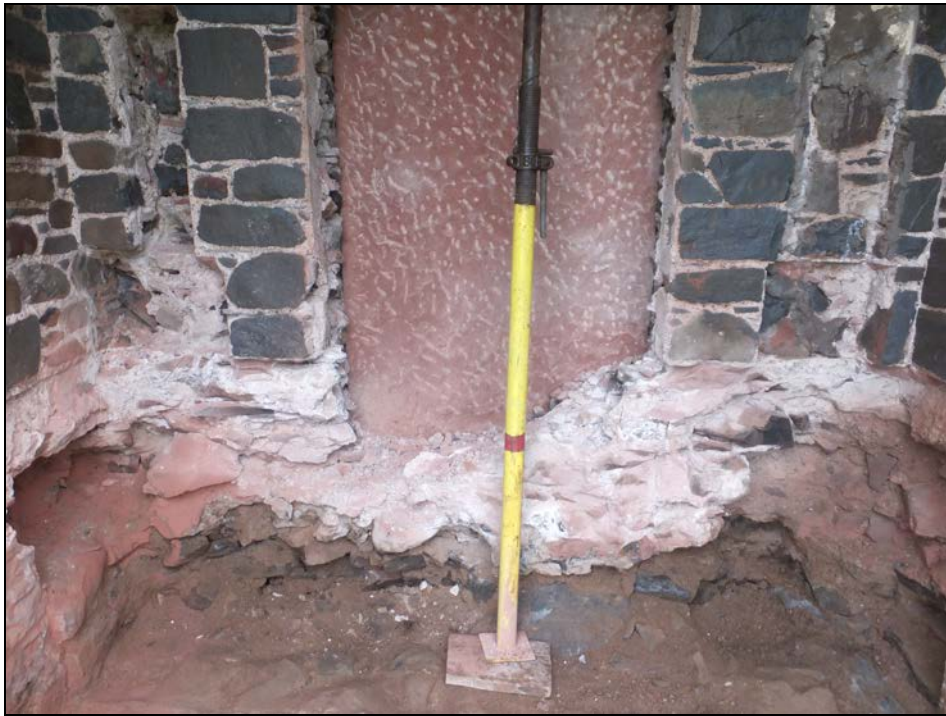
Prior to arrival on site much of the floor had already been removed (in 2013). A small block remained (001) in on the W side of the porch, against the fabric of the church. This was some 20cm thick, and formed of pebble rich concrete.

The removal of this area exposed a rubble filled strip at the back (E) side of the porch (002), while to the W the concrete continued down. The rubble was not removed. Scars were visible in all three sides of the porch, relating to the display of the stones.

A large slab of red sandstone was visible on the W side of the porch, evidently a slab which faced into the church (003). Access was not possible to inspect the front face of this stone.

Plate 1: The excavation as finished, from the W

Nothing of archaeological significance was recorded. The rubble filled strip is unexcavated, but is likely to be simply foundations for the concrete floor. The slab visible within the church is presumably a memorial stone. It is unclear why it appears in the wall of the porch - no evidence was noted on this side to suggest it is a blocked door.
