**HISTORIC SCOTLAND PROPERTIES IN CARE
MINOR ARCHAEOLOGICAL WORKS 2014/2015**

Stirling Castle • Monitoring • June 2014

SITE: Stirling Castle, Stirling

DESCRIPTION: Archaeological monitoring during the installation of new lights in an area around the statue of Robert Bruce on the castle esplanade.

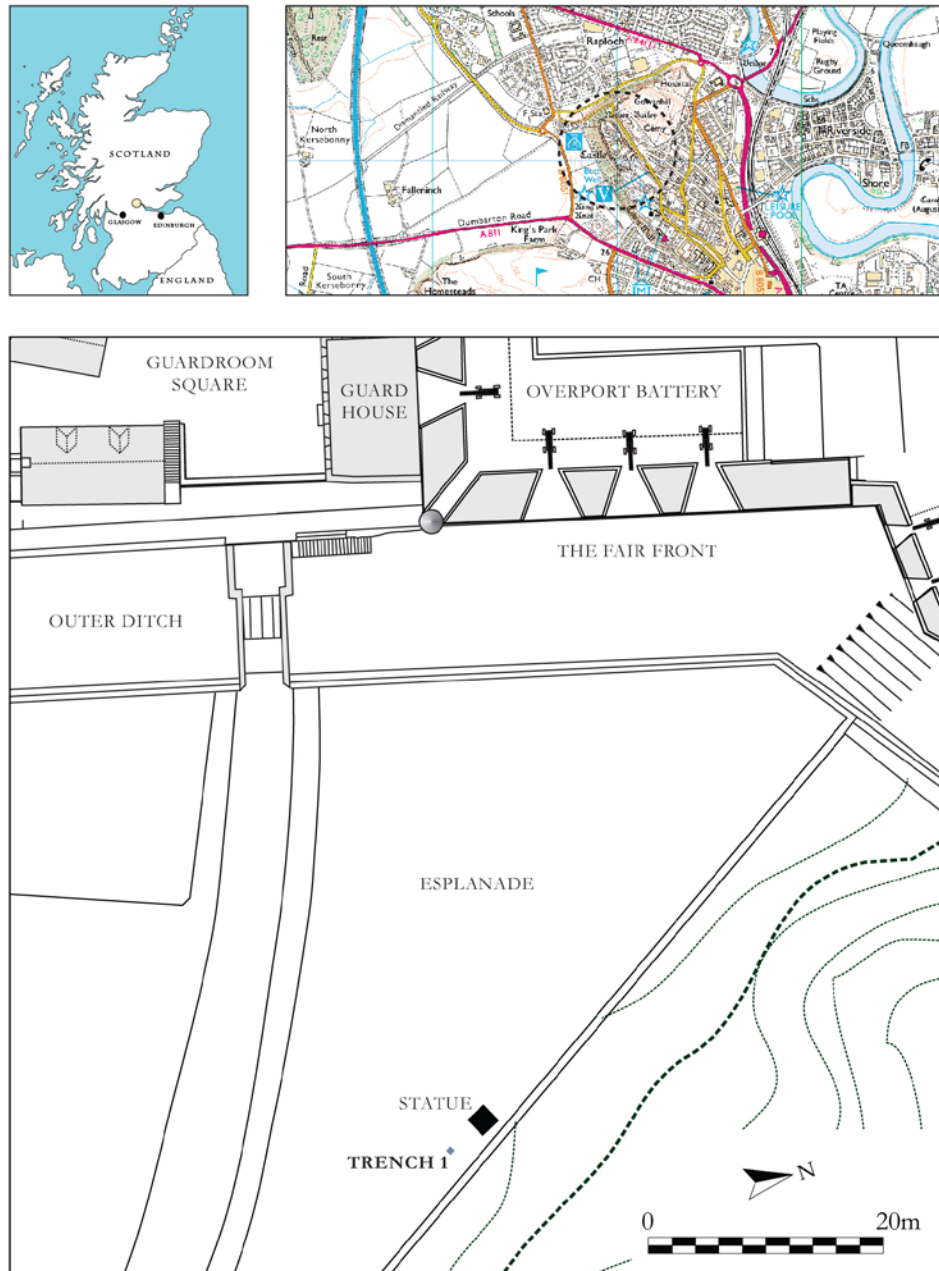
Figure 1: Plan showing the location of the Robert Bruce statue and the area of works.

Under the terms of its PIC call-off contract with Historic Scotland, Kirkdale Archaeology was asked to undertake an archaeological watching brief at Stirling Castle during the installation of four lights within the repaved area around the base of the Robert Bruce statue. The statue is located on the eastern side of the Esplanade (Fig.1).

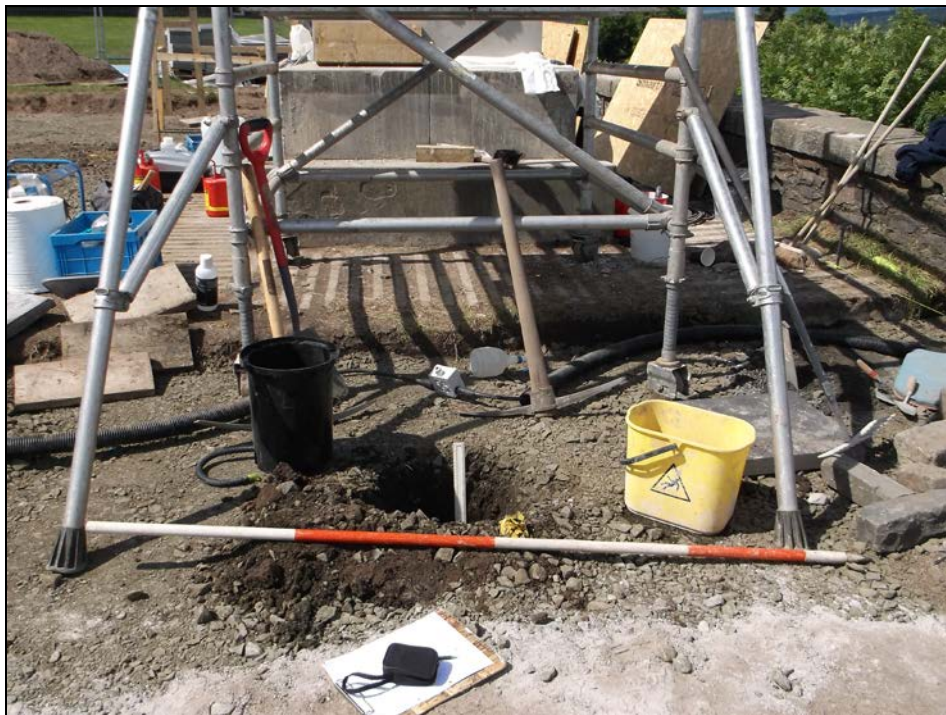
The centre point of the trench was located \approx 2.3m from the S face of the statue plinth. The upper fill comprised loose, imported stone chippings (**001**) over an imported dump of reddish coloured clay rich silt and stones (**002**) up to 100mm deep. Asbestos was found immediately below **002**, as part of the fill of a spread of dark grey silt and stones (**003**) which was reburied following consultation with Historic Scotland staff.

Plate 1: View of Trench 1 during excavation.

Contexts **001** and **002** represent recent landscaping, utilising imported material. Context **003** with its asbestos sheeting fragments, is also indicative of recent (20th century) levelling, but is most likely associated with activities of the garrison, utilising debris cleared from elsewhere on the site. This material lies at a depth of \approx 200mm below the present ground level, in the vicinity of the statue base.
