HISTORIC SCOTLAND PROPERTIES IN CARE
MINOR ARCHAEOLOGICAL WORKS 2014/2015

Tantallon Castle • Stage II Evaluation • May 2014

SITE: Tantallon Castle

DESCRIPTION: Archaeological evaluation of geophysical anomalies.

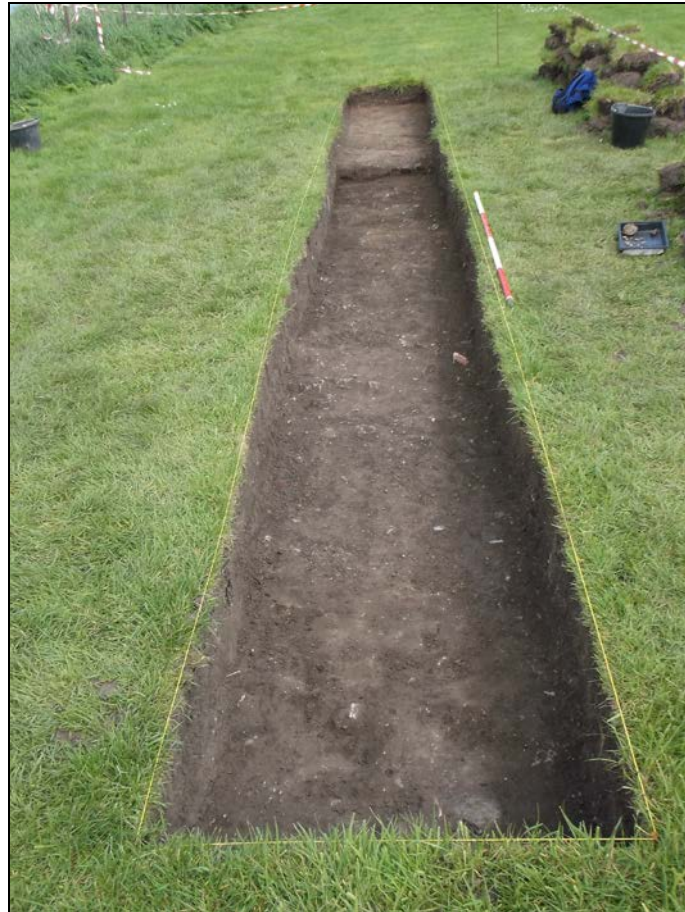
Plate 1: Trench 5, from the S

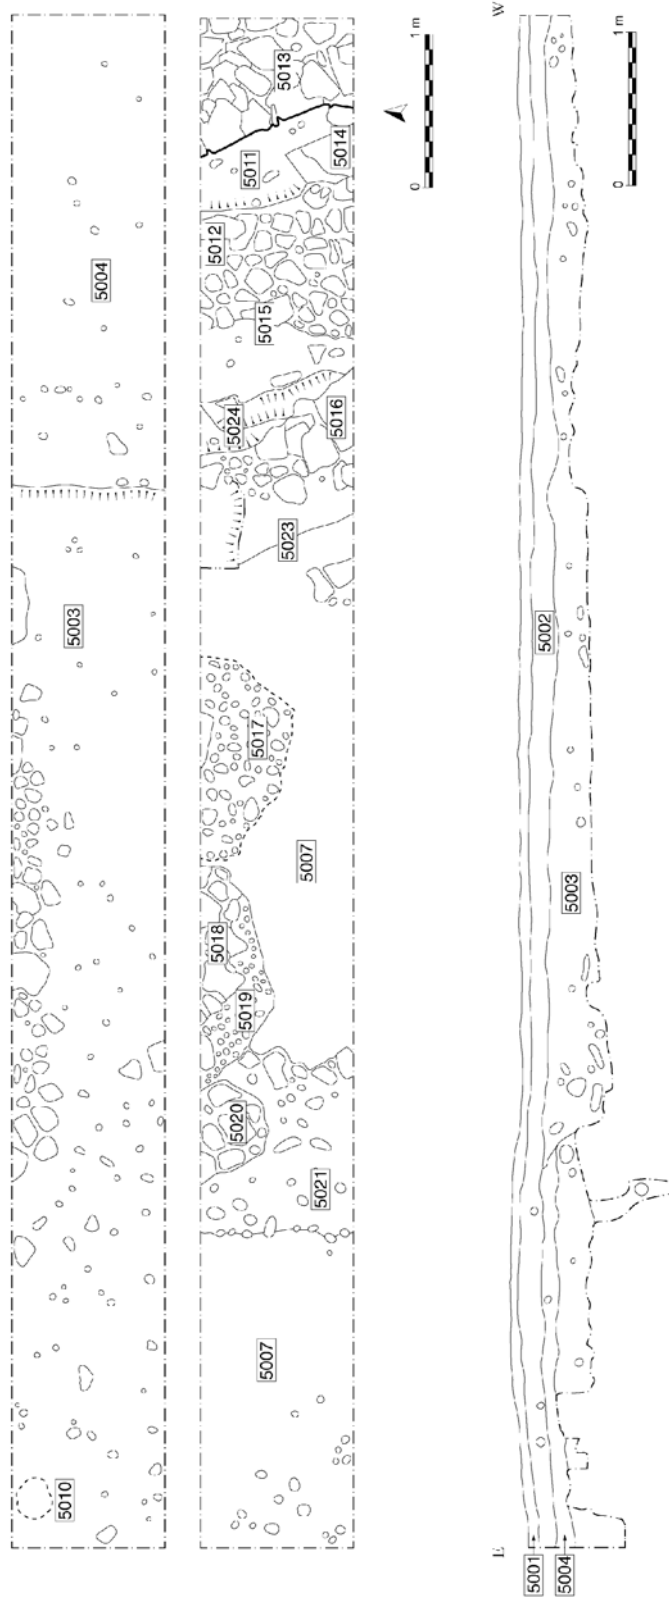
Figure 3: Trench 5 post-excavation plans (top) and N-facing section

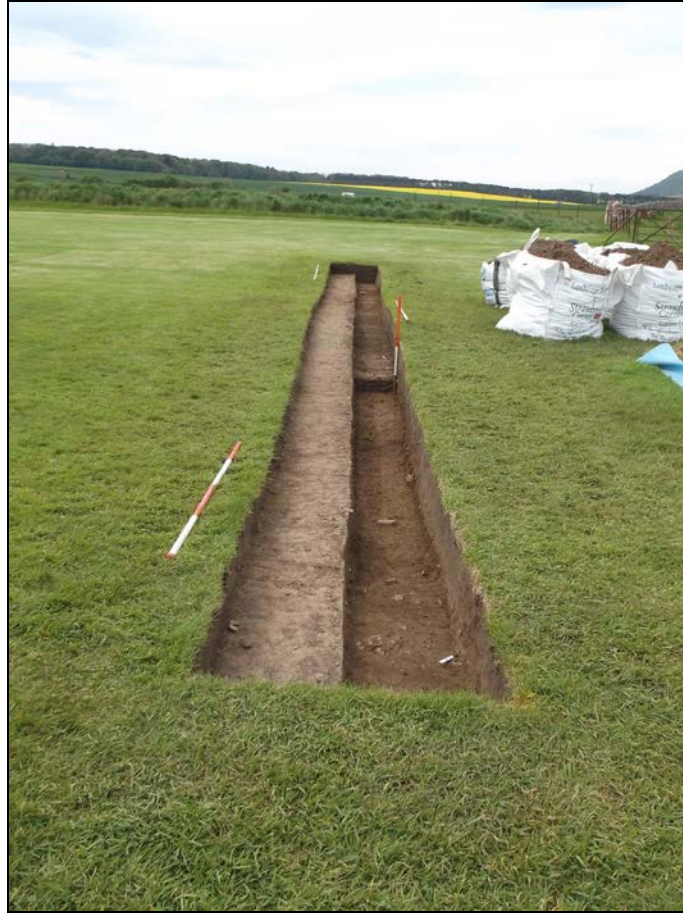
Plate 2: Trench 10, from the N

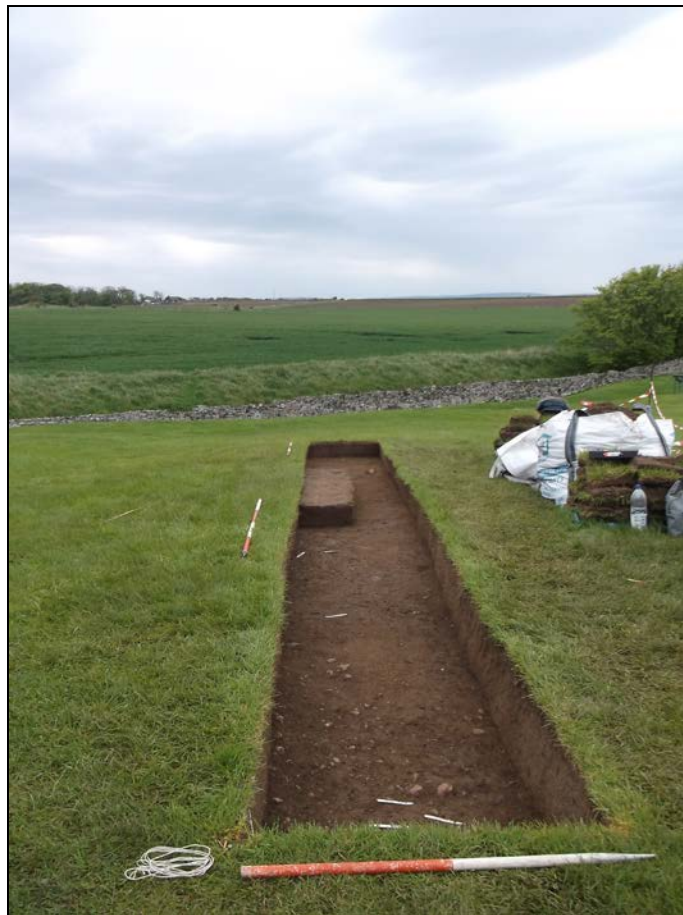
Plate 3: Trench 11, from the W

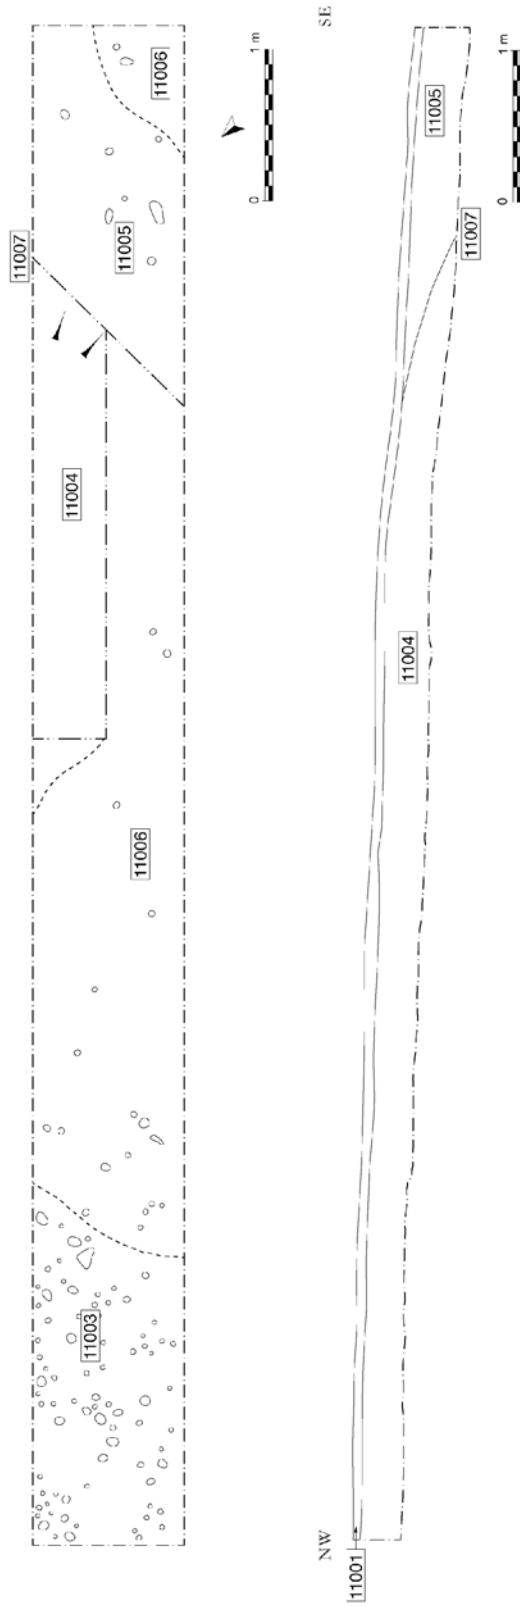
Figure 5: Trench 11 post-excavation plan (top) and SW-facing section

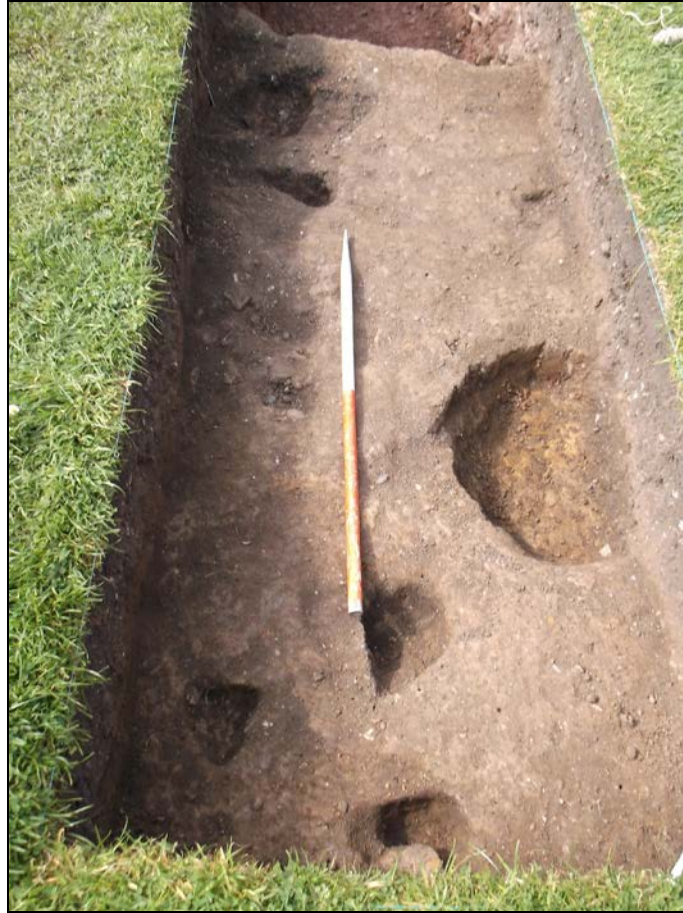
Plate 4: Trench 12, from the N, showing pits 12012 – 12014, post-excavation

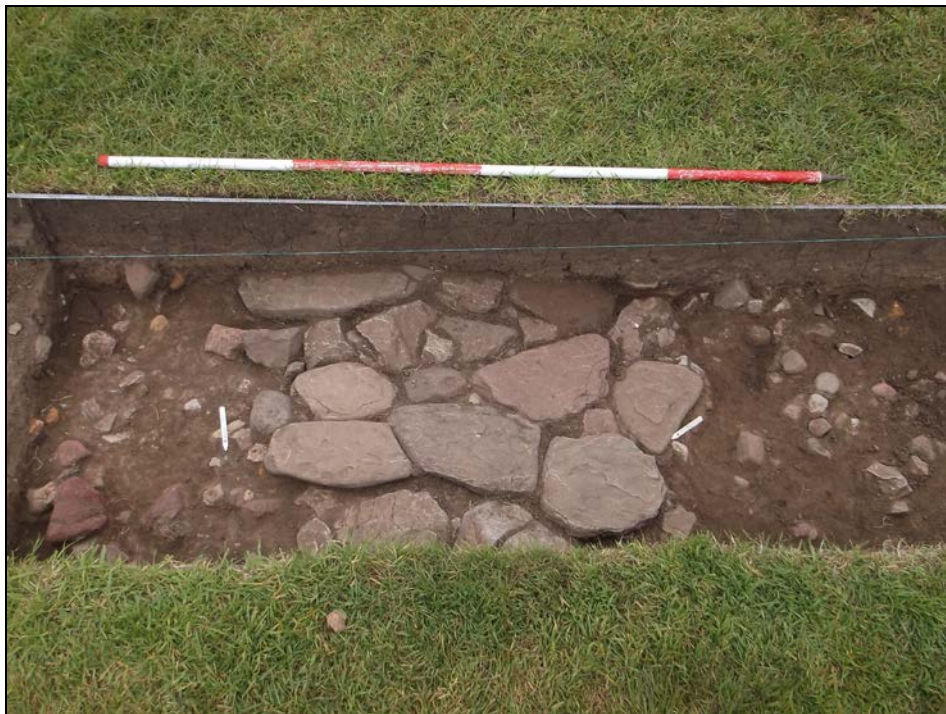
Plate 5: Trench 17, from the N, showing 17006, post-excavation

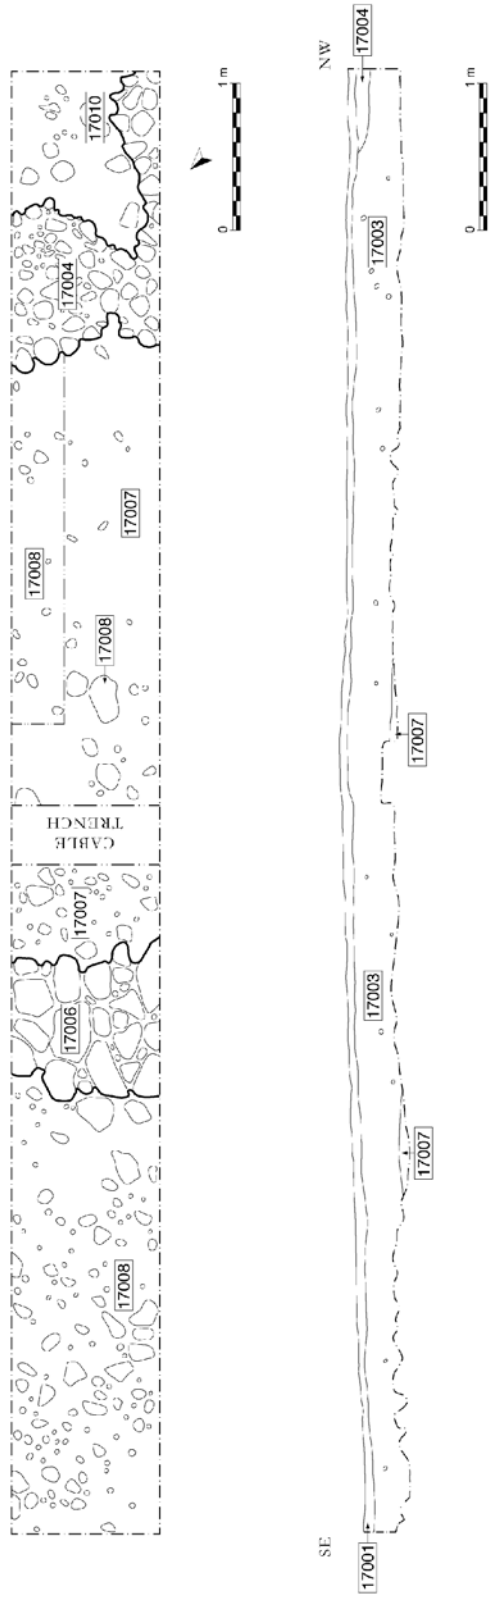
Figure 7: Trench 17 post-excavation plan (top) and NE-facing section

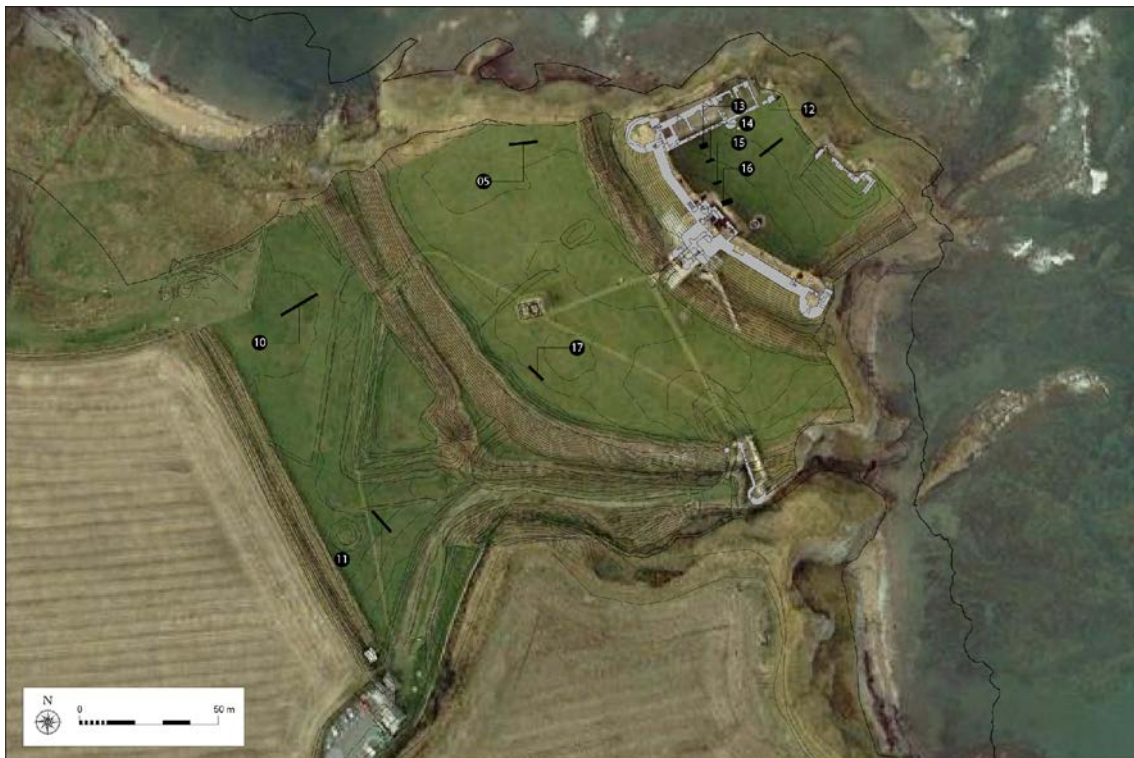
Figure 8: Trench locations superimposed on a modern aerial photograph of Tantallon Castle and the immediate environs.

A review of the trenches superimposed on a modern aerial photograph (Figure 8) appears to show a series of marks towards the NE end of Trench 10, extending to the S – these in part at least, could reflect drainage patterns.
