**Historic Scotland
Properties in Care
Minor Archaeological Works 2010**

**Castle Campbell:
Drain Blockage Excavations
April 2010**

**HS PIC Index Number: 90063
Project Code: HSCO-90063-2010-02**

<u>Site</u>	Castle Campbell, near Dollar, Clackmannanshire
<u>N.G.R</u>	NS 96128 99300
<u>Project Description</u>	Watching Brief on the digging of two trenches to try to discover where a drainpipe serving the courtyard ticket office was blocked.
<u>Project Code</u>	HSCO-90063-2010-02

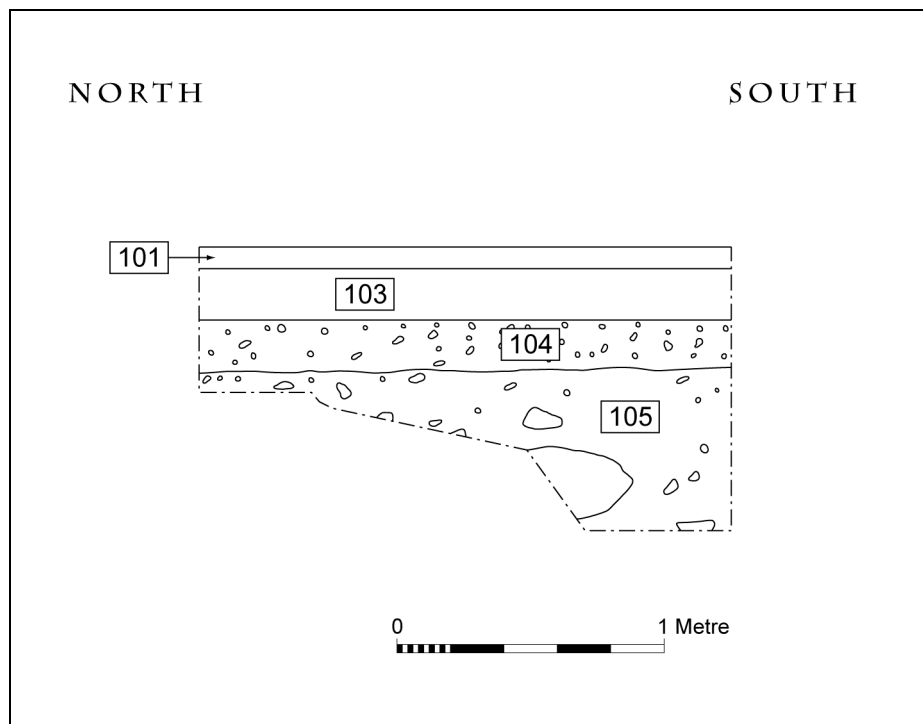
Figure 2: West-facing section in Trench 1

The turf (102) was removed and was seen to be 60mm thick. Below this (and the grass bars) was a compact mid-greyish brown silt (105) containing numerous sub-angular pieces of sandstone and basalt, with some re-deposited clasts of clay within the matrix. This suggested that the ground was made-up - however there was

nothing to suggest that this was a recent intervention. The only find recovered from (105) was a single sherd of green glaze pottery SF001 indicating that that the layer could be the result of medieval or post-medieval landscaping.

It was apparent that there was no cut for a pipe trench present, and continued excavation of the trench was halted.
