**Historic Scotland
Properties in Care
Minor Archaeological Works 2009**

**Dumbarton Castle (Governor's House):
Archaeological excavation,
November & December 2009**

**HS PIC Index number: 90107
Project code: HSCO-90107-2009-02**

<u>Site</u>	Dumbarton Castle (Governor's House)
<u>N.G.R</u>	NS 400 744
<u>Project Description</u>	Archaeological excavation
<u>Project code</u>	HSCO-90107-2009-02

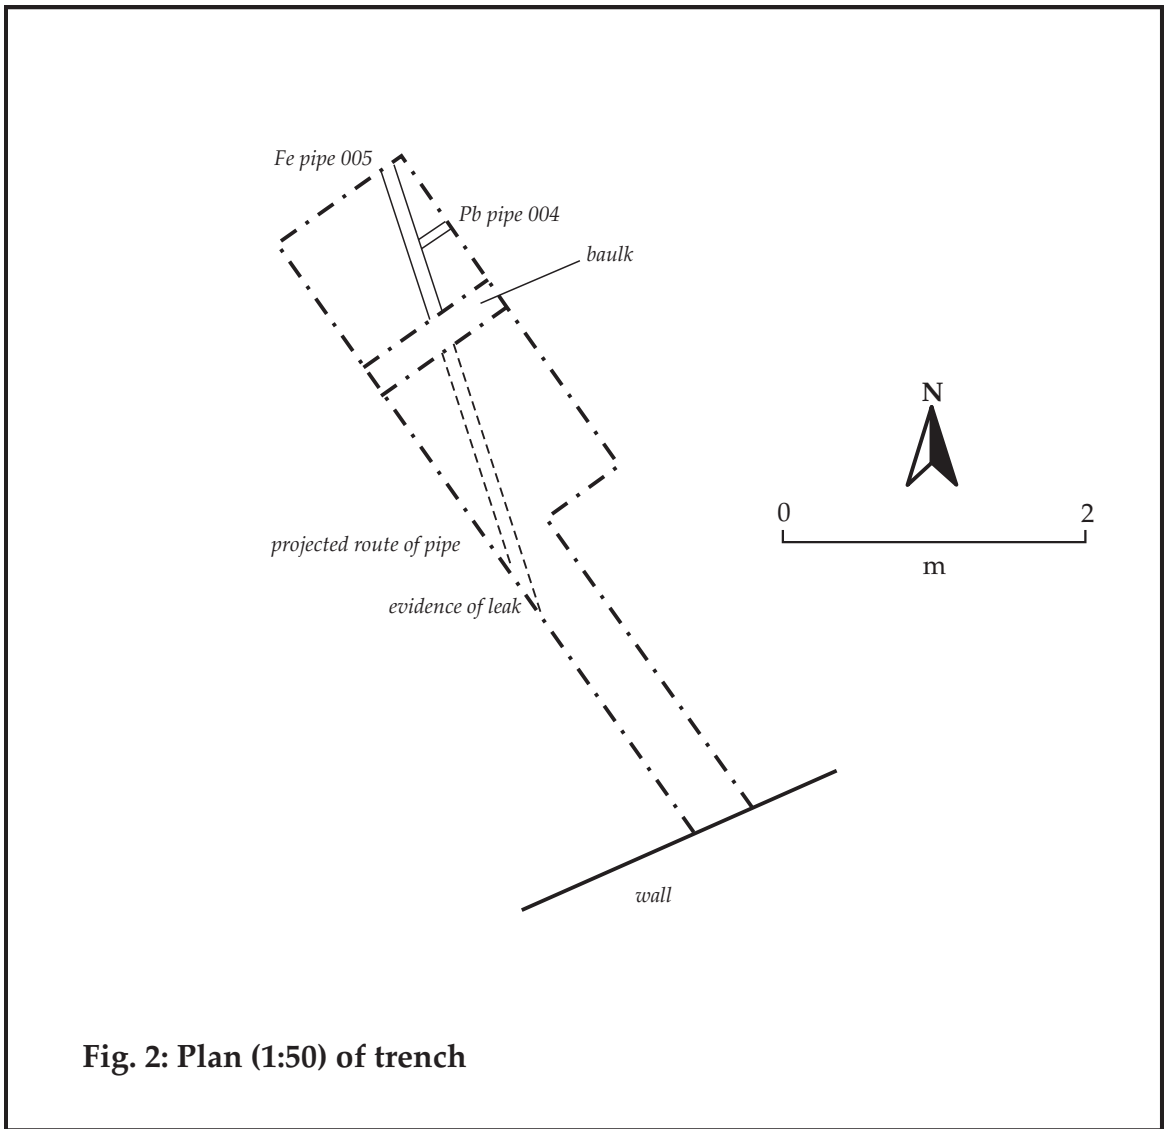
A trench aligned NW-SE was excavated between the corner of the Governor's House and the boundary wall in order to locate a burst pipe. The pipe was located at a depth of *c* 450mm running *c* N-S towards the northwestern end of the trench.

Topsoil (**F001**) was removed to a depth of 150 mm to reveal ash layer (**F002**) *c* 50 mm thick. This gave way to **F003**, a layer of broken sandstone fragments mixed with silt and mortar . This deposit was excavated to a depth of 250 mm but not fully bottomed. Cut against **F002** and **F003** was a narrow trench (**F 006**) for a cast iron pipe (**F005**) which was filled with **F004** (a mixture of redeposited **F002** and **F003**). A second, lead pipe (**F007**) was located, feeding into **F005** on its NE side towards the NW end of the trench. The damaged cast iron pipe was revealed and ultimately fully exposed before the repair and diversion of the water supply

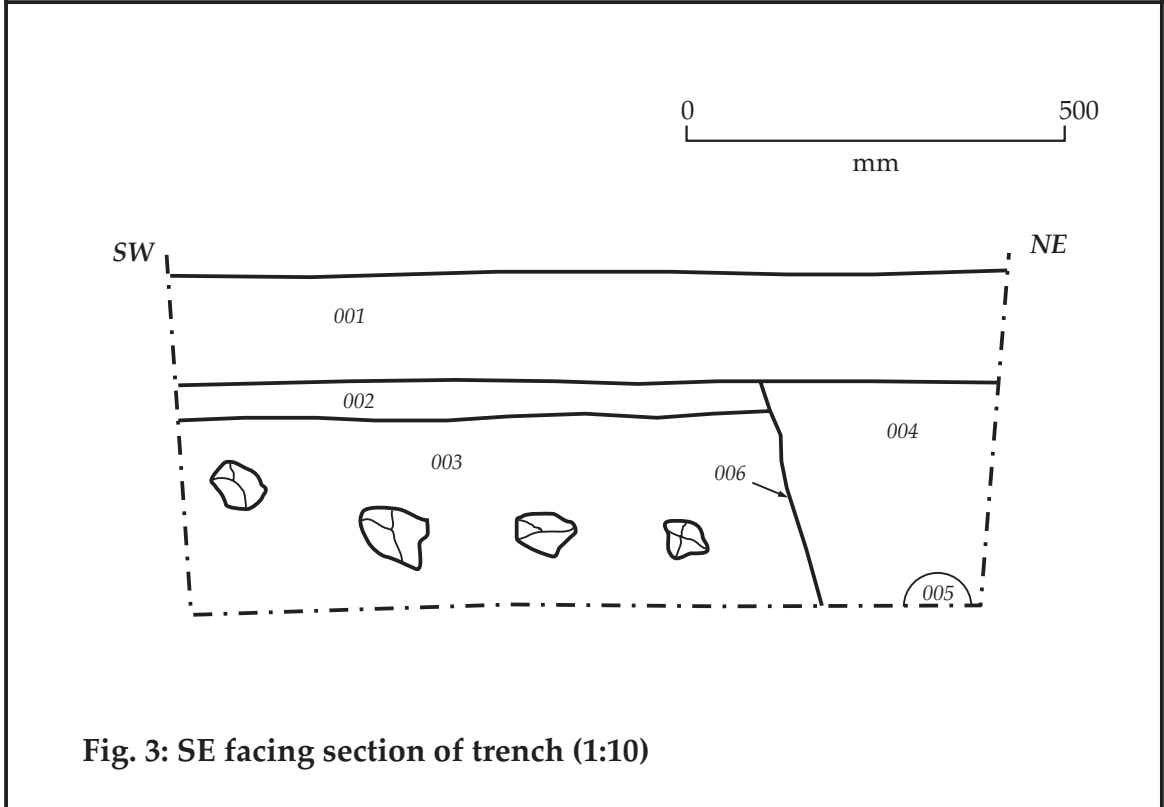
#	Description
001	Turf and topsoil.
002	Ashy layer – mixed with dark grey silt
003	Sandstone rubble fragments plus mortar fragments in dark silt matrix.
004	Mixture of 003 and 002 – fill of 006.
005	Cast iron pipe
006	Cut for 005 – c 300mm wide – not fully excavated
007	Lead pipe
