Discovery and Excavation in Scotland

**Historic Scotland
Properties in Care
Minor Archaeological Works 2010**

Inchcolm Abbey: Signage Removal and Installation May 2010

**HS PIC Index Number: 90166
Project Code: HSCO-90166-2010-01**

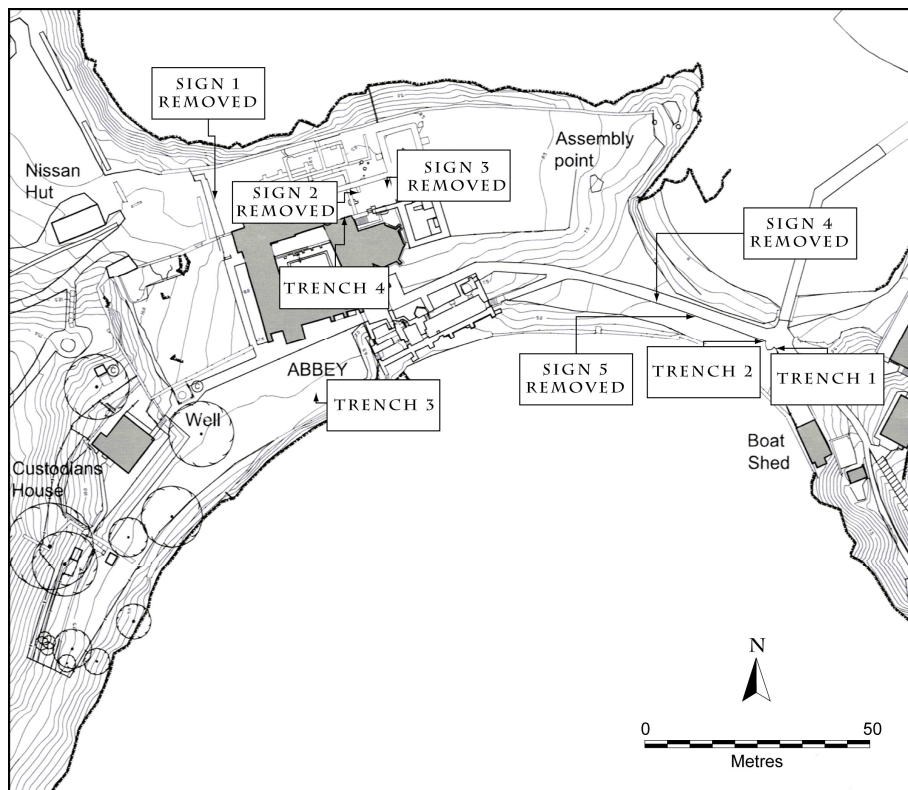
Figure 1: Location plan of trenches and removed signs.

Trenches 1 and 2 were located either side of the flagpole to the W of the Visitor Centre. Trench 1 housed sign INX5; Trench 2 housed sign INX4 (see Figure 1).

Trench 3 was located in the grassed area W of the abbey's latrine. The trench housed sign INX9 (see Figure 1).

Trench 4, for sign INX7, was located in the church choir but only required the removal of a section of modern turf (see Figure 1).

The existing, weather-worn signs, were removed as part of the works (see Figure 1). Sign 1 was located to the NW of the nave of the original church. Signs 2 and 3 were within the grassed area within the choir. Signs 4 and 5 were located on the grassed area to the S side of the path from the Visitor Centre to the abbey complex. Their removal was recorded photographically. They were all bedded under the turf line on square-footed legs. The turf was cut, the signs were removed, and the turf was put back into place.

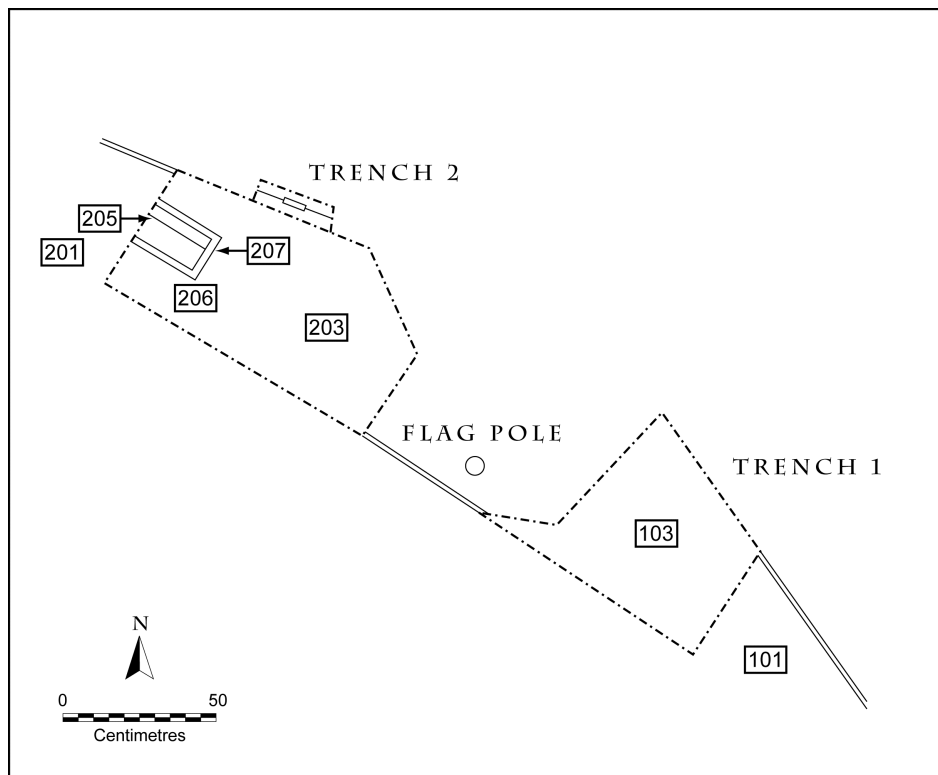
Figure 2: Plan of trenches 1 and 2.

Trench 1 was located to the SE of the flagpole. An area 600mm x 600mm was de-turfed and the wooden shuttering cut back. The turf (**101**) was 500mm thick and sat on a mid-brown silty topsoil (**102**) 100mm thick. This appeared to be modern landscaping which cleared onto a base of Type 1 stone (**103**). New shuttering was cut to take the basal concrete pour for the new sign.

Trench 2 was located to the NW of the flagpole. An area 500mm N/S x 1000mm E/W was de-turfed and the wooden shuttering cut back. The turf (**201**) was 500 mm thick and sat on a mid-brown silty topsoil (**202**) 100mm thick. This appeared to be modern

landscaping which cleared onto a base of Type 1 stone (203). Within this, an iron manhole cover (204) was found covering an open section of pipe (205) set within a red brick built box (206). A black rubber-coated electricity cable (207) ran back towards the abbey, and this had to be avoided during the work. New shuttering was cut to take the basal concrete pour for the new sign.

Nothing of archaeological significance was encountered in either of these two trenches.

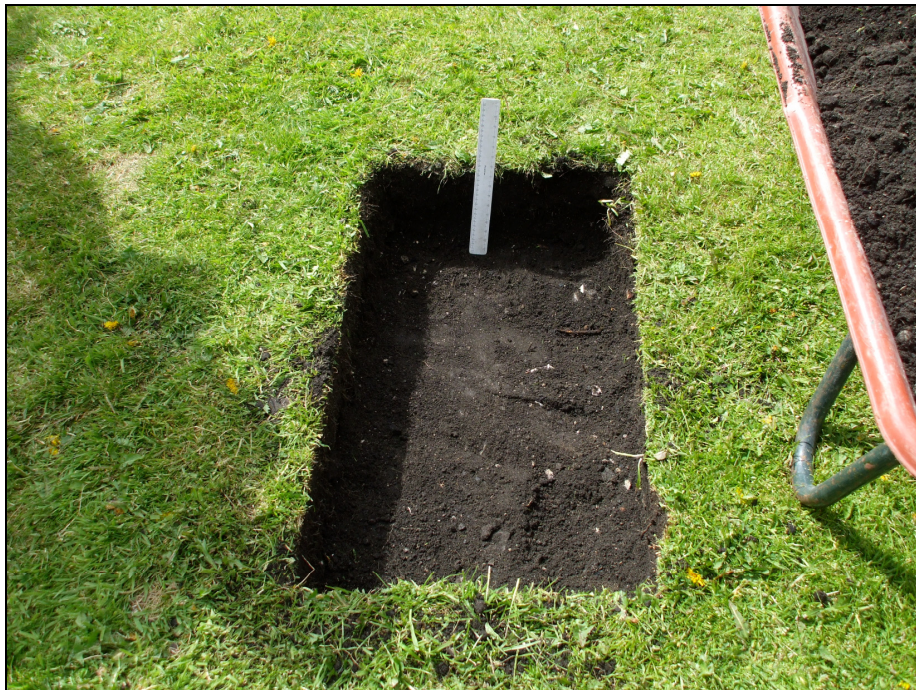
Figure 3: W-facing section of Trench 3 for INX9.

Trench 3 measured 500mm N/S x 900mm E/W x 200mm deep. The section showed turf and topsoil (301) to a depth of 100mm over a moderately compact black silt containing shell and bone fragments (302).

Nothing of archaeological significance was encountered in this trench.
