**Historic Scotland
Properties in Care
Minor Archaeological Works 2010**

The King's Knot: Drainage Trench Monitoring May 2010

**HS PIC Index Number: 90288
Project Code: HSCO-90288-2010-01**

<u>Site</u>	The King's Knot, Stirling.
<u>N.G.R</u>	NS 7900 9400
<u>Project Description</u>	Archaeological monitoring of two trenches dug to address ongoing drainage issues.
<u>Project Code</u>	HSCO-90288-2010-01

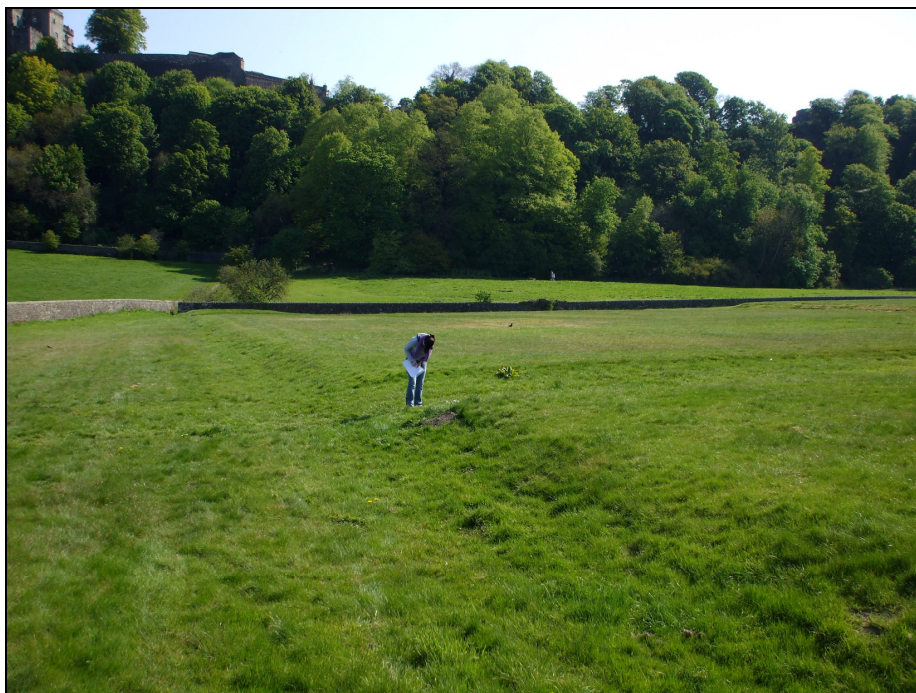
Figure 1: N end of the *parterre*.

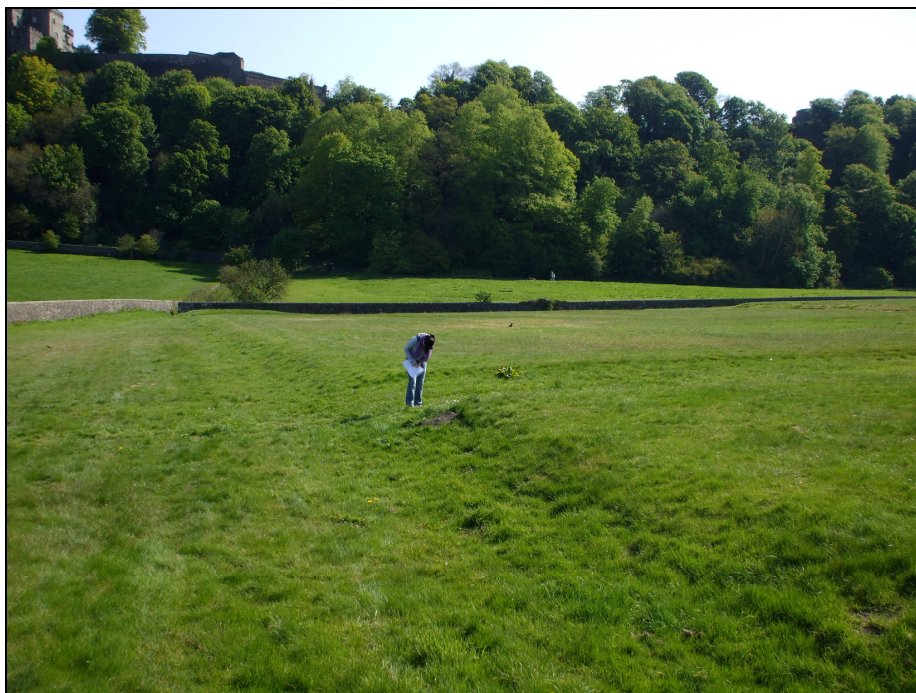
Figure 1: N end of the *parterre*.
