Historic Scotland Properties in Care Minor Archaeological Works 2009

Palace of Holyroodhouse:

Archaeological recording, October 2009

> HS PIC Index number: 90132 Project code: HSCO-90132-2009-01

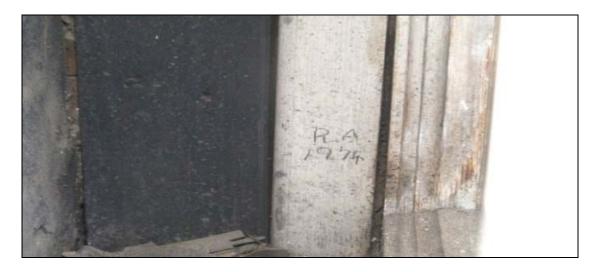
During the recording, **001** was not fully legible but after examining the photographs it is clearly read as "William Thompson glazed this pane 15th August 1867".

On the E side of frame 14, 101 is copper script written with a pencil and runs

vertically from top to bottom, it reads "William Thompson Ia[...] this pane 15th August 1867".

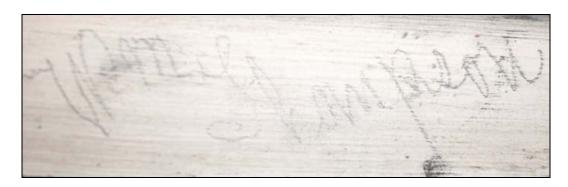
The name at the start of **003** appears to be Wm. Thompson.

At the base of the W side of frame 15, **103** is pencil writing, running from top to bottom, transcribed as "...... Thompson late of".

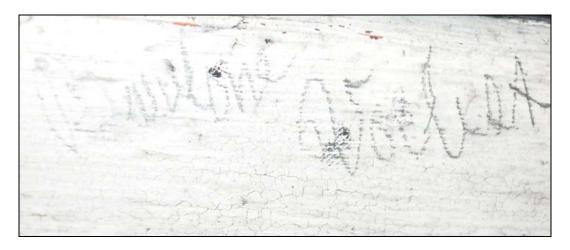
The second part of the writing has not been ascertained; perhaps the name of a building or glazing company is most likely. The first word probably ends "[...]lone" and the second looks most like "Voiliet" or "Valiet".

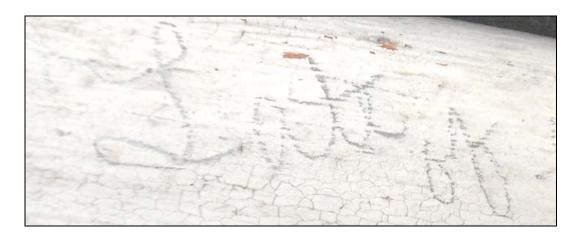
This is followed by "late of".

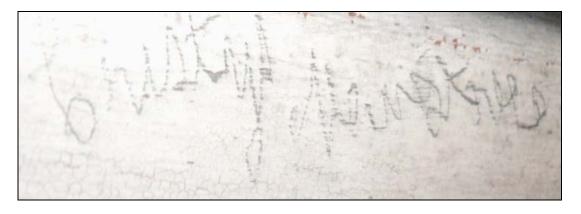
A possibility is that the final part transcribes as "C[h]risty's Newingtone", a company.

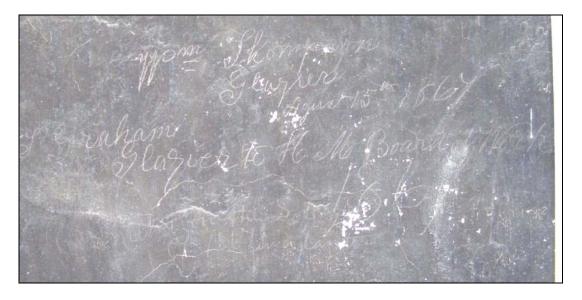
004 was confidently translated as Wm. Thompson Glazier August 15th 1867" and "J Graham glazier to H M Board of Works 1867".

104, ".... Thompson Glasgow August 15th 1867" and "J Graham glazier to [...] Board [...] 1867" are scratched into the paint on the outer face of the blocking behind pane 11. There were further scratched inscriptions, **105**, below **104** but these were not legible.

William (Wm) Thompson is also inscribed on the blocking behind the window at **104**, again on August 15th 1867, alongside J Graham glazier to H M Board of Works 1867. If one of the glaziers involved was employed by to H M Board of Works it seems fairly likely the other was – although that is certainly not what is written at **103**.

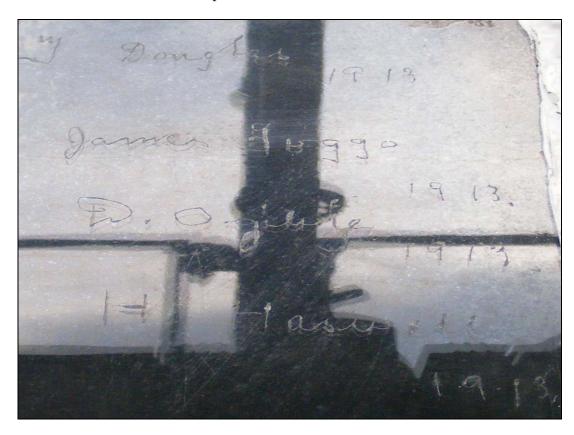
301 was clearly legible.

It has been speculated that J Douglas, James Hogg, D Ogilvie, and H Haswell may have been Board Of Works employees, it also seems likely that some or all of them went to war soon after. Perhaps their histories could be traced.

On the top of the E corner of pane 15, **301** was the names J Douglas 1913; James Hogg 1913; D Ogilvie 1913; H Haswell 1913 - these are in a column and are listed from top to bottom - scratched onto the glass.

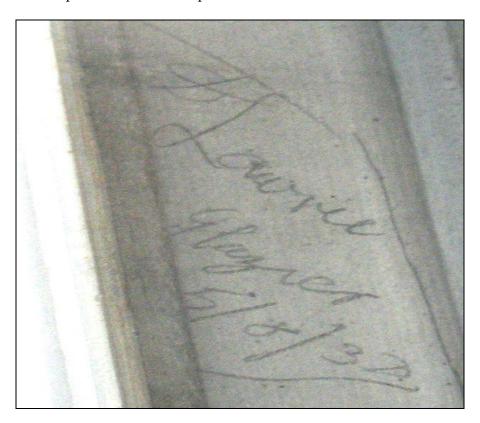
Behind pane 1, 302 was deciphered as "Lawrie Glazier 5/8/32".

Behind pane 1, on the inside of the frame close to the top, **302** was transcribed as "D Laurie Glazier 5/8/3-". It was written with pencil.

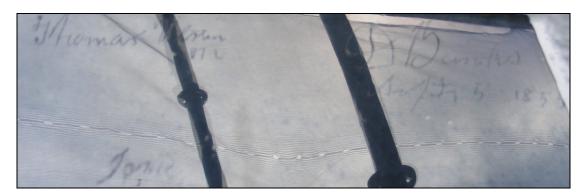
The translation, as given, for the features on pane 13 are not always entirely clear on the photographs. **401** could almost as easily read "Thomas Wilston". The date on **402** may be 1855 (rather than 1853) and partially painted over. **403** is more likely "Jon.R" than the previously suggested Jamie.

Panes 3 and 12 are both broken and 10 is cracked. The inscriptions on this window are scratched into the glass toward the top of pane 13. **401** reads "Thomas W Liston 1872", to right (E) of **401**, **402** was transcribed as "D Banks Sept 5 1853". **403** below the right side of **401** was read as "Jamie".
