**Historic Scotland  
Properties in Care  
Minor Archaeological Works 2010**

**Stirling Castle Palace:  
Lath & Plaster Removal in U20  
June 2010**

**HS PIC Index Number: 90291  
Project Code: HSCO-90291-2010-01**

**30<sup>th</sup> June 2010  
Kirkdale Archaeology**

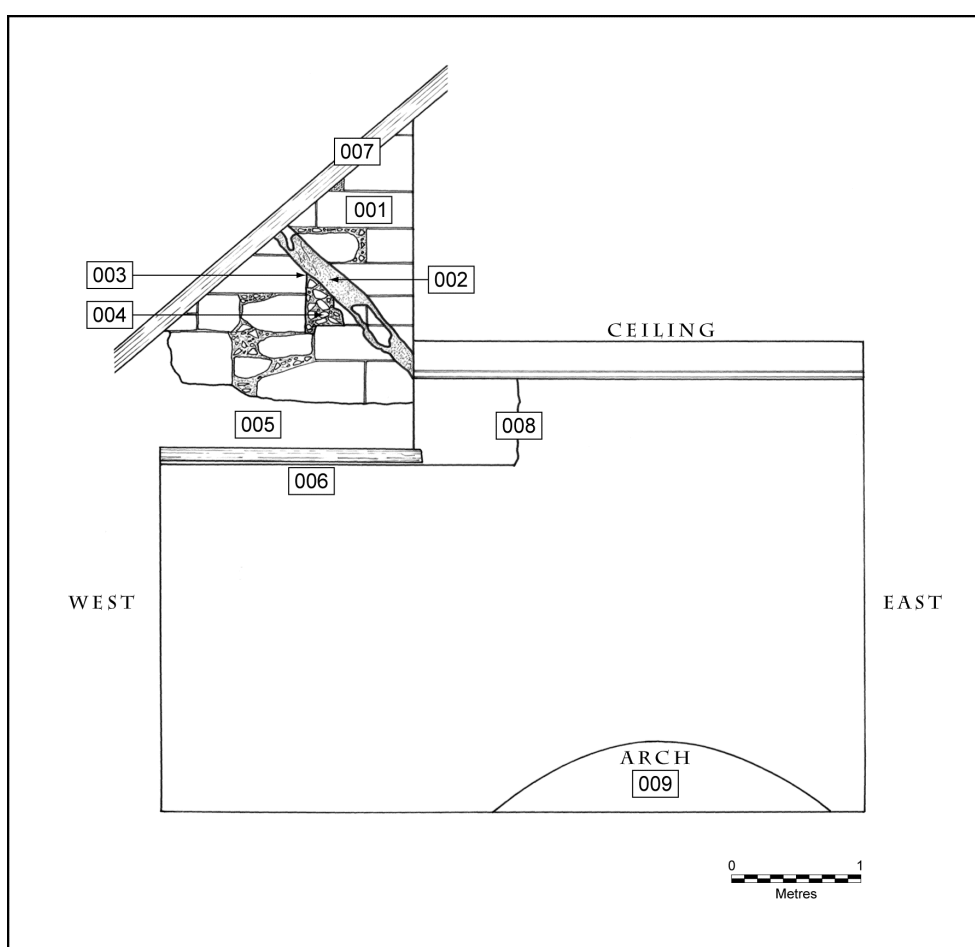
**Figure 2:** Features visible behind the lath and plaster in U20 plus the arch (009) and the cut in the lath and plaster (008).

A broadly rectilinear cut (008) was made through the lath and plaster in the W end of the N wall (Figure 2). This revealed (001), the masonry build of the chimney breast, comprised of yellow sandstone blocks with dressed edge quoins, bonded by yellow lime mortar. Within this was a mortar scar (002) up to 60mm thick and 160mm wide, running diagonally upwards. Also within (001) was possible evidence for a (now removed) purlin. This was revealed in the form of an

irregular cut. It truncated part of (001) at a sharp right angle, suggesting the cut may be real. Within (003) was a sub-angular sandstone and lime mortar fill. This may have been part of (001) if (003) was not a cut. If (003) was related to the prior presence of a purlin, then this fill could be reasonably early in date due to its compositional matrix of lime mortar. The lower part of (001) appeared to feature the scar of a removed roof element (005), possibly leaded to make it water tight. It was a maximum of 160mm deep to the E. Also made visible by the cut (008) were (006), a sole piece from the 17<sup>th</sup> Century roof, and (007) a rafter from the 19<sup>th</sup>/20<sup>th</sup> Century roof.

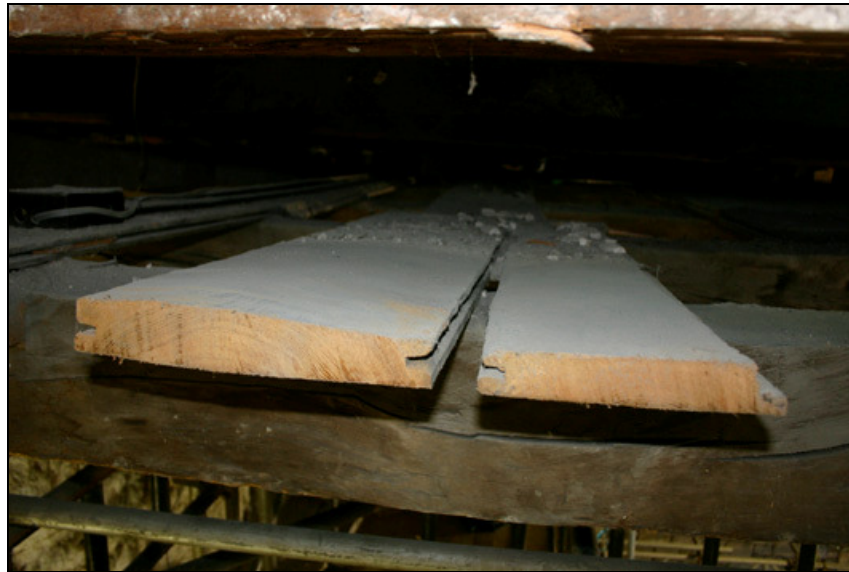
**Figure 3:** Floorboards (1538d) and joists (1538d) over the Queen's Bedchamber.

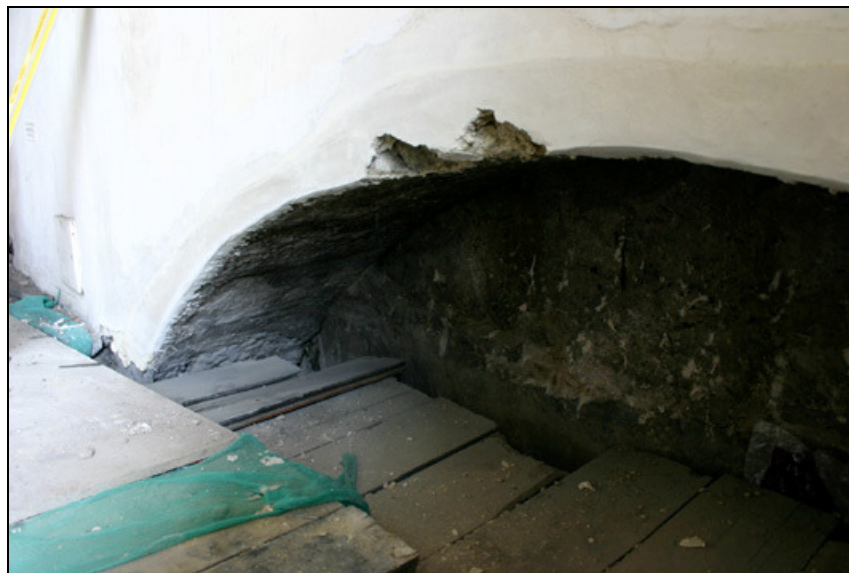
**Figure 4:** The western part of the relieving arch in U20 (probably c.1538). The arch is butted against rising rubble masonry which apparently belongs to the cross-wall that divides the Queen's Bedchamber and the King's Bedchamber. It is, without embarking on further research, impossible to say whether the rubble wall pre-dates or post-dates the arch.

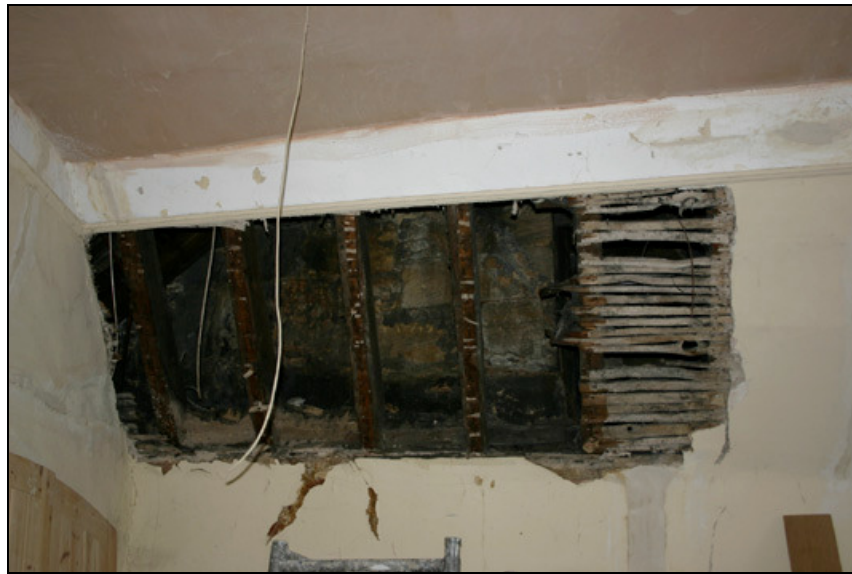
**Figure 5:** The chimney inside the N-wall of U20 (probably c.1538).

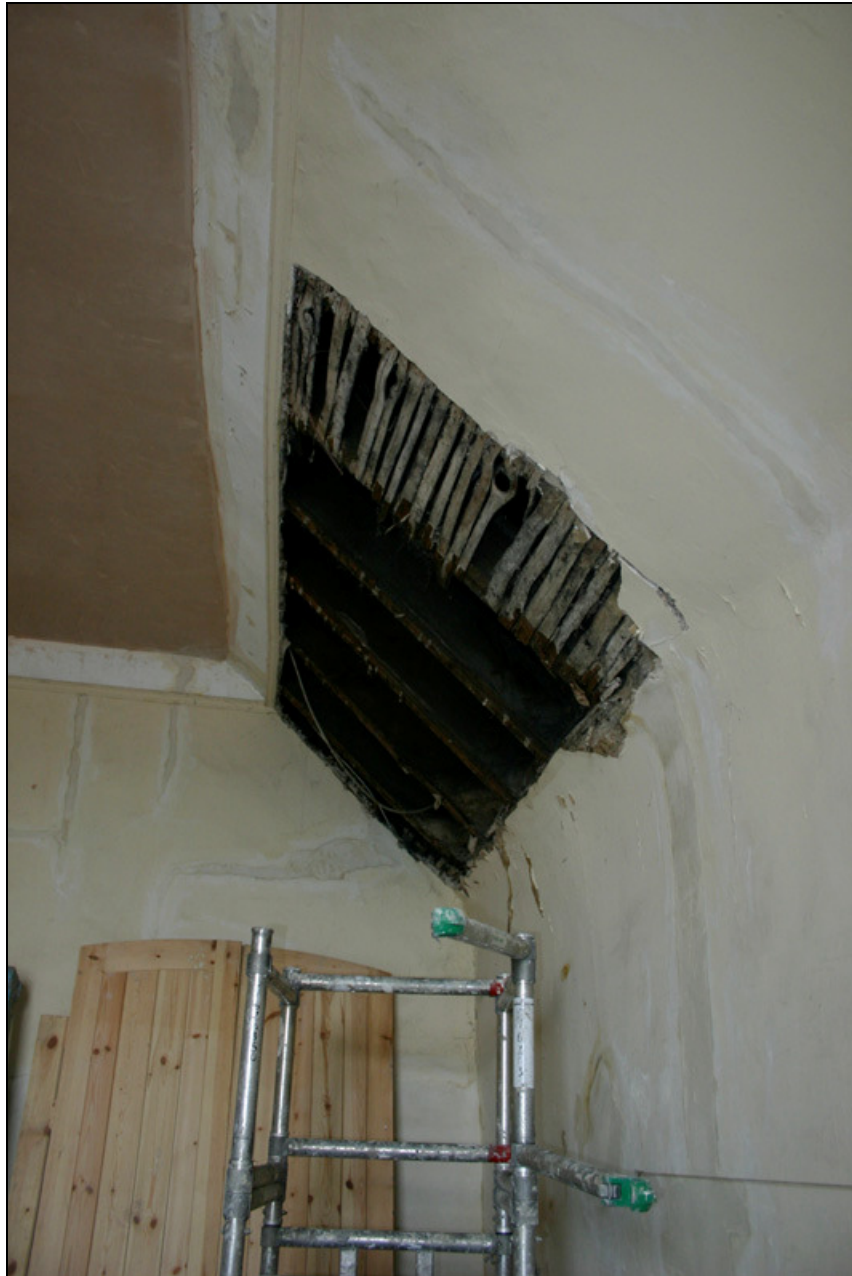
**Figure 6:** The roof (late C17) and lath and plaster ceiling (late C17) over U20 .

The most enigmatic architectural element of U20 is a relieving arch (009) which is incorporated into the northern cross-wall. The position of its springers respects the 1538 floor arrangement over the Queen's Bedchamber and, as will be discussed later in the captions of Figs. 6, 8 and 11, there is good reason to believe that they were put in place around 1538 as well. The arch binds at its eastern side into the E-wall of the palace and at its western side into the chimney that belongs to the fireplace (001) in the NW-corner of the Queen's Bedchamber.

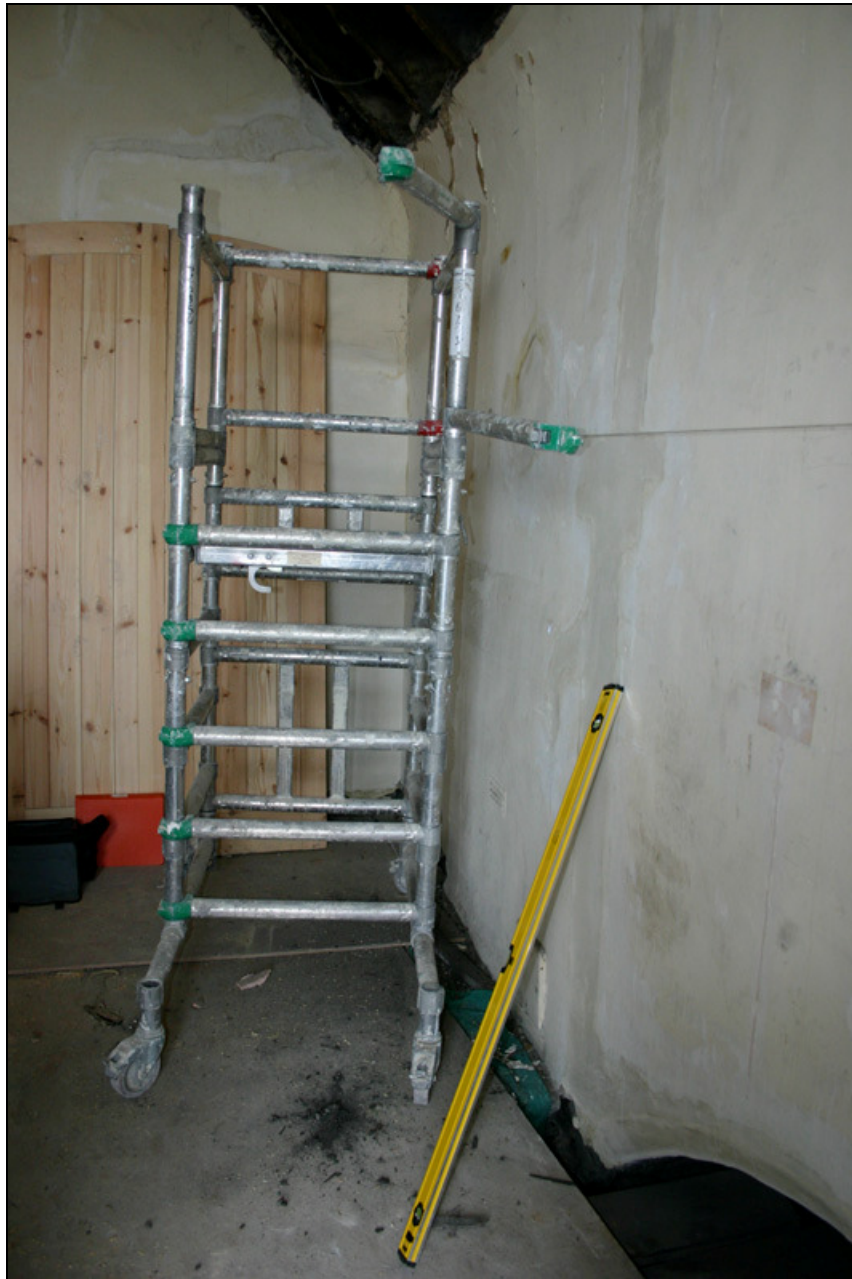
Figure 7: The roof (late C17), ceiling (late C17) and relieving arch (probably c.1538) in U20.

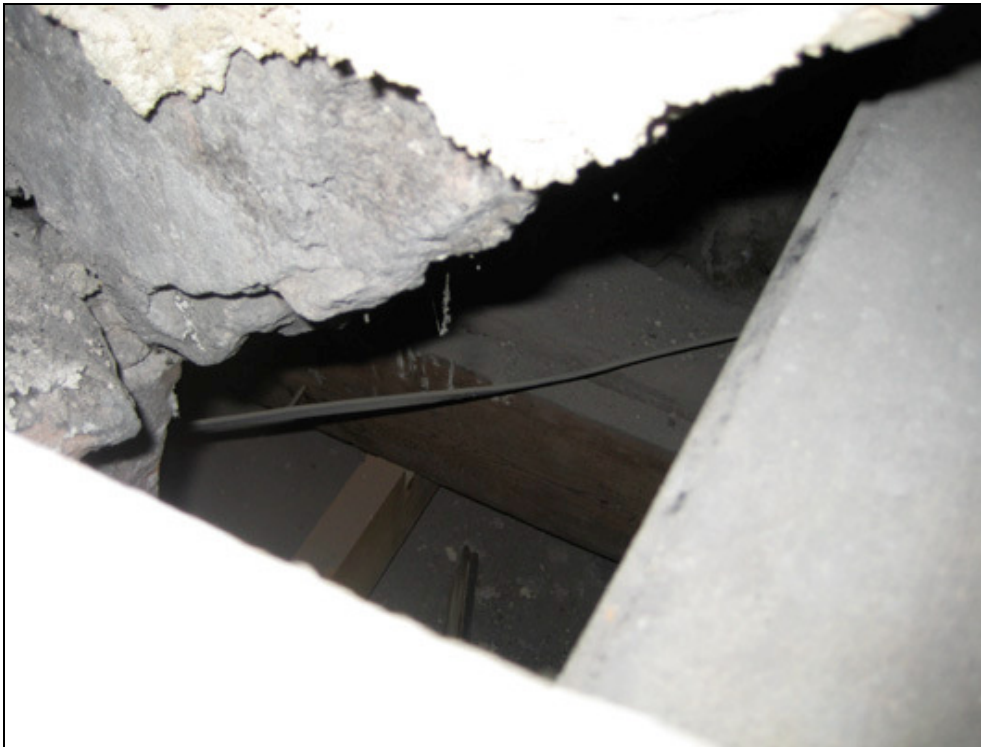
**Figure 8:** The relieving arch (probably c.1538) and floor joist (1538d) at the N wall of U20. The arch relates to the northernmost floor joist of the Queen's Bedchamber. This suggests that the arch was created in the context of the 1538 building operations.

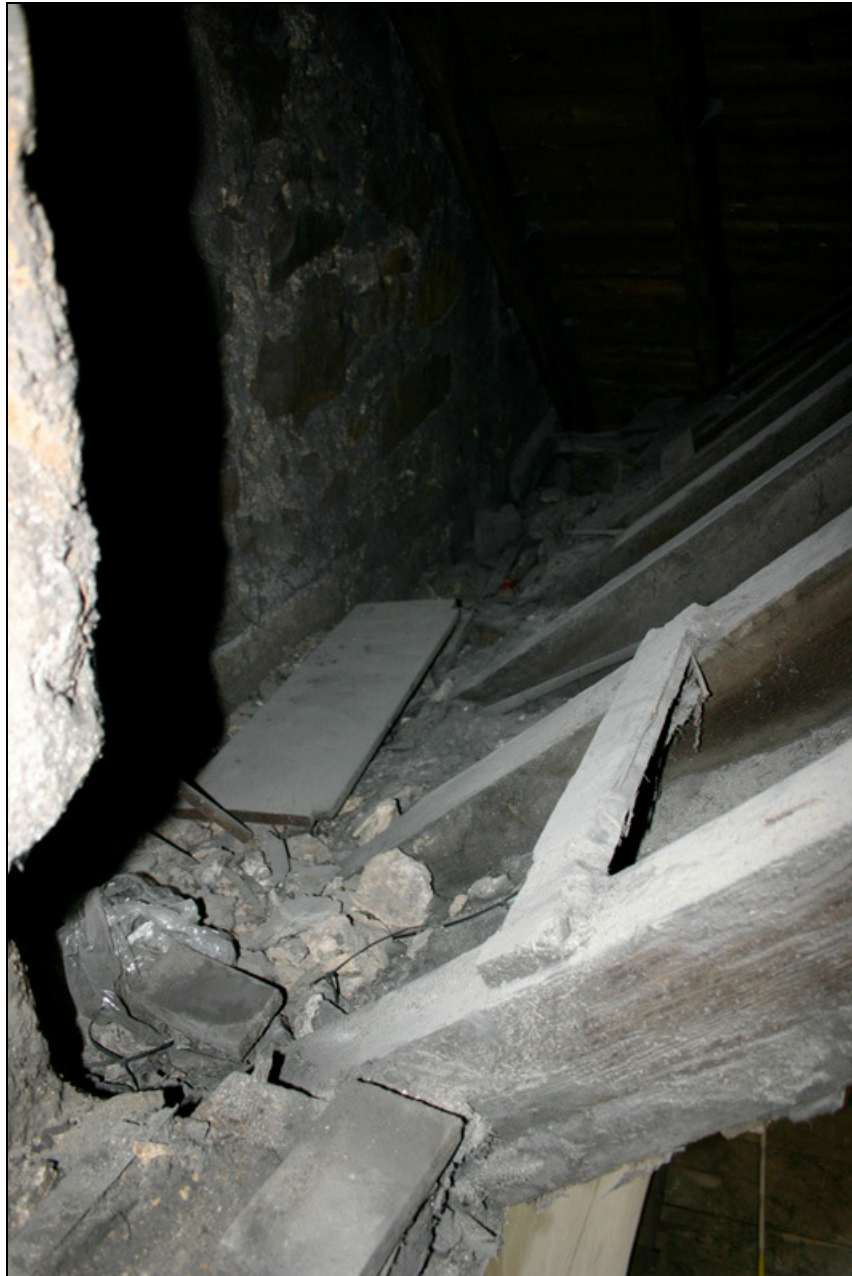
**Figure 9:** The roof (late C17), chimney (probably c.1538) and N wall (probably c.1538) of U20 at attic level.

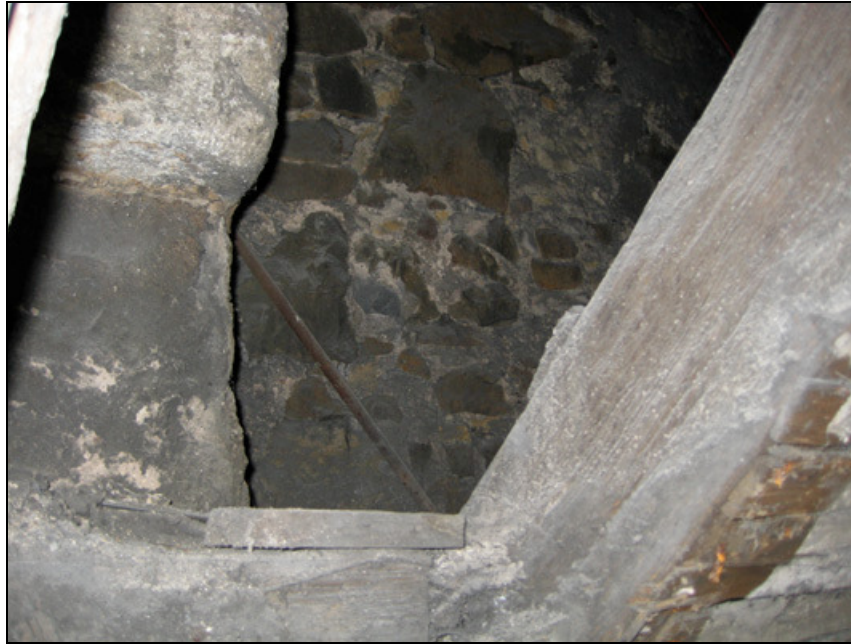
**Figure 10:** The chimney (probably c.1538), N wall of U20 (probably c.1538) and rafter of R10 (late C17). The chimney, datable in all probability to the years around 1538, possess a notch that appears more or less at current wall-head level. This notch may belong to the original roof over the SE-corner of Stirling Palace. The rubble wall over U20 at attic level may also belong to that period because it is highly unlikely that Stirling Palace originally possessed hip-and valley rafters. Instead it was common practice to butt the roof slabs against extended gable walls. The notch at the chimney may have been used for receiving lead-clad timbers employed for waterproofing the valley between the rafter feet and the rising wall.

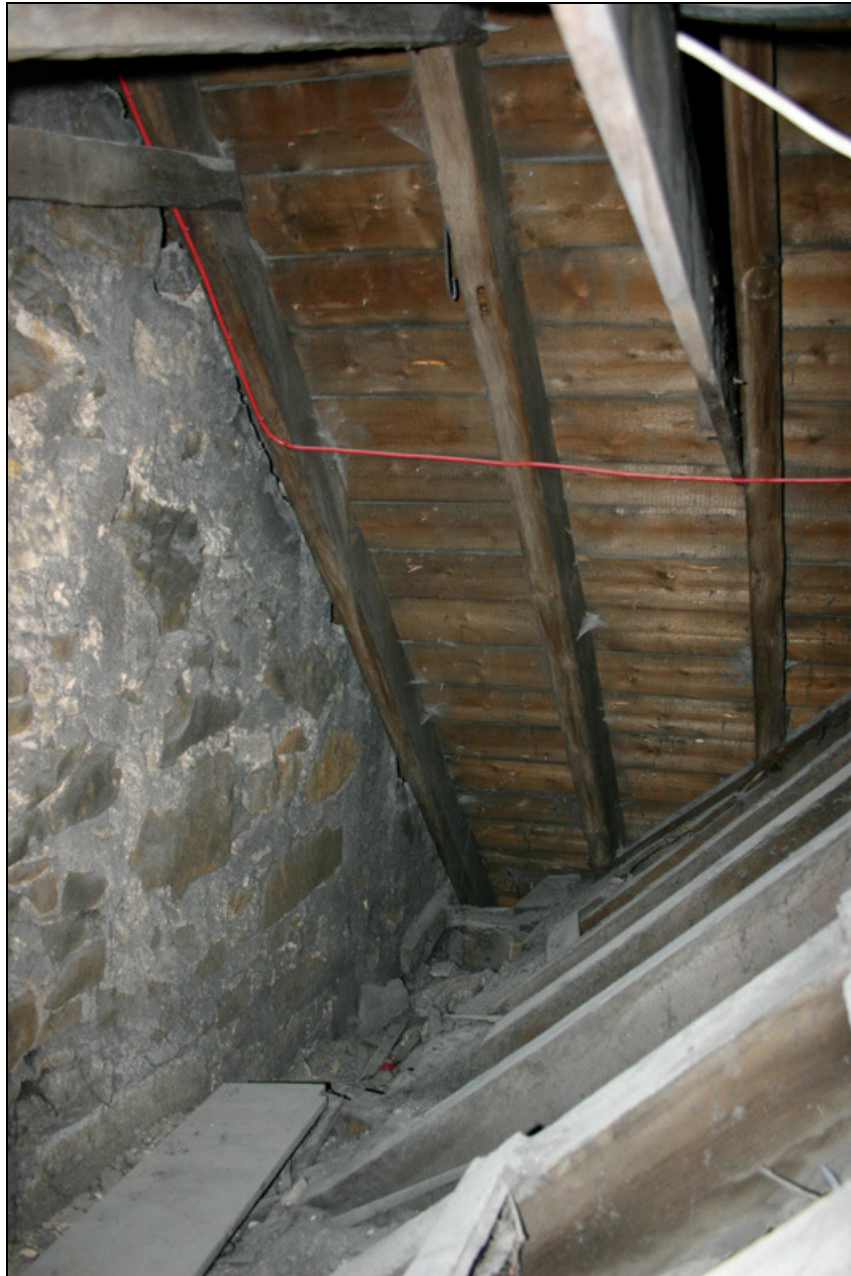
**Figure 11:** The N wall (probably c.1538), roof R05 (post-C17) and roof R10 (late C17) in U20.

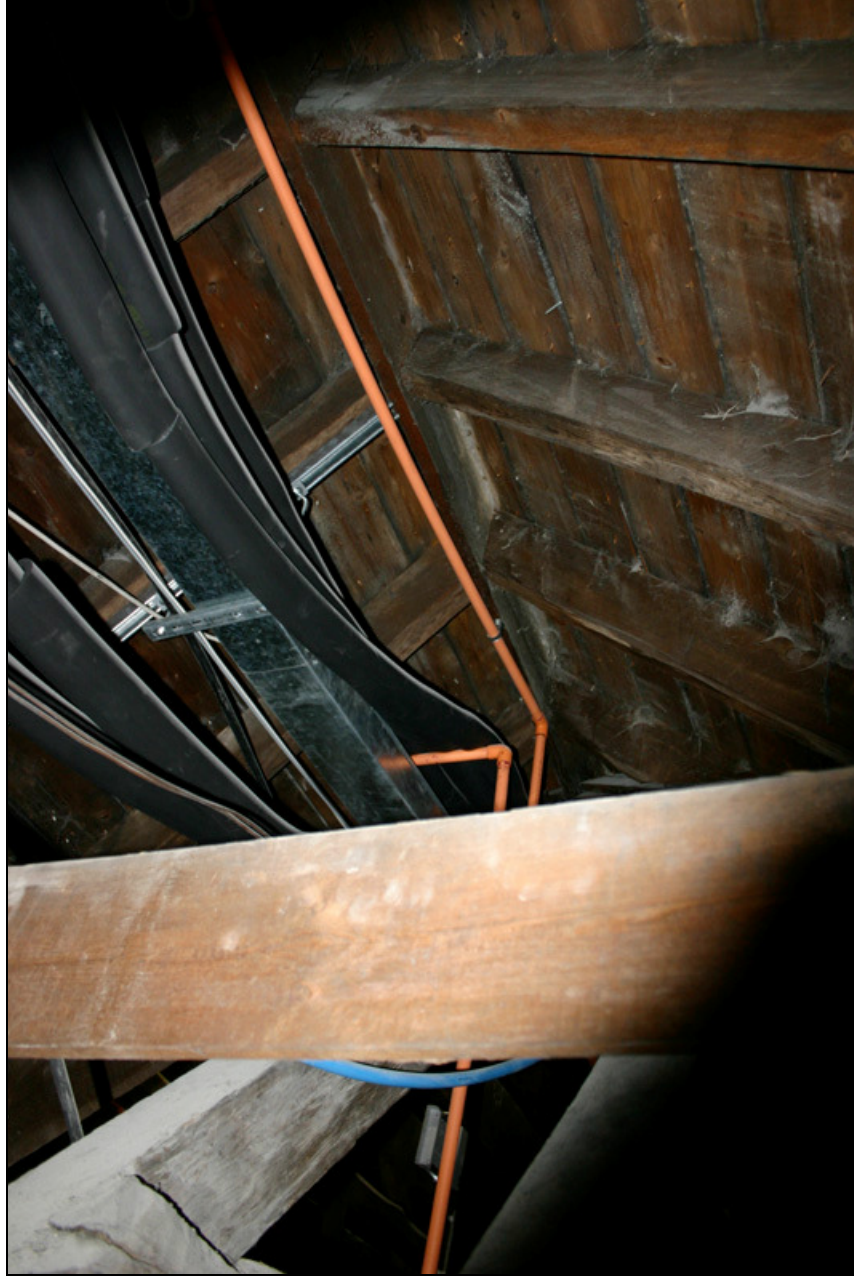
**Figure 12:** The roof R05 over U20 (post-C17).

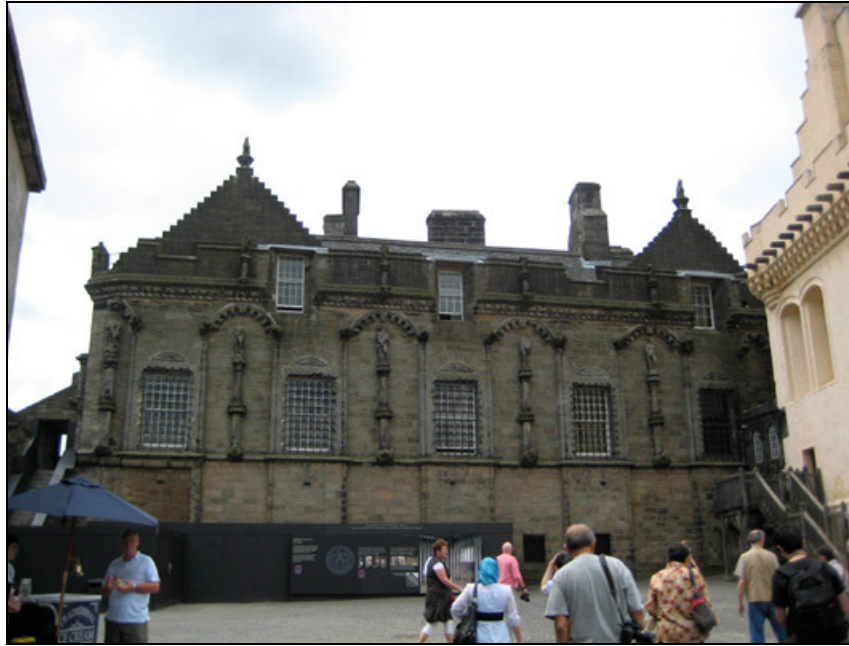
**Figure 13:** The E-façade of Stirling Palace (c.1538). James V's elevation, employing two crow-stepped gables at the northern and southern ends of the E-range, implies that the original roof over the S-range resembled the current roof-architecture. This can be assumed because the gable-triangle ultimately defines the pitch, height and width of the roof. It is therefore highly likely that the U20 arch was created by James V's craftsmen.

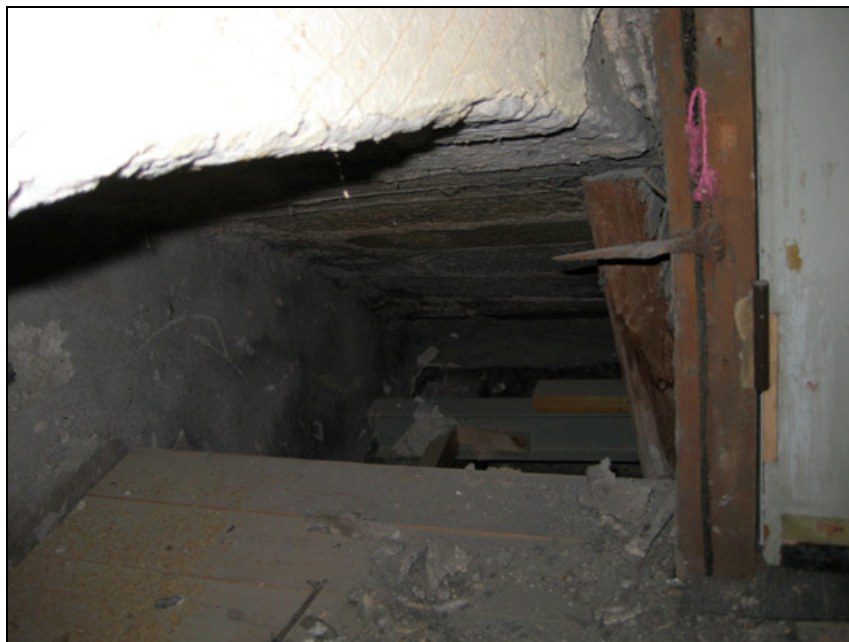
**Figure 14:** The western part of the relieving arch in U19, U21 and U22 (probably c.1538).

A second arch, which is similar in shape and construction to the first one, is incorporated in the S-wall of the palace quadrangle. Although both arches show similar dimensions as well as appearing at similar heights, they do, however, not correspond in terms of location. The U20 arch is located considerably further east than its counterpart within the southern wall of U19, U21 and U22 and thus both arches do not seem to be related to each other.

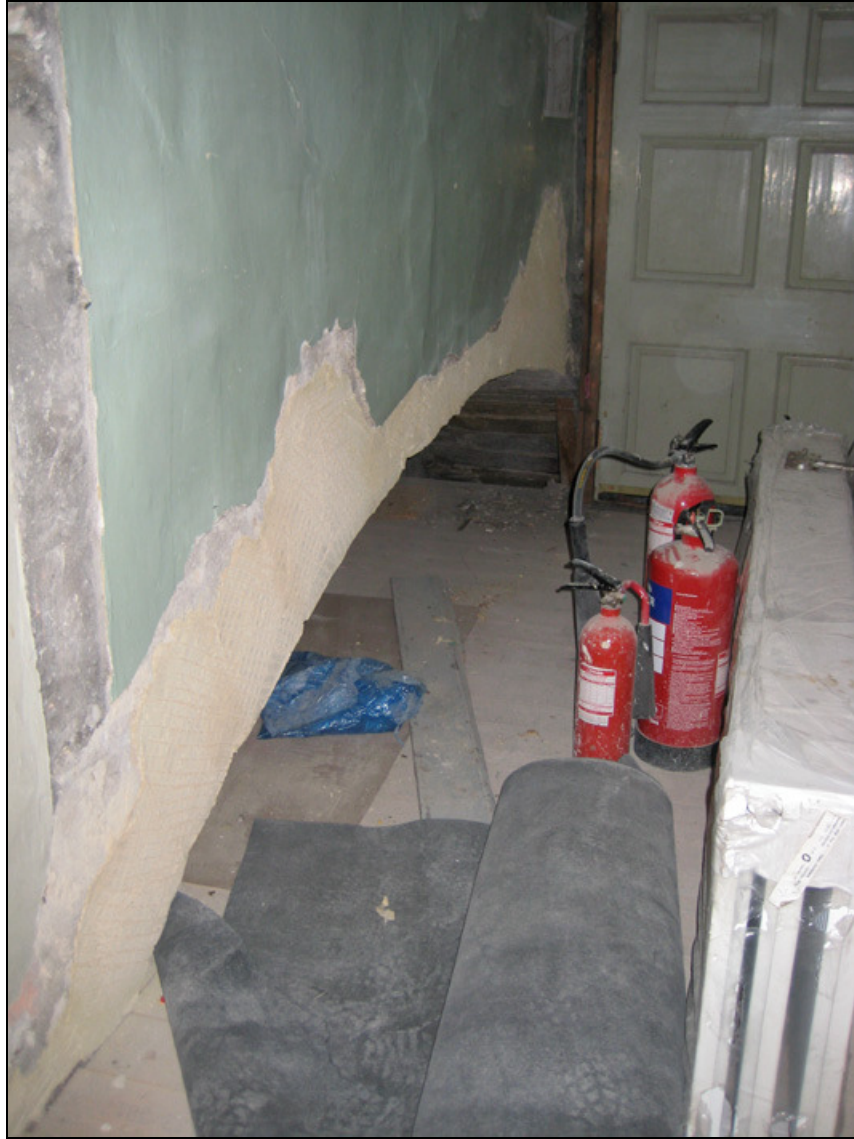
**Figure 15:** The relieving arch in U19, U21 and U22 (probably c.1538).

It might be assumed that the construction of both arches was motivated by structural requirements related to the roof-architecture of R10/R17 as well as the wall-architecture of the cross-wall separating P04 and P07. Since the purpose of arches is to permit the creation of apertures, the function of the southern arch can easily be understood. This arch relieves the large window in the S-wall of the Queen's Bedchamber and transfers the load resulting from the eastern couples of the roof into the more solid portions of the S wall.

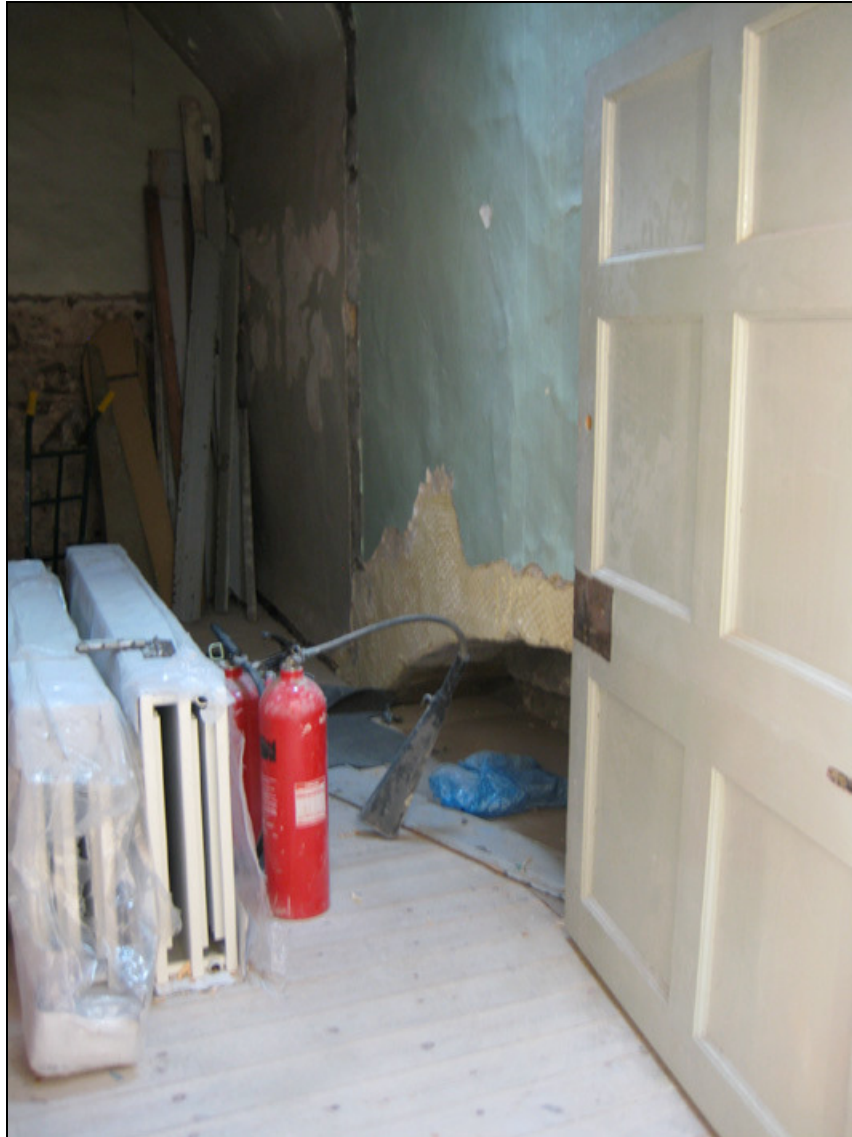
**Figure 16:** The eastern part of the relieving arch in U19, U21 and U22 (probably c.1538).
