**Historic Scotland
Properties in Care
Minor Archaeological Works 2010**

Tantallon Castle: Signage Replacement June 2010

**HS PIC Index Number: 90295
Project Code: HSCO-90295-2010-02**

**4th June 2010
Kirkdale Archaeology**

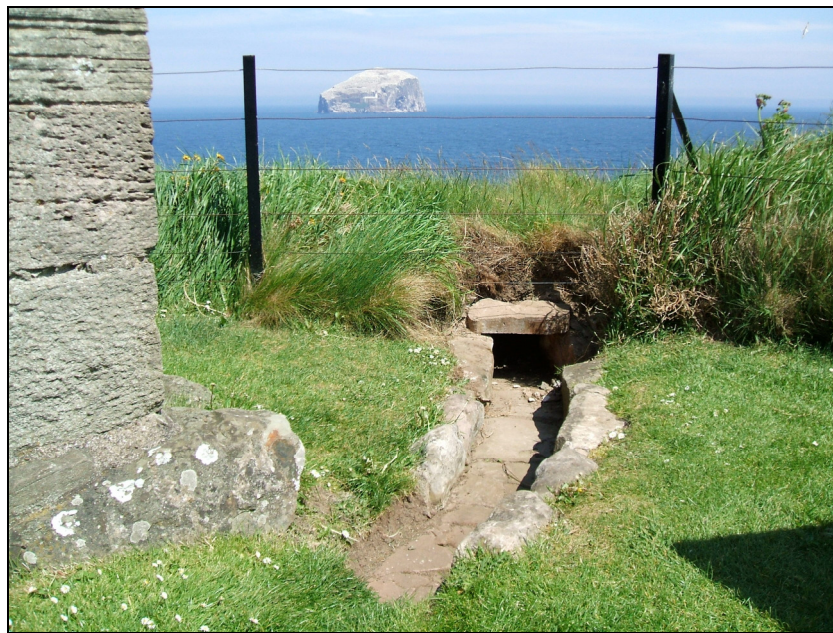
While on site, Kirkdale Archaeology was notified that a linear stone feature located on the NE side of the castle courtyard had recently been weeded and tidied by a castle custodian. The feature ran NE/SW and was located almost parallel to the remains of the old brewery. It consisted of two courses of roughly worked stone blocks, each of which was sitting either side of some stone slabs beneath. At the NE end of this linear feature a stone lintel covered the structure as it ran underneath overgrown grass and possibly out to the cliff face. At the SW end, the feature was still covered by grass, so its full extents could not be determined. From what was visible, it appeared to be c.2m long. This feature was possibly a stone drain, which perhaps ran from the old brewery into the sea.

Figure 3: The stone drain near the Brew House.

In order to expose the full extents of this feature and properly identify it, it would be necessary to remove the soil and vegetation which now fills it on its SW side. From the section visible at the SW end, this would involve removing a depth of c.0.09m of soil (a figure which could increase due to the sloping nature of the courtyard).
