Discovery and Excavation in Scotland – OASIS-type Form (2006)

Historic Scotland
Properties in Care
Minor Archaeological Works 2010

Castle Campbell:
Information Board Excavations
April 2010

HS PIC Index Number: 90063
Project Code: HSCO-90063-2010-03

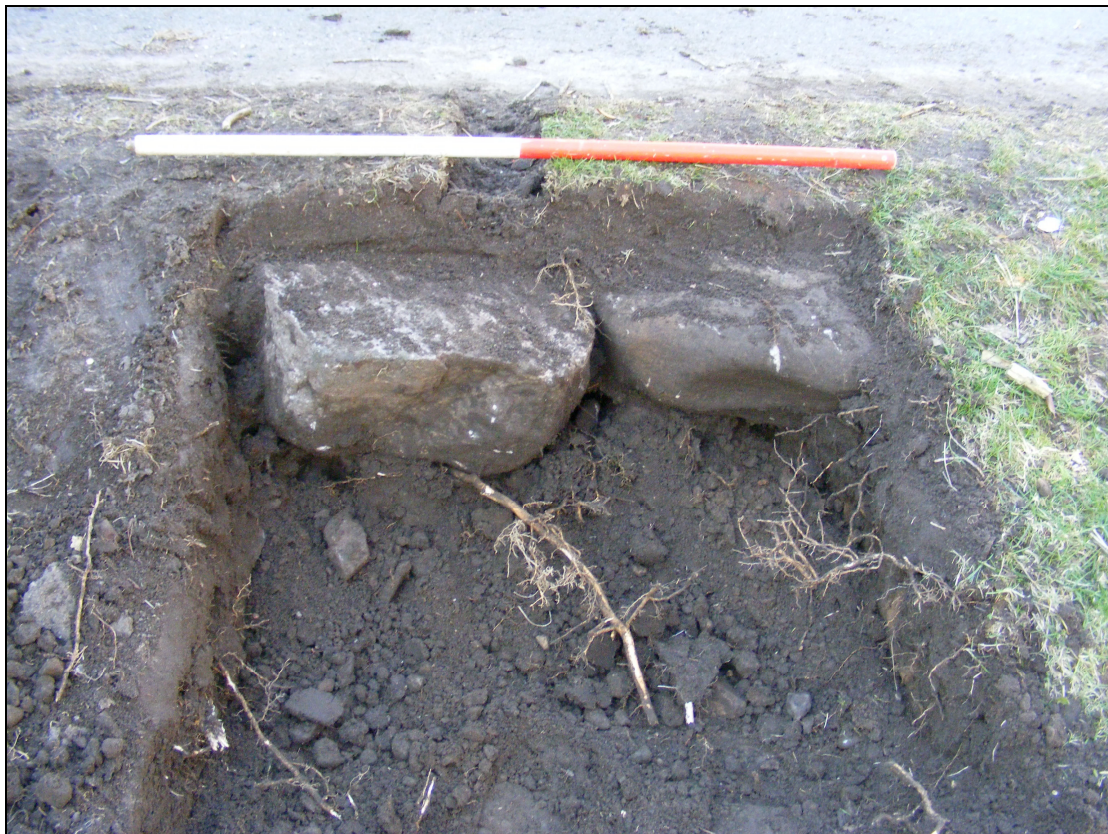
Trench A - which was dug in order to create a stable base for the Historic Scotland sign - measured 700mm x 1200mm, and was located to the E of the approach road. After the removal of the topsoil, two large boulders were exposed on the W side of the trench (nearest the road). These boulders were beneath the level of the road and were most likely foundation stones for the road itself. The largest boulder measured 650mm long x 500mm wide x 250mm thick, while the smaller one measured 450mm long x 270mm wide x 230mm thick; they both appeared to be sandstone blocks. The removal of these caused the trench to be extended by a section to the NW measuring 350mm x 530mm. The trench was excavated to a depth of 530mm at its deepest, on its W side. The fill of the trench was a dark brown, loose, silt with sub-circular pebble inclusions measuring from 20mm to 80mm in diameter. The soil was full of roots of varying size and thickness, which could be seen protruding from the section and base of the trench. One modern luminous yellow, plastic bead of an irregular shape was found within the fill.

Figure 1: Trench A, with the two boulders *in situ*.

The two large sandstone boulders protruding from the W side of Trench A were most likely foundation stones for the modern approach road. However it is worth

noting that they were similar in size to those used in the building of the castle, and thus could have been re-used.
