**HISTORIC SCOTLAND PROPERTIES IN CARE
MINOR ARCHAEOLOGICAL WORKS 2015/2016**

Castle Campbell • Standing Building Recording • 2010 – 2016

SITE: Castle Campbell, near Dollar, Clackmannanshire.

DESCRIPTION: Standing building survey comprising the production of an annotated measured drawing and feature descriptions of the various components of the external east elevation of the castle ahead of remedial works to prevent water ingress.

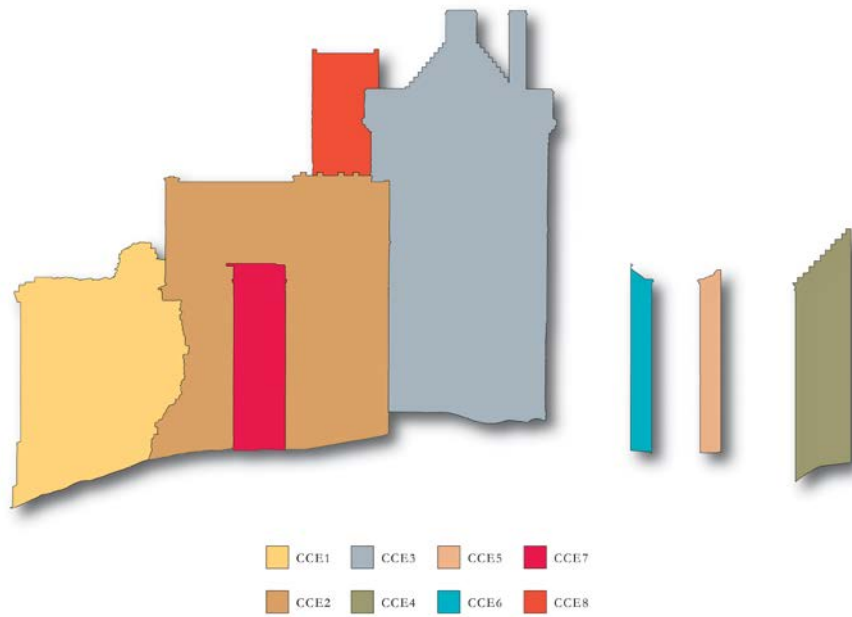
The elevation was divided into eight components prefixed with ‘CCE’ denoting ‘Castle Campbell Exterior’:

No.	Description
CCE1	The east elevation of the south range.
CCE2	The east elevation of the east range.
CCE3	The east elevation of the tower
CCE4	The north elevation of the east range.
CCE5	The north elevation of the projecting <i>garderobe</i> suite of the east range.
CCE6	The south elevation of the projecting <i>garderobe</i> suite of the east range.
CCE7	The east elevation of the projecting <i>garderobe</i> suite of the east range.
CCE8 ¹	The east elevation of the north-east stair tower.

Figure 1.3: The position of the eight components of the east elevation of the castle.

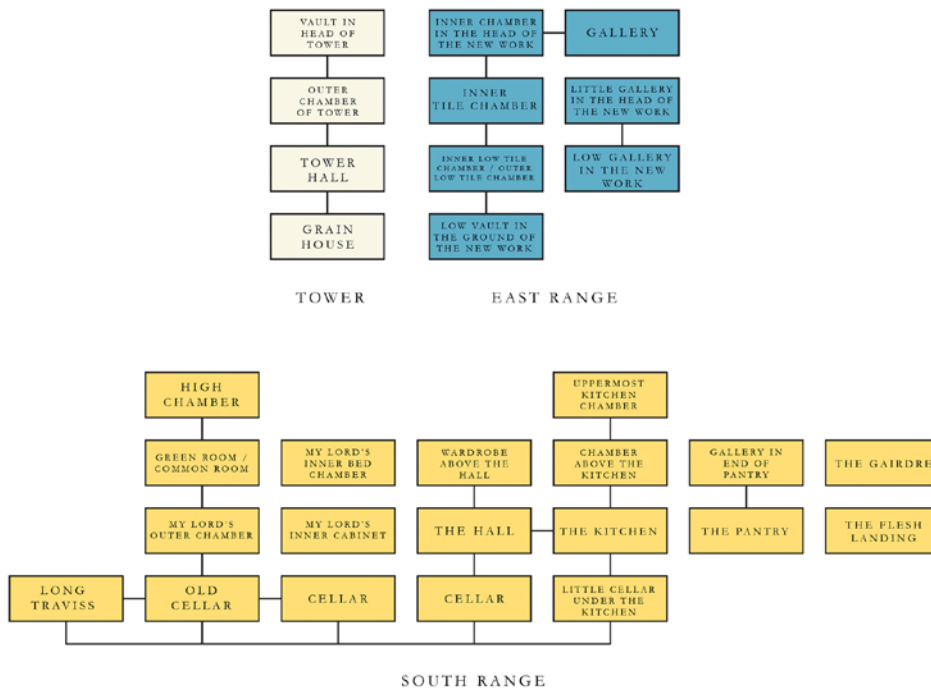
This allows us to build up a picture of the location of the rooms and how they relate to each other (Fig. 2.1).

Figure 2.1: The relationship of the rooms of the castle in 1595 as inferred from the Castle Campbell Inventory. In the east range, the “Low Gallery in the New Work” would have been carried on the open loggia at ground floor level.

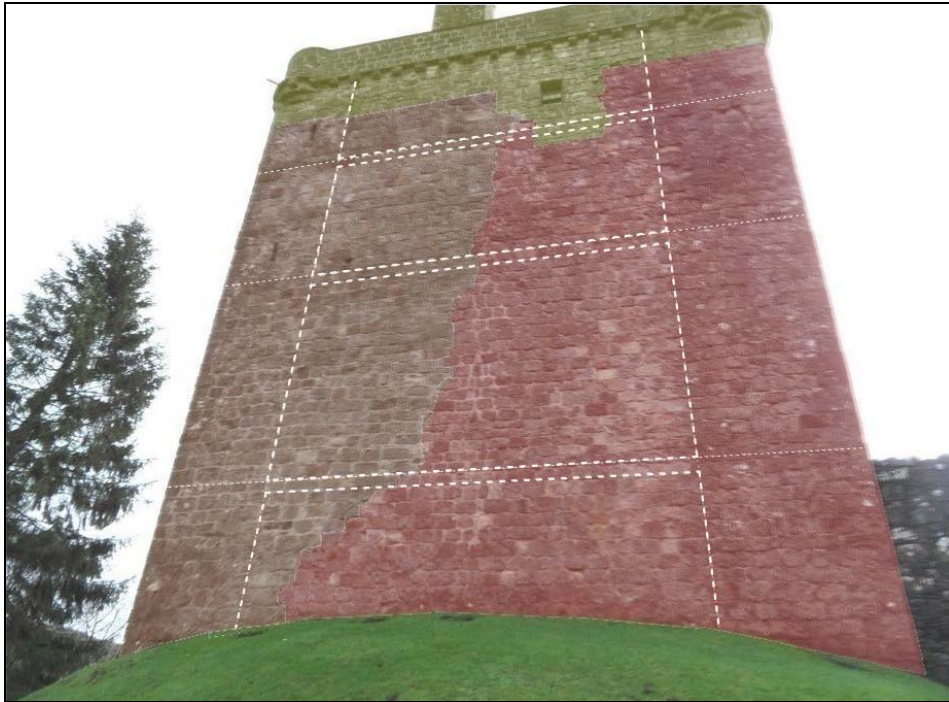
Plate 2.1: The external north wall with room limits and floors imposed. The red build is original, the brown build was added, and the yellow build represents the insertion of the new 3rd floor vault along with upper wall courses and parapet. At ground level it can be seen that internally the vault could have been preserved while externally portions of the original masonry were lost.

Close examination of the tower shows that there is a ragged break in build running up the external north and south walls. Internally, the ground floor cellar vault seems intact but there is a break in build running up the internal south and north walls and across the vault at 1st floor level. At 2nd floor level, the same break in build can be seen and defines the difference between the close-set corbels and their widely-spaced counterparts. At 3rd floor level, the walls still retain much render obscuring the walls and it is already clear that the vault is a late-16th century replacement. On the external south wall at 3rd floor level, the margins of a blocked window aperture can be seen – this has been truncated in its upper portion, suggesting that internally there must be the remains of earlier walls. Externally, the upper three courses and the string course and parapet they carry are therefore later additions, likely to date to the replacement of the 3rd floor tower vault in the late-16th century. This suggests that the tower is in fact a composite of two builds. To the west are the upstanding remains of a tower which suffered a major destructive episode. The ground floor cellar and vault survived intact although the external wall faces to the north-east and the east wall face were also destroyed. At 1st floor level, less of the west portion of the south wall survived than the west portion of the north wall – this would have left a splayed portion of the vault intact. A similar situation occurred at 2nd floor level as there are less closely-spaced corbels extant to the south than to the north. The original floor would therefore have comprised only closely spaced corbels. There has clearly been a catastrophic collapse/destruction episode in which the intact upstanding remains were repaired with new masonry to the east. The replacement floor at 2nd floor level used widely spaced corbels

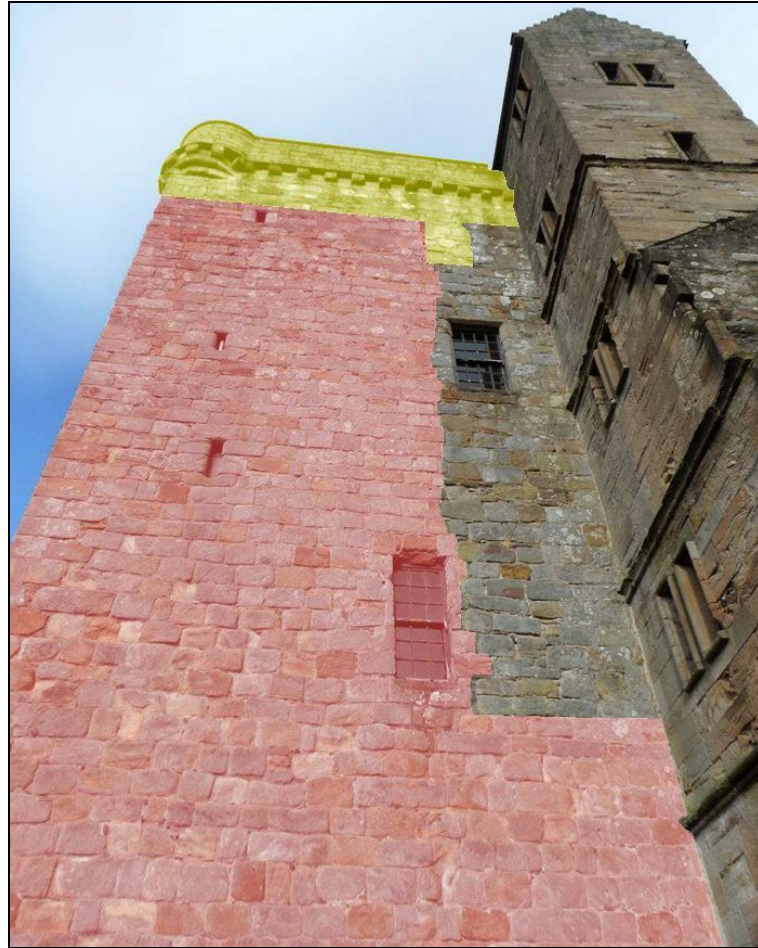
Plate 2.2: The external south wall. The red build is original, the brown build was added and the yellow build represents the insertion of the new 3rd floor vault along with upper wall courses and parapet and the blocking of a window aperture. The north-east stair tower on the right was added at the same time as the 3rd floor vault.

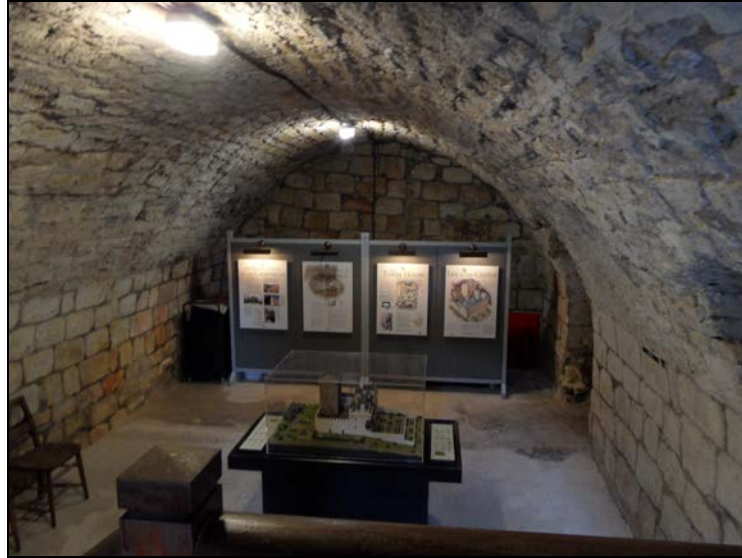
Plate 2.3: The undisturbed masonry of the ground floor cellar vault.

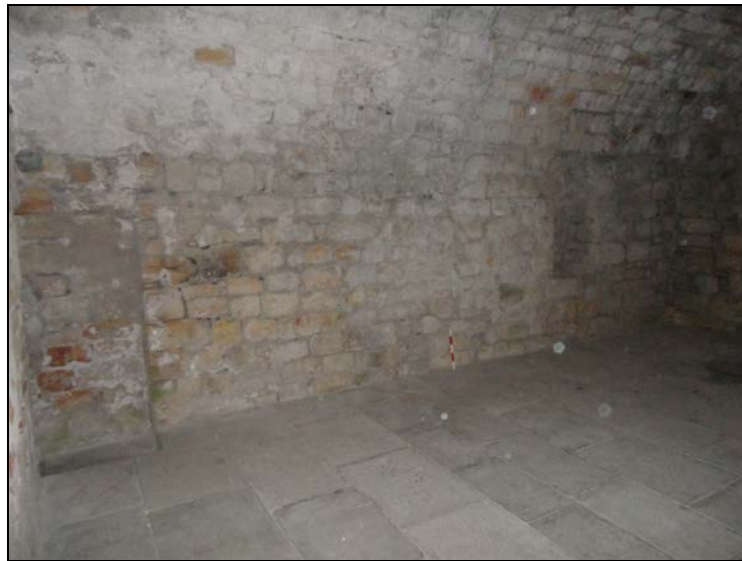
Plate 2.4: The break in build on the north wall and vault on the 1st floor.

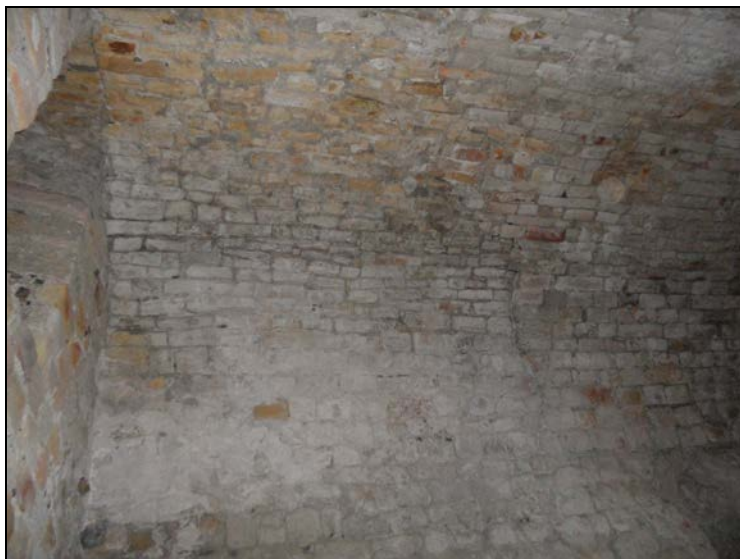
Plate 2.5: The break in build in the vault on the 1st floor.

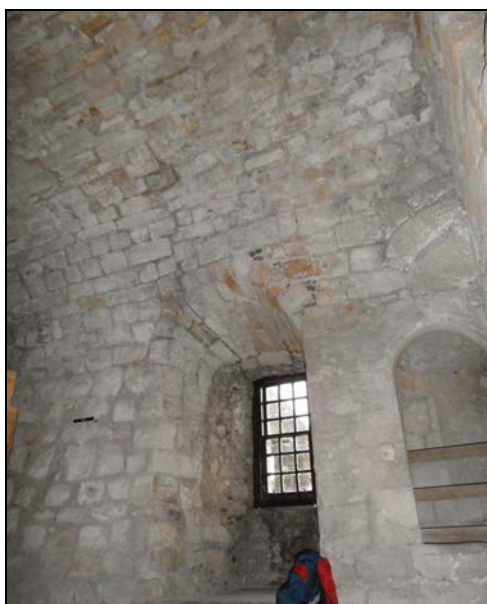
Plate 2.6: The break in build on the south wall and vault on the 1st floor.

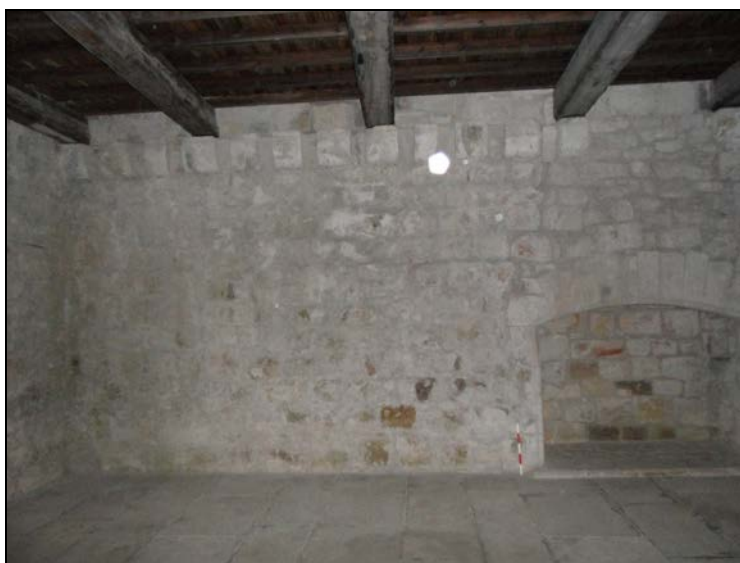
Plate 2.7: The break in build on the north wall on the 2nd floor.

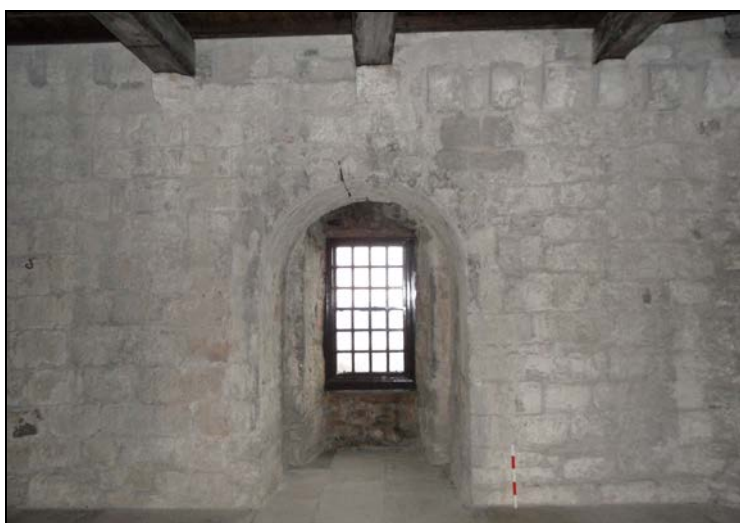
Plate 2.8: The break in build on the south wall on the 2nd floor.

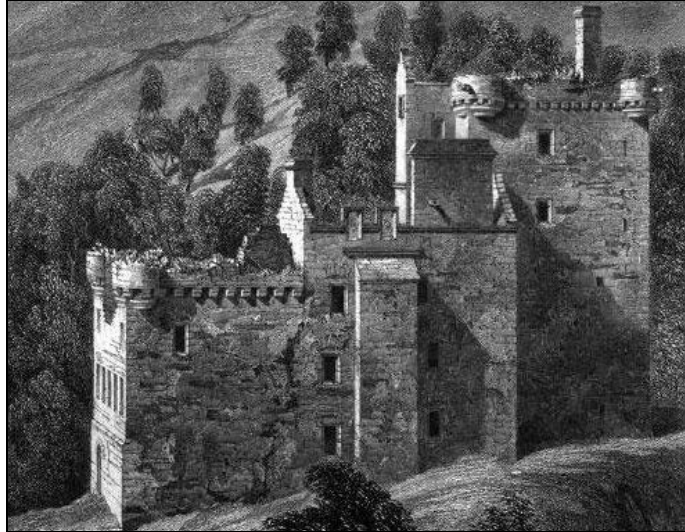
lower faces separated by a flat horizontal fillet. This originally sat over the lower portion of build **CCE2.087** and carried a high chamfered crown (as shown on Billings' illustration of the east elevation in 1847) but was reconfigured and became the crown, sitting over an added build in the late 19th century. It carries a squat ceramic chimney pot **CCE2.089** which has been moved from its original position.

Figure 3.1: Robert Billings' 1847 illustration of the east elevation shows a much squatter chimney crowning the south gable of the east range – this was altered in the late-19th century. The chimney on the east wall has a large chamfered crown which has been removed.

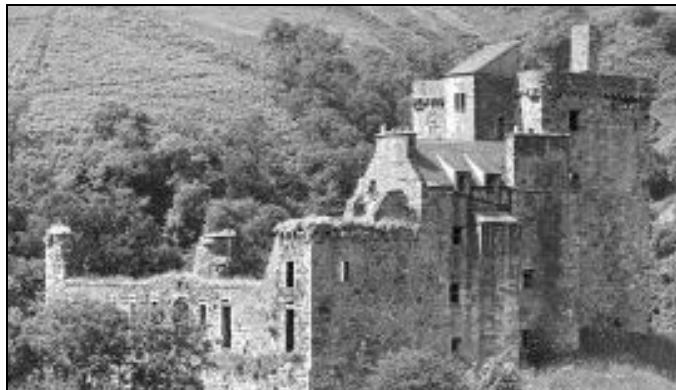
This elevation was illustrated only partially, as it is partly hidden behind the roof of the east range. The main masonry build **CCE8.004** is formed from blocks of mid to fine grained yellowish-grey sandstone ashlar tightly bonded in a very compact buff-coloured mortar. The build contains a blocked door aperture **CCE8.005** 1.48m high x 600mm wide. It is framed by a c.50mm wide chamfer and is rebated around the opening to carry a door frame and door which would have opened out the way either to the north or south. The lintel **CCE8.006** of the door is framed by a c.50mm wide chamfer and is rebated on its underside to carry a door frame and door. It is formed from a single block of mid-to-fine grained yellowish-grey sandstone ashlar tightly bonded in a very compact buff-coloured mortar. The door appears to be contemporary with masonry of the stair tower. Its function is unclear but it is possible that there was some inter-connection between stair tower and the upper floor of the east range. There are no clear indications of how this could have been achieved. It is also possible that this provided access onto the east range roof to allow maintenance works to be carried out. It is blocked by masonry **CCE8.007** formed from large sandstone blocks with horizontal tool marks on their surfaces. This represents mid-20th century blocking of a late 16th century doorway. It was probably blocked when the crow-stepped gable was reinstated by the Ministry of Works. The door is shown open in the guide book of 1953, although Billings shows the stair tower roofed, as it is now, with south and north crow-stepped gables. This configuration was only re-introduced in the 1950's. Prior to this, the stair tower had been given a roof with a single pitch and concrete sides.

Plate 3.1: View from the south-east showing the roof of the south-east stair tower in the mid-20th century. Canmore image SCO1202596. ©NLS.

As this detracted greatly from the look of the building, the crow steps were re-instated by the Ministry of Works. The south **CCE8.001** and north **CCE8.002** crow-stepped gables of the stair tower are formed from greyish sandstone ashlar. There are ten crow steps in each including the projecting skew putt at the base. These carry a grey slate roof **CCE8.003**.
