**HISTORIC ENVIRONMENT SCOTLAND
PROPERTIES IN CARE
MINOR ARCHAEOLOGICAL WORKS 2015/2016**

Doone Castle • Standing Building Recording • March 2016

DESCRIPTION: Standing building recording of the central ground floor cellar of the hall range ahead of its conversion into a shop.

PROJECT CODE: HSCO-90335-2016-01

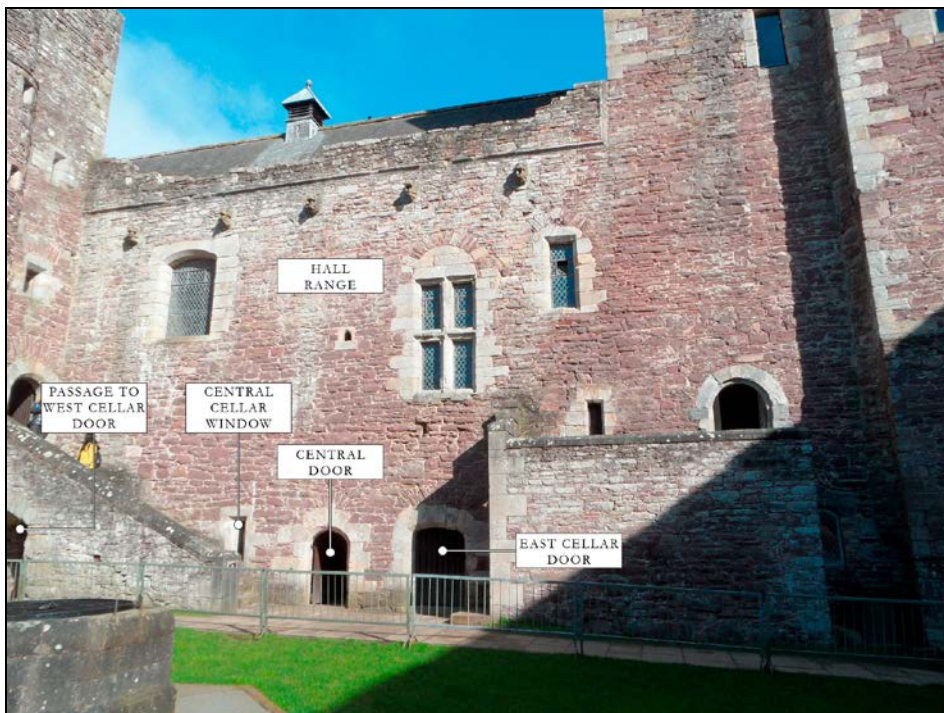
Plate 1: Looking north from the courtyard, showing the layout of the ground floor cellars of the hall range.

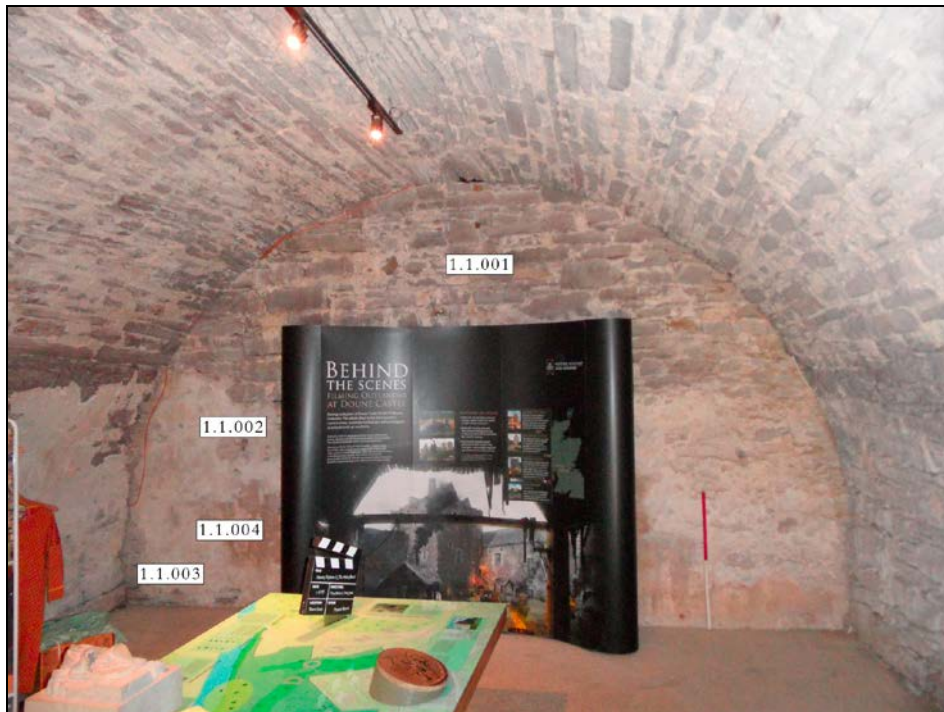
The north wall **1.1.001** of the cellar is comprised of angular pieces of pinkish/grey sandstone rubble up to 40cm wide x 25cm high bonded in lime mortar. The wall is partially covered by a base plaster **1.1.002** c.1.5cm thick of lime mortar containing numerous small <5mm to large <30mm sub-rounded pebbles covered with a thin layer of fine lime finishing plaster **1.1.003**, c.3mm thick. Provision has been made within the plaster for dook holes **1.1.004**, a few of which survive. These are contemporary with the plaster. The north wall is not properly conjoined to the east or west walls or the vault of the cellar, suggesting that it was *in-situ* prior to the construction of the vault. This suggests that it formed a curtain wall attached to the gatehouse tower and was later absorbed into the hall range. The risband joints between the north wall and the rest of the cellar are described in the sections on the east wall (**1.2.009**) and the west wall (**1.4.009**).

Plate 2: Features on the north wall.

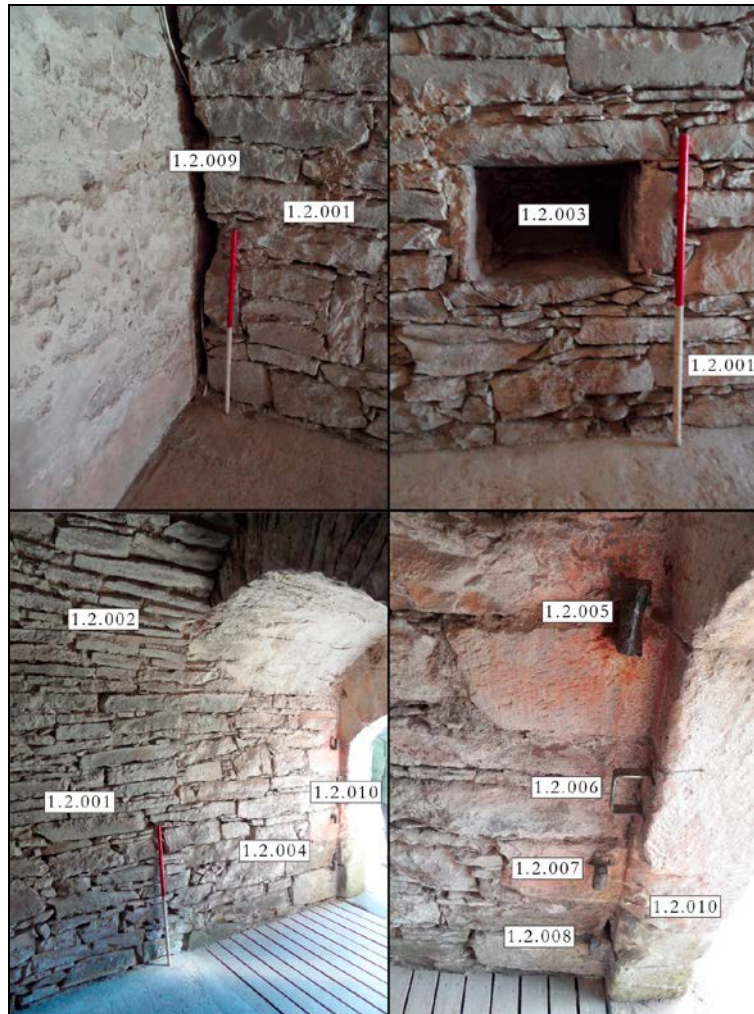
The east wall **1.2.001** of the cellar is comprised of angular pieces of pinkish/grey sandstone rubble up to 1m wide x 0.15m high bonded in lime mortar. Interspersed with the large stones are smaller pieces of the same angular stone filling the voids. The wall starts to spring to the vault c.1.20m above the floor. The build continues up into the vault **1.2.002** where the long thin rubble masonry predominates. There is a small recess **1.2.003** with a horizontal rectangular aperture centrally within build **1.2.001** with its base sitting c.55cm above the cellar floor. It is constructed with the same angular pinkish/grey sandstone rubble which forms the east wall and vault and is innate to the wall build. The aperture is 48cm wide x 35cm high x 48cm deep. The main east wall build of the cellar meets the splayed masonry build **1.2.004** of

the door lobby wall to the south. It is also constructed with the same angular pinkish/grey sandstone rubble which forms the east wall and vault and is contemporary with them.

At the south end of build **1.2.004** is the eastern door jamb **1.2.010** of the cellar door, formed from light yellowish/grey Ballengeich sandstone ashlar. On the exterior, the blocks forming the jamb are moulded with a broad chamfer 17cm wide. The door lobby wall **1.2.004** is rebated back from the jamb by *c.*10cm. The masonry of the door jamb continues into the build of the lobby wall and is contemporary with it.

Plate 3: Features on the east wall.

Within the rebate are several pieces of door furniture that show that the original door was hinged on this side (it now hangs on the west wall of the door lobby). There are three iron pintles leaded into the lobby wall behind the rebate of the door jamb. The upper pintle **1.2.005** is hand made with a flaring base and irregular top and appears to be contemporary with the lower pintle **1.2.008** which has a pinched base and cylindrical upright. The middle pintle **1.2.007** is curious in that its upright points downwards. It is shorter and squatter than the others and has a cylindrical upright. It may be that all three pintles helped to hang an original door or possibly that the middle one was added in order to carry an additional hinge in a later

configuration. The masonry builds of the east wall **1.2.001** and vault **1.2.002** form a risband joint **1.2.009** to the north wall in the form of a vertical void 8 – 10cm wide which contains only small portions of rubble in lime mortar to tie the builds together, suggesting that the north wall was *in-situ* prior to the construction of the vault. This suggests that the north wall was originally a curtain wall attached to the gatehouse tower and was later absorbed into the hall range. It was also noted that the eastern wall splays slightly to the north-east. This is a reaction to the fact that the neighbouring cellar (to the east) has as its eastern wall as the west wall of the gatehouse tower which is oriented NE/SW. The more gradual splaying of the eastern wall of the middle cellar allows the west wall to become more or less aligned N/S and the neighbouring cellar to the west to have a more regular plan.

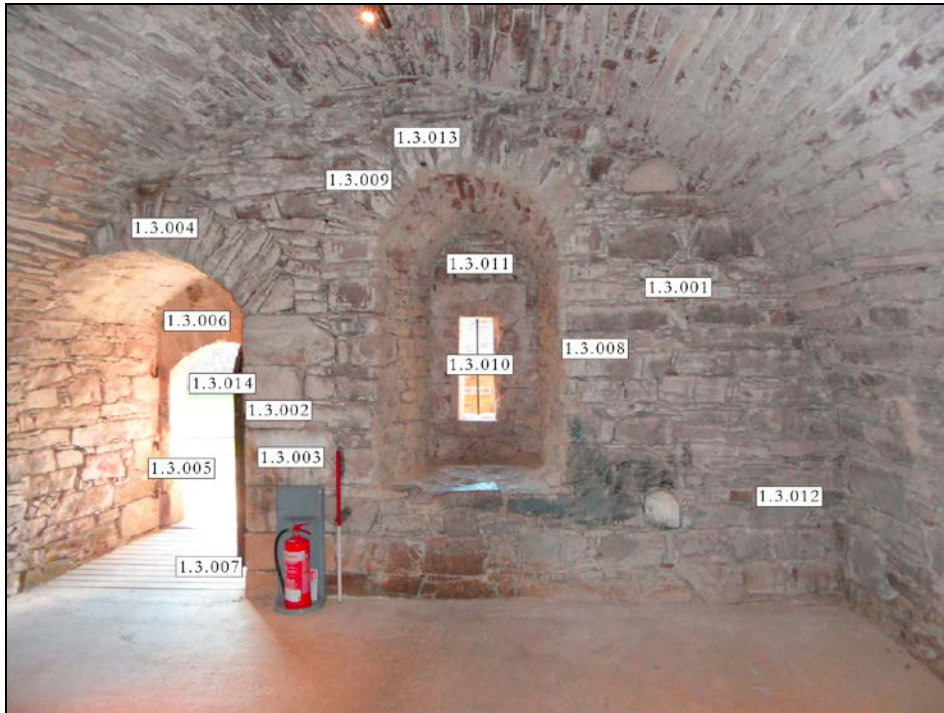
The south wall **1.3.001** of the cellar is comprised of angular pieces of pinkish/grey sandstone rubble up to 60cm wide x 20cm high bonded in lime mortar. Interspersed with the large stones are smaller pieces of the same angular stone filling the voids. To the east is an arched aperture **1.3.002** giving access from the door lobby into the cellar. It has vertical quoins **1.3.003** forming its western side of yellowish/grey sandstone blocks with an arched top **1.3.004** which ties into the eastern wall and also forms the soffit of the lobby. One of the quoins carries a mason's mark in the shape of an upward pointing arrow **1.3.014**. The soffit, like the cellar vault, is formed from long thin pieces of angular rubble masonry, with its apex is c.1.20m lower than the main vault. To the south, the cellar door **1.3.005** itself has an aperture with vertical sides and an arched top **1.3.006** of segmental blocks of light yellowish/grey Ballengeich sandstone ashlar moulded to the aperture with a wide chamfer 17cm wide externally. The doorway is currently occupied by a modern planked door **1.3.007**. Centrally within the south wall is an arched window bay **1.3.008**, 1.25m deep N/S to where it meets the window back. The window bay has east and west sides formed from angular rubble masonry containing a few empty dook holes and an arched soffit **1.3.009**, formed from long thin pieces of angular rubble masonry which splays up to the interior of the cellar. Its apex is 70cm lower than the main vault. The window aperture **1.3.010** is vertical/rectangular, 30cm E/W x 90cm high and has a surround formed from blocks of light yellowish/grey Ballengeich sandstone ashlar moulded to the aperture with a wide chamfer 17cm wide externally. There is a vertical iron bar blocking the window centrally. The ashlar build of the window surround is crowned by a small patch of angular rubble masonry **1.3.011**. The south wall contains a few modern machine-cut wooden dooks **1.3.012**, and an old rusted flat iron fixture **1.3.013** with a looped end projects from arched soffit **1.3.009**. It may have been used to hang a lamp.

Plate 4: Features on the south wall.

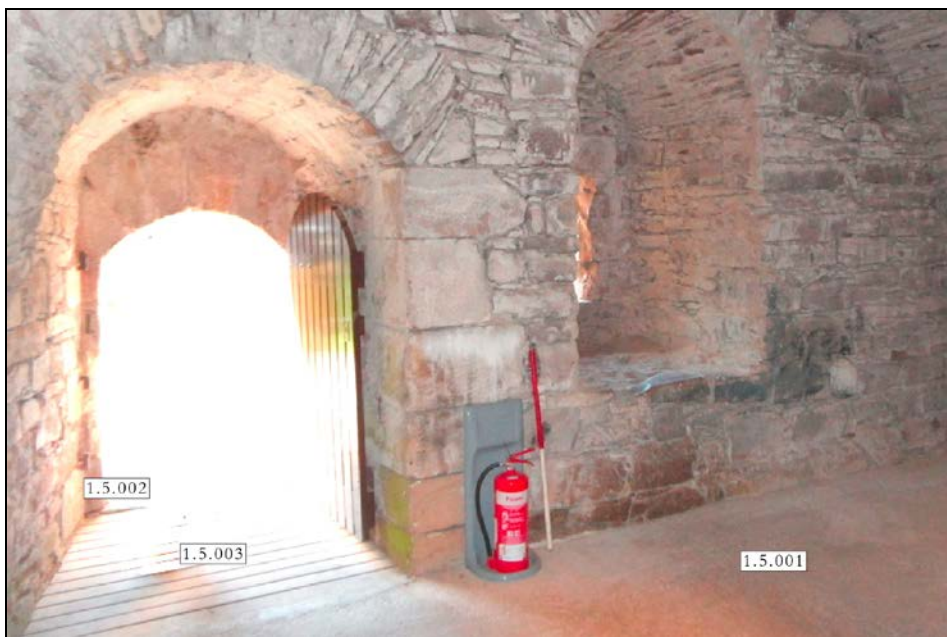
The cellar has a poured concrete floor **1.5.001**. The door lobby is floored with wooden planking **1.5.002** which runs up to meet the Ballengeich yellowish/grey sandstone sill **1.5.003** of the cellar door to the south. The sill is split centrally.

Plate 6: Features on the cellar floor.

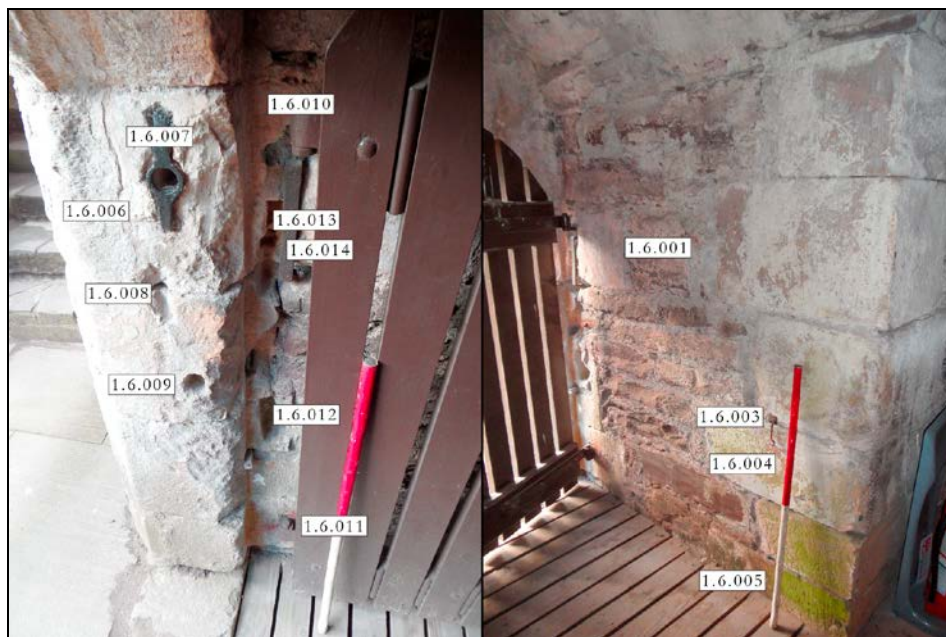
The masonry **1.6.001** of the west wall of the door lobby leading to the cellar is comprised of angular pieces of pinkish/grey sandstone rubble up to 50cm wide x 17cm high bonded in lime mortar.

Interspersed with the large stones are smaller pieces of the same angular stone filling the voids. It has vertical quoins **1.6.002** (the same as **1.3.003**) forming its north side, of yellowish/grey sandstone. Two of the quoins have mason's marks: **1.6.004** in the shape of an upward pointing arrow, and **1.6.005** in the shape of an 'M'. The quoins contain a modern metal door catch **1.6.003** for holding the door in an open position to allow visitor access.

Plate 7: Features on the west wall of the door lobby.

At the southern end of build **1.6.001** is the western door jamb **1.6.006** of the cellar door, formed from light yellowish/grey Ballengeich sandstone ashlar. On the exterior, the blocks forming the jamb are moulded with a broad chamfer 17cm wide. The door lobby wall **1.6.001** is rebated back from the jamb by c.10cm. The masonry of the door jamb continues into the build of the lobby wall and is contemporary with it. On the reveal of the door jamb there is an iron bolt receiver plate **1.6.009** in the form of an iron staple flush to the jamb face with a circular aperture centrally. There is a further circular scar **1.6.009** below which may also have been used to recess a bolt. This shows that the door was locked and latched internally and was secured externally with draw bolts, probably the type with L-shaped ends. Between the bolt receivers is an area of damage **1.6.008** which may be accidental or related to door furniture.

Within the rebate of the western door jamb are the pintles and loops **1.6.010** and **1.6.011** which carry the modern cellar door. The rebate contains two vertical horizontal scars with undulating interiors **1.6.012** and **1.6.013** indicating that lock receivers sat in these positions. There is an iron staple **1.6.014** *in-situ* at

scar **1.6.013**, which would have been used to receive a lock. The combination of double locks and external bolts suggest that the cellar contained items of some importance or value, as there is a degree of 'excess' in the number of locking mechanisms. Whether these were used in tandem or whether they represent disparate forms of door lock is unclear.
