**HISTORIC SCOTLAND PROPERTIES IN CARE
MINOR ARCHAEOLOGICAL WORKS 2015/2016**

Edinburgh Castle • Watching Brief • October 2015

SITE: Johnston Terrace, Edinburgh.

DESCRIPTION: Archaeological watching brief during the relocation of the footpath running along the northern edge of Johnston Terrace, below Edinburgh Castle.

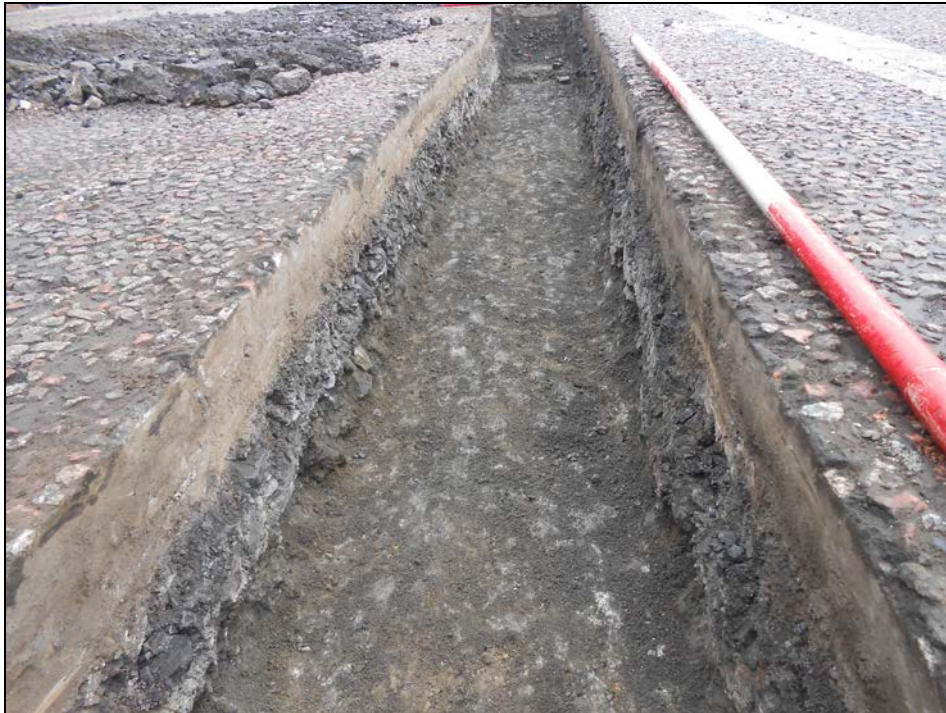
Tarmac **100**, some 100mm thick, overlay **101**, an 80mm – 100 mm thick layer of angular 'type 1' gravel mixed in with tar. Below this, **102** was a 100mm thick layer of type 1 gravel (with no tar) which peeled off onto context **103**. This was a compacted surface of angular chips of whin stone, which followed the gradient of Johnston Terrace. Just appearing at the base of the trench, **104** was a compact pinkish clay with occasional mortar and charcoal flecks throughout.

Plate 1: Surface 103.

An informal surface, **103** and **203**, sealed these redeposited natural deposits. This followed the slope of the current road surface, and might be best interpreted as a temporary 'working surface' used while the landscaping of the future road was enacted. In both these trenches this surface was then sealed by angular stone chips, **102** and **202**, below the modern road surface and its make-up. This is likely to be bedding for the original surface of Johnston Terrace, presumably either of stone slabs or smaller stone setts now removed.

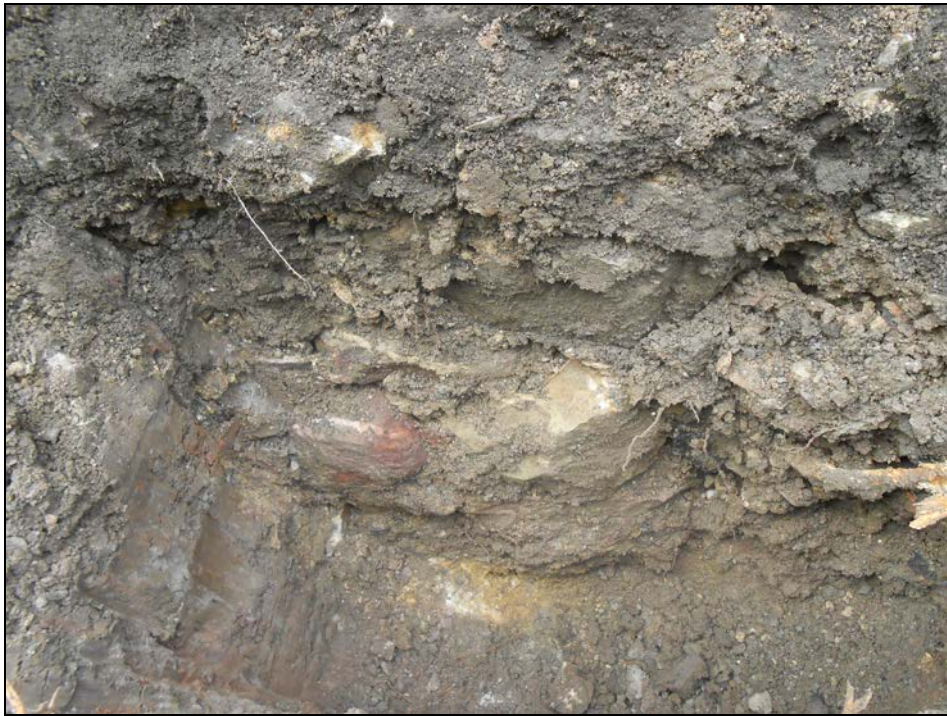
removed. Here wall **305** also continued down against the south side of the trench, and a possible tight, near vertical cut **307** filled with mortar **306** for the wall against **304** was noted.

Plate 3: The western end of Trench 3, showing wall 305.

Trench 3 was dug close to the junction of Johnston Terrace and this bridge, so the extreme thickness of **304**, the pinkish clay at the base of the sequence, is unsurprising. Small amounts of mortar were noted throughout this material, and it seems best interpreted as redeposited natural dumped as part of this landscaping. Wall **305**, forming the southern boundary of the road, seemed to be cut through **304**, but these were probably broadly contemporary operations. The concrete surface **302**, some 250mm below the level of the current pavement, indicates that the pavement has been raised.
