Discovery and Excavation in Scotland

HISTORIC ENVIRONMENT SCOTLAND
PROPERTIES IN CARE
MINOR ARCHAEOLOGICAL WORKS 2015/2016

Linlithgow Palace • Watching Brief • February/March 2016

- SITE:** Linlithgow Palace, Linlithgow.
- N.G.R.:** Centred c. NT 0021 7732
- DESCRIPTION:** Archaeological watching brief during the removal of existing cobbles, ground preparation and resetting of new cobbles within the palace courtyard against the east range and portions of the south range.

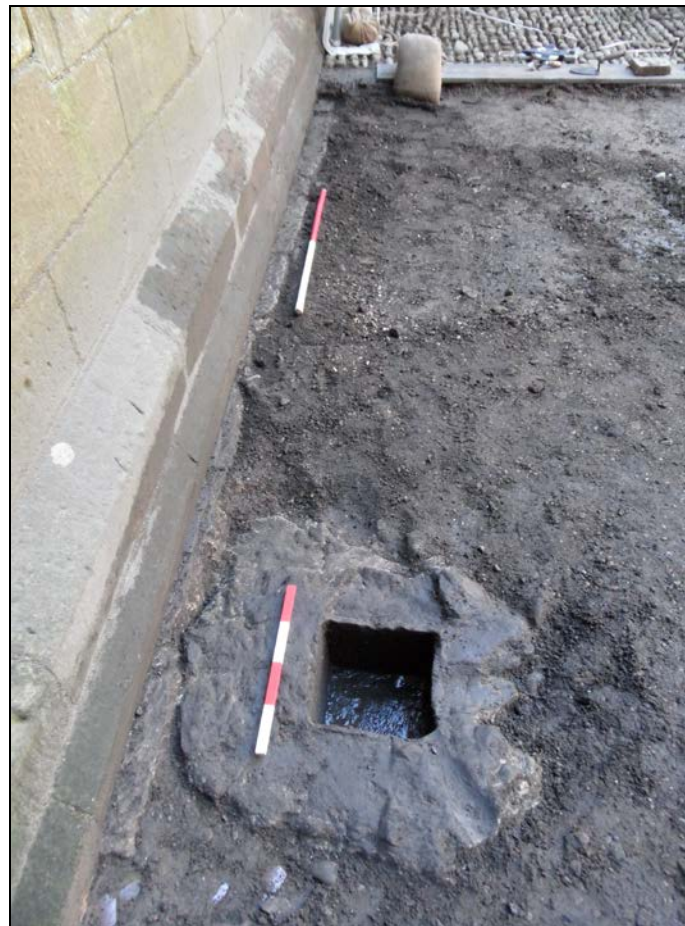
The bedding layer **201** below the cobbles was a mixed deposit of ash, sandy gravel, small pebbles and angular stones. Against the south courtyard wall (containing the open-window gallery of the south range internally) the foundation course **202** (seen in Stage 1 as **102**) of stippled sandstone blocks carrying the base course of the wall could be seen. There were again slate packers between some of the slabs and the wall above. When seen together, the foundation courses revealed in Stages 1 and 2 are on a different alignment to the wall above. This suggests either that the foundation course is older, or that the angle of the wall was adjusted slightly after the foundation course had been set in place. Immediately north of the eastern end of the foundation course, and at the same level, a stone setting **203** with a central square recess was uncovered (*see* Plate 2).

Plate 2: Looking west at the foundation course 202 (left) and feature 203 (lower centre).

The stone surround measured up to 0.85m E/W x 0.80m N/S. The central recess measured 0.25m E/W x 0.25m N/S x 0.25m deep (*i.e.* 10" x 10" x 10"). There were two possible shallow troughs on the surround – one running north-east from the north-east corner of the central void, and another running north from the central portion of the void's northern edge. The function of the stone setting remains enigmatic. It could possibly be a pad for an upright related to a now-vanished building, or similarly a setting for an upright post of unknown date and function (*signage etc.*)

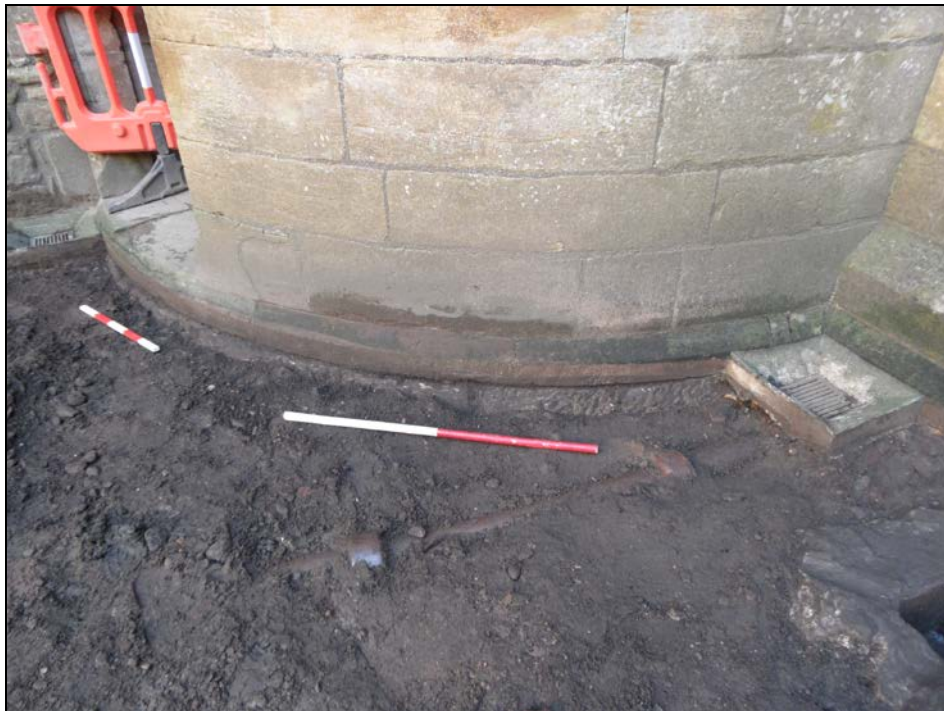
In the angle between the south wall and the south-east stair tower, the modern stone drain **204** was shown to feed a cast iron drain pipe **205** in several sections. This was partially revealed within **201** for a distance of 1.5m N/S. The cylindrical body of the south-east stair tower was also shown to have been built upon a foundation course **206** of stippled sandstone blocks, this time with angled instead of flat faces. The course projected from the build above by 4cm – 8cm. Unfortunately, the relationship between the foundation courses of the south wall and the south-east stair tower was truncated by the insertion of the stone drain **204**. In the angle between the south-east stair tower and the wall of the east range, another modern stone drain **207** had again obscured the relationship between the two.

Plate 3: Looking south-east at the foundation course 206 of the south-east stair tower.

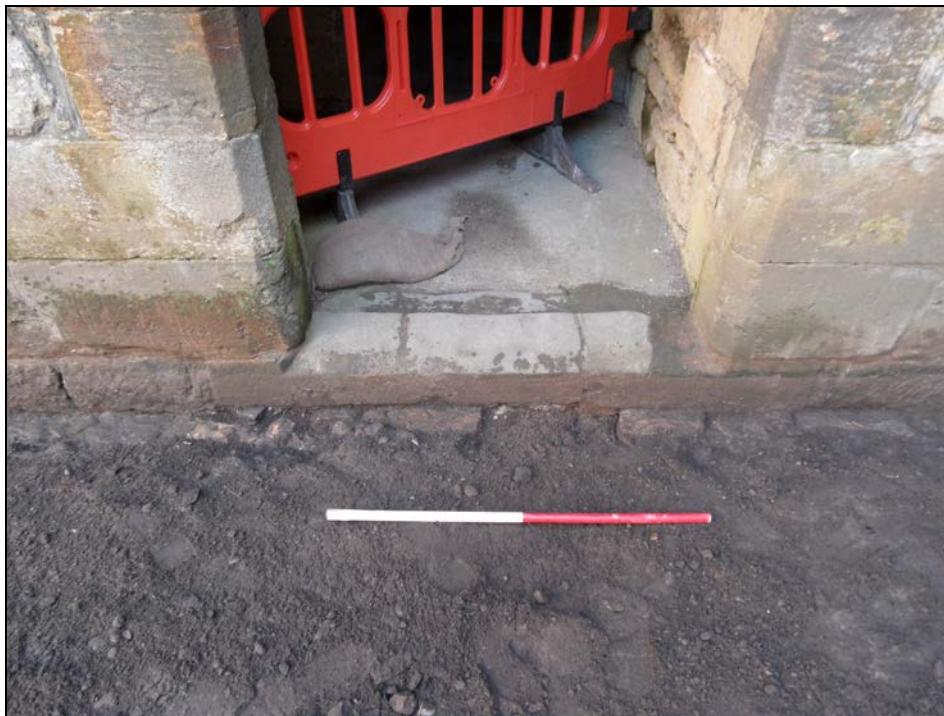
The bedding **301** below the cobbles was a mixed deposit of ash, sandy gravel, small pebbles and angular stones. Against the east courtyard wall, a foundation course **302** of stippled sandstone blocks carrying the wall could be seen, on the same alignment as the wall above. There were slate packers between some of the slabs and the wall above, and the foundation projected from the wall by ≈ 0.1 m. The foundation course was interrupted for 0.5m at the small door in the east wall near the south-east stair tower by a cut **309** in the area of which terram could be seen; this appeared to be a modern service cut.

Plate 4: Looking east at the foundation course 302 of the east wall and the cut 309 through it.

In total, the aligned foundation course ran for 6m in Stage 3 at which point the foundation course turned to a ragged rubble course **303** which ran for 3m up to the south side of the main east doorway (*see* Plate 4). This course projected by up to 0.2m and had a totally different character from **302**. The change is difficult to interpret given that it was only observed in a discrete area. The suggestion would seem to be either that a wider foundation was required near the main eastern doorway, or that this possibly represents a feature which predates it.

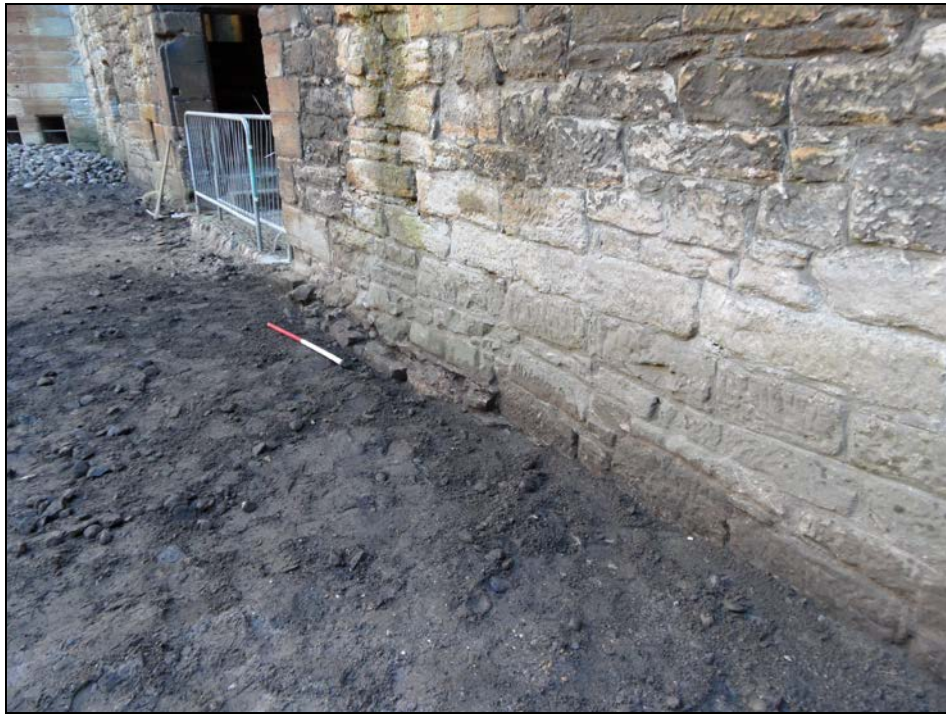
Plate 5: Looking north-east at the ragged foundation course 303 of the east wall at the east door.

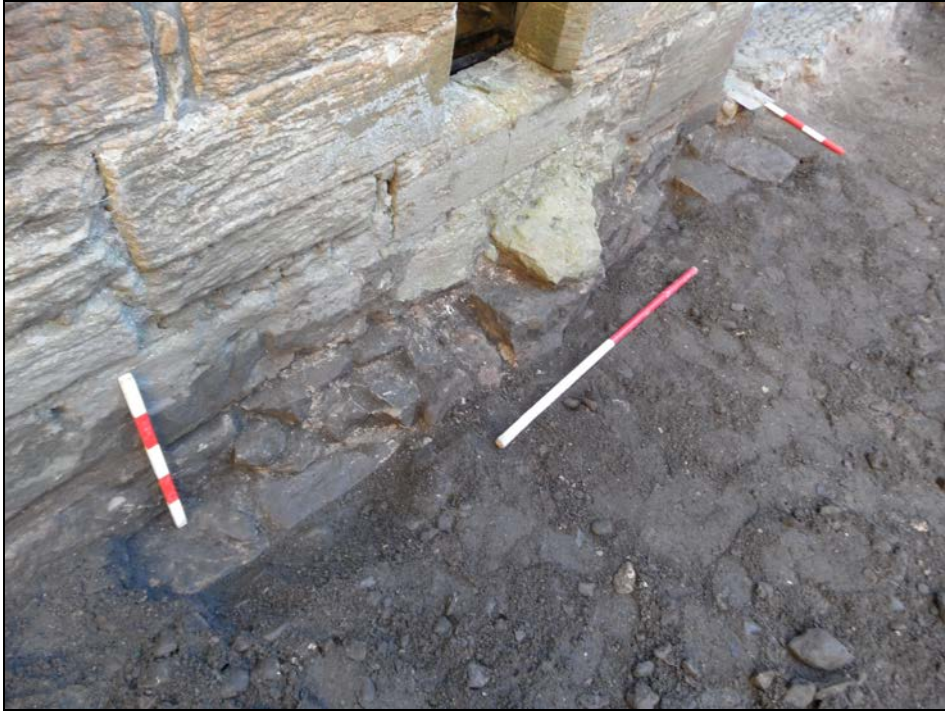
Some voided sandstone rubble **304** was partially uncovered to the north of **303** below the bedding layer **301**. This may be related to voided rubble **308** on the opposite side of the east doorway and either shows the composition of the made-up ground or that services have been channelled through this portion of the courtyard and the eastern doorway. A patch of modern cement **305** (for bedding the cobbles) was left against the excavated eastern section of the cobbles. On the north side of the eastern doorway, a similar arrangement to that on the south side was noted. Against the eastern courtyard wall, a foundation course **306** of flat stippled sandstone blocks carrying the wall could be seen, on the same alignment as the wall above. The foundation projected from the wall by $\approx 0.18\text{m}$ and was only visible in a discrete area 0.70m N/S at the northern end of the Stage 3 work. Between this course and the edge of the eastern doorway was another ragged rubble course **307** which ran for 2.4m to the north side of the main eastern doorway (*see* Plate 6), stopping 0.36m short of the corner. This course projected by up to 0.30m centrally while the north and south ends sloped in towards the wall. The impression is that the wall is built over something which used to project here; there is even a hint of partial rotundity to the feature on its western face, which may suggest a stair base. Alternatively it may simply be an additional strengthening of the wall at this point.

Plate 6: Looking south-east at the foundation course 306 and the ragged foundation course 307 of the east wall at the east door.
