# HISTORIC ENVIRONMENT SCOTLAND PROPERTIES IN CARE MINOR ARCHAEOLOGICAL WORKS 2016/2017

# St. Andrew's Cathedral • Watching Brief • September 2016

SITE:	St. Andrew's Cathedral, St Andrews.	
N.G.R.:	NO 5147 1665; NO 5152 1663; NO 5145 1670	
DESCRIPTION:	Archaeological watching brief during the installation of three to support new signage.	ee stone plinths
PROJECT CODE:	HSCO-90260-2016-01	
CONTENTS:	Introduction	1
	Description	2
	Conclusions	5
	List of Contexts	5
	List of Drawings	5
	List of Digital Photographs	5

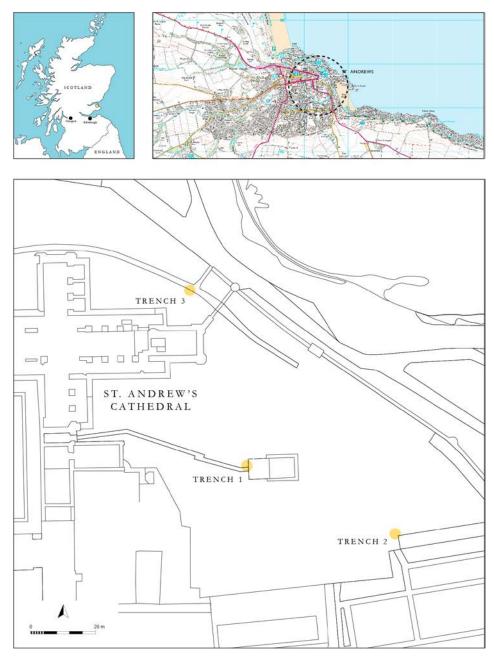
**Figure 1**: Plan showing the general locations of the three trenches.

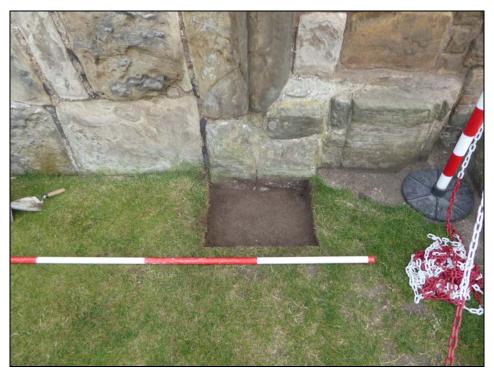
The trench was located to the north of the extant door, at the base of the northern of the two roll mouldings. It measured 54cm N/S by 43cm E/W and reached a maximum depth of 8cm. the topsoil 100 proved to be a very fine light brown silt, while at the base of the trench 101 was a similar soil matrix, but with flecks of mortar throughout.

Plate 1: Trench 1, as finished.

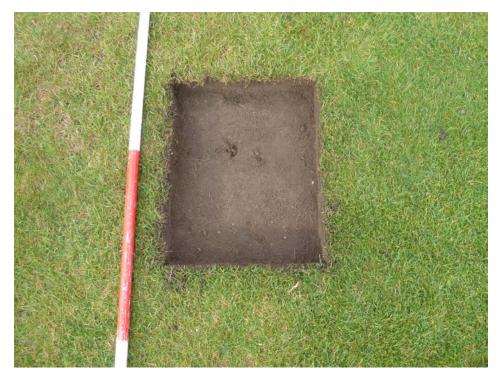
Trench 2 was located in the south-east corner of the graveyard, 6.25m north of the gate connecting the older graveyard with an extension to the south-east. A highly eroded, probably eighteenth century, gravestone (illegible) was situated 1.9m north of the trench. The trench measured 54cm E/W by 43cm N/S and reached a depth of 8cm. Fine light brown silt **200** overlay **201**, a similar soil with some mortar flecks and rounded gravel inclusions throughout.

Plate 2: Trench 2, as finished.

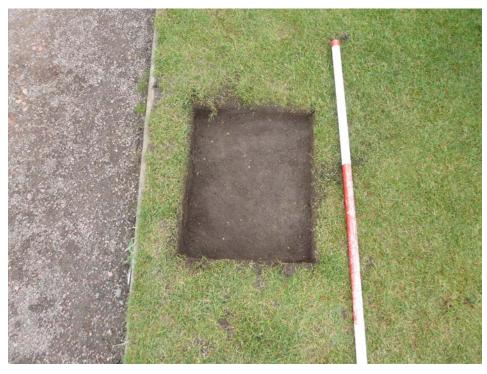
Trench 3 was opened up on the south side of the path running around the northern end of the cathedral. It was aligned parallel to this path (approximately NW/SE) and was located opposite a gate through the north side of the cemetery wall, just north of the east end of the cathedral. The trench measured 54cm NW/SE x 43cm NE/SW. A similar sequence of 8cm of fine light brown silt **300** was removed to expose a similar soil, **301**, flecked with mortar.

Plate 3: Trench 3, as finished.

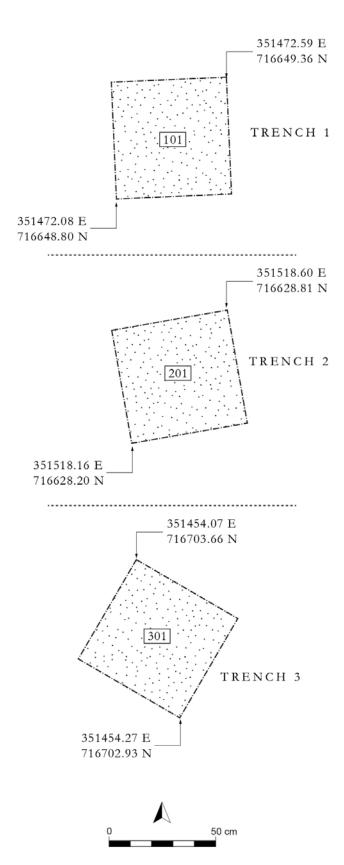
**Figure 2**: Trenches 1 - 3, post-excavation plans.

All three trenches revealed a similar sequence of topsoil over a similar soil with mortar and stone inclusions. This basal deposit may well represent the disturbed soil of the cemetery. No bone was seen, and nothing of archaeological significance was found.
