**HISTORIC ENVIRONMENT SCOTLAND
PROPERTIES IN CARE
MINOR ARCHAEOLOGICAL WORKS 2015/2016**

Stones of Stenness • Archaeological Recording • February 2016

DESCRIPTION: Archaeological watching brief during the digging of two trenches to emplace new gates.

PROJECT CODE: HSCO-90285-2016-01

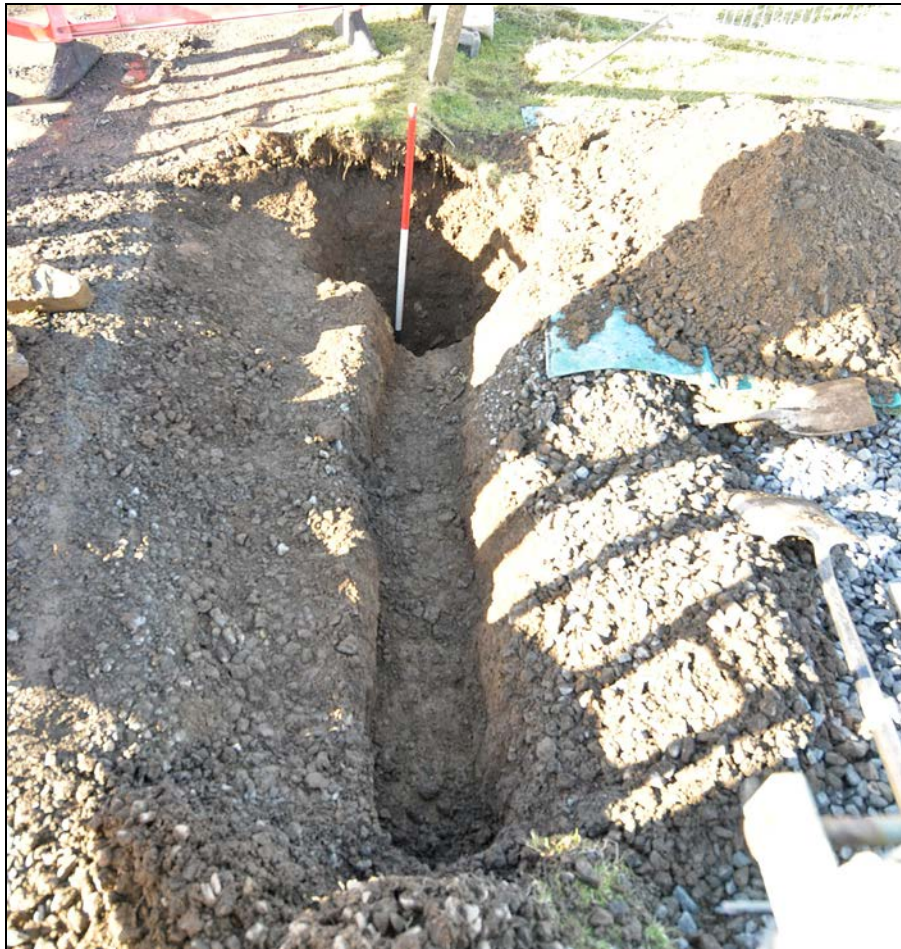
This was located towards the southern corner of the field, just north-west of the livestock gate where the extant visitor access 'kissing gate' and nearby strainer post were to be removed. All the material removed was either part of the concrete foundation of the existing strainer post and gate, or material previously disturbed and re-deposited. The area excavated measured $\approx 2.5\text{m}$ NW/SE by 1.2m NE/SW. In general the trench was excavated to a depth of 0.1m onto a clear gravel surface. Within this a $\approx 0.50\text{m}$ wide and 0.35m deep channel was dug, with a deeper, wider area at its north-western end, $\approx 0.8\text{m}$ wide with a maximum depth of 0.8m . The latter area did not extend beyond the trench created by the concrete foundations of the removed strainer post, and as such, no undisturbed material was affected.

Plate 1: Trench 1, post-excitation.

The deposits seen in Trench 1 were clearly a mixture of surfacing material and recently re-deposited soil.

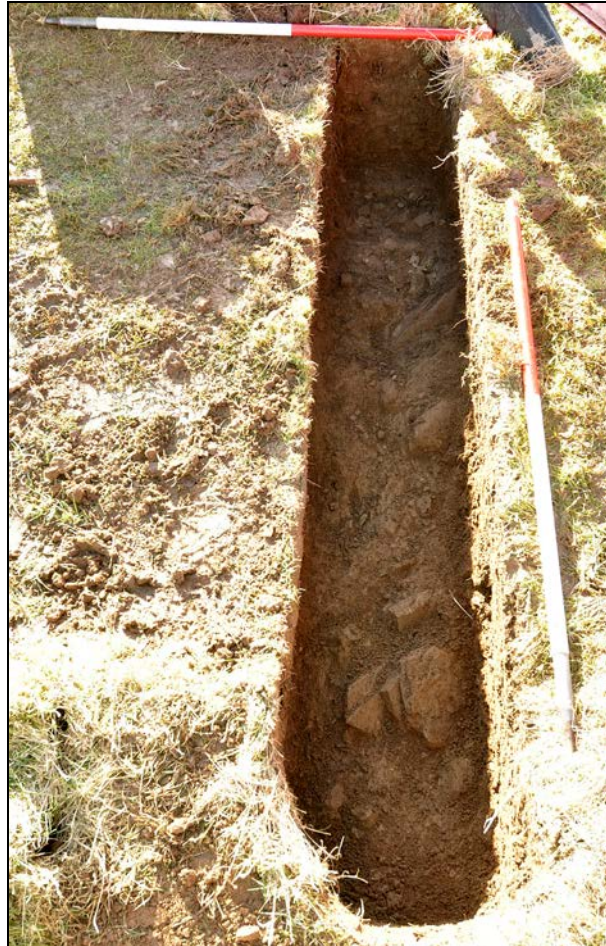
Trench 2 was located at the far northern corner of the field, where a stile over the fence giving access to the path to Barnhouse Village was to be replaced with a gate. An exploratory 'prod' of the turf with a spade revealed a lot of stone near the surface, in the originally intended location, so the area excavated was moved a little to the south-west where no stone was detected. A trench measuring 2.15m NE/SW was opened, with a width of 0.3m NW/SE. The removal of 0.1m of turf and topsoil, **201**, revealed **202**, a fairly compact layer of mid-to-dark greyish brown, silty, clay, 0.15m – 0.18m thick, with occasional small, angular, sandstone fragments. Beneath this was **203**, a 0.15m – 0.18m thick layer of material almost identical in composition to **202**, although a little lighter in colour, slightly stonier and with a few charcoal flecks. The boundary between **202** and **203** was not clearly defined. The removal of **203** revealed **204**, a compact, grey-brown clay with abundant large, angular stone fragments. The surface of this deposit was encountered at a maximum depth of 0.45m.

Plate 2: Trench 2, post-excitation.

The stones near the surface of the location in which Trench 2 was originally to be excavated were most likely the remnants of a post-medieval stone dyke. The upper soil deposit **202** most likely represents improved, well-manured plough soil, over a potentially much older soil horizon, **203**, slightly lighter in colour. Context **204** was clearly a natural deposit, and although it was not easy to distinguish within such a narrow trench, the stone visible had the appearance of a bedrock outcrop.
