**HISTORIC ENVIRONMENT SCOTLAND
PROPERTIES IN CARE
MINOR ARCHAEOLOGICAL WORKS 2015/2016**

Stirling Castle • Monitoring • December 2015

DESCRIPTION: Watching brief during the excavation of a trench related to the replacement of a worn railing on the lower level of the French Spur.

PROJECT CODE: HSCO-90291-2015-02

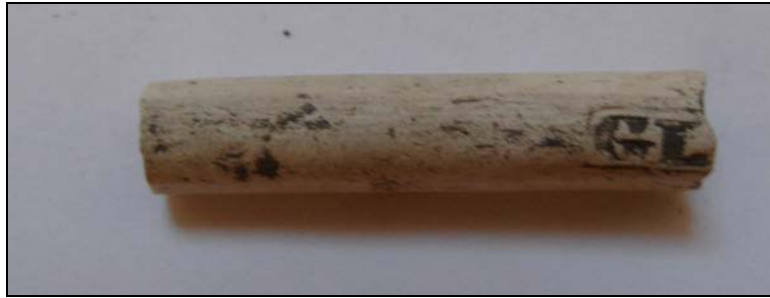
Plate 1: 19th century pipe stamped with 'GL' (for Glasgow) found in layer 103.

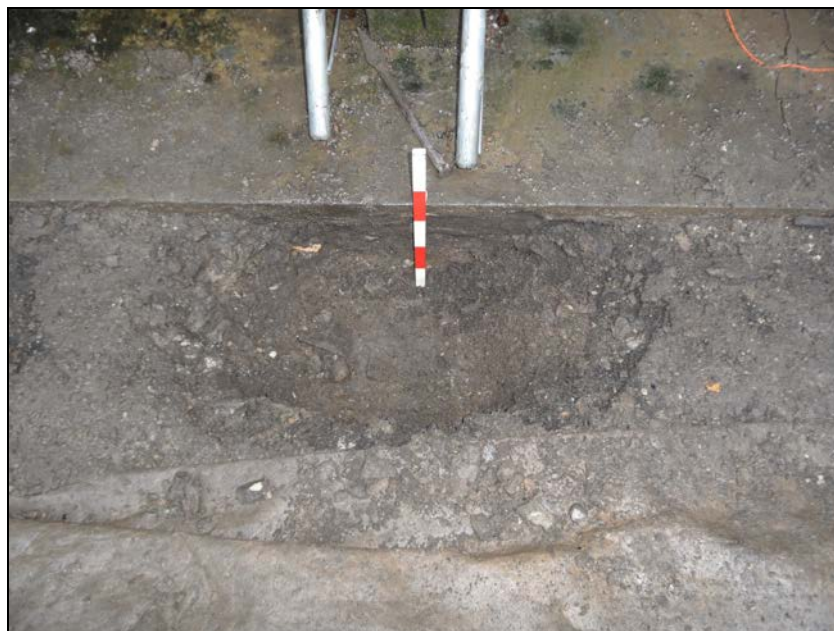
Plate 2: Post-excavation view of the central part of the trench (contexts 102, 103, 104 and 105).

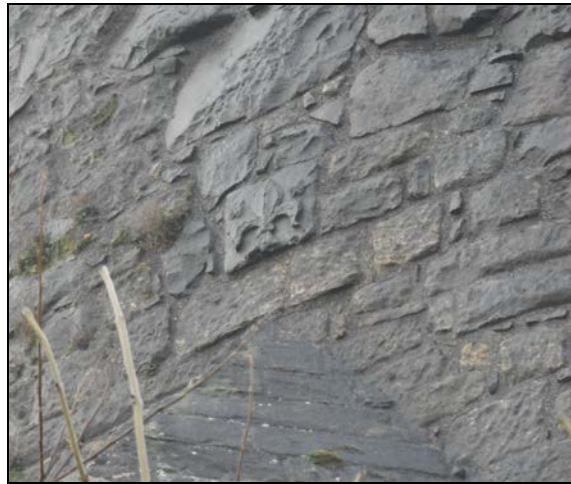
It was noted during the works that the French Spur carries an armorial on its external eastern corner, just above the lower buttressing. The stone is broken in its lower portion (possibly due to the insertion of the buttress). The armorial consists of a central *fleur-de-lis* flanked in its upper portion by two *cinquefoils* (flowers with five petals). It could be that this is a conjoining of the *fleur-de-lis* of Mary of Guise with the two upper and single lower (now missing) *cinquefoils* of the Hamiltons. Mary of Guise's master of works from 1543 – 79 was John Hamilton of Millburn, and he would have been responsible for the construction of the French Spur.

Plate 2: The armorial on the eastern corner of the French Spur.
