Discovery and Excavation in Scotland

Crookston Castle • Watching Brief • March 2017

SITE: Crookston Castle near Pollock, Glasgow (SW).

DESCRIPTION: Archaeological watching brief during the excavation of two trenches to house new signage. Additional monitoring of the removal of an existing plinth sign.

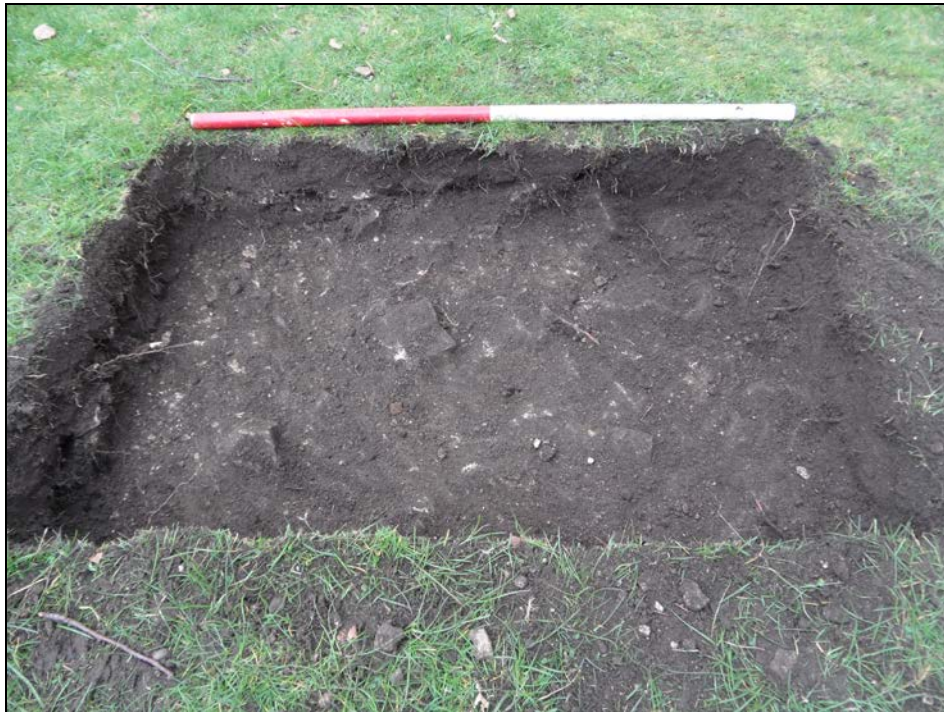
Trench 1 (to house sign CRK02) was excavated on a relatively flat area to the north-west of the stone tower. The area then falls away via a steep sloping bank to the north-west, north and north-east. The trench measured 1m NE/SW x 0.7m NW/SE. The turf and mid-brown silty topsoil **101** containing numerous sub-rounded and sub-angular stones and some modern artefacts was removed to a depth of 100 – 180mm across the trench. This exposed a surface of compacted stone and mortar **102** which had to be considered an archaeological horizon and therefore a stopping point. Though the preferred depth of the trenches for the new signage was 450mm, comprising a 300mm concrete foundation plus 150mm for bedding material, following consultation with the HES Cultural Resources team, it was decided to use the excavated depth to emplace the sign rather than risk disturbing in situ archaeological deposits.

Plate 1: Trench 1 showing mortar and stone surface 102 below the turf and topsoil.

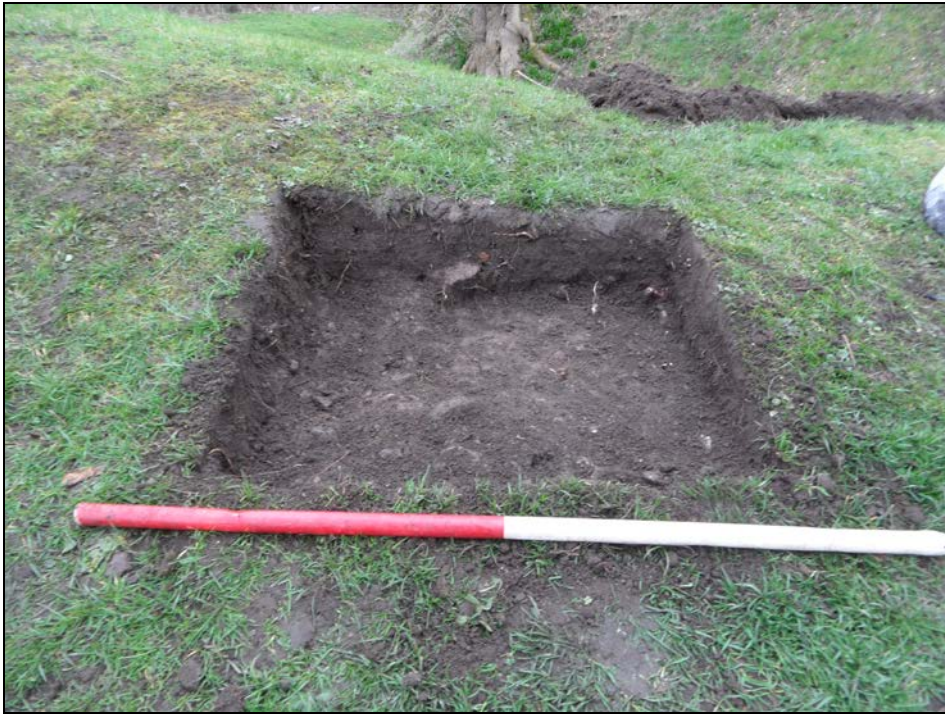
Trench 2 (to house sign CRK01) was excavated on the head of the outer ditch scarp on the north side of the entrance path. The trench measured 0.60m NE/SW x 0.70m NW/SE. The turf and mid-brown silty topsoil **201** containing a moderate amount of sub-rounded and sub-angular stones and some modern artefacts was removed to a depth of 100 – 180mm across the trench (the section to the north-east was highest at 180mm, with the south-west section being down slope and measuring only 100mm). This exposed a surface of re-deposited clay flecked with charcoal **202** which represented the original fabric of the outer ditch and probably of 12th century date. In consultation with the HES Cultural Resources team,

it was decided to use this excavated depth to emplace the sign rather than risk disturbing in situ archaeological deposits.

Plate 2: Trench 2 showing re-deposited clay bank 202 below the turf and topsoil.

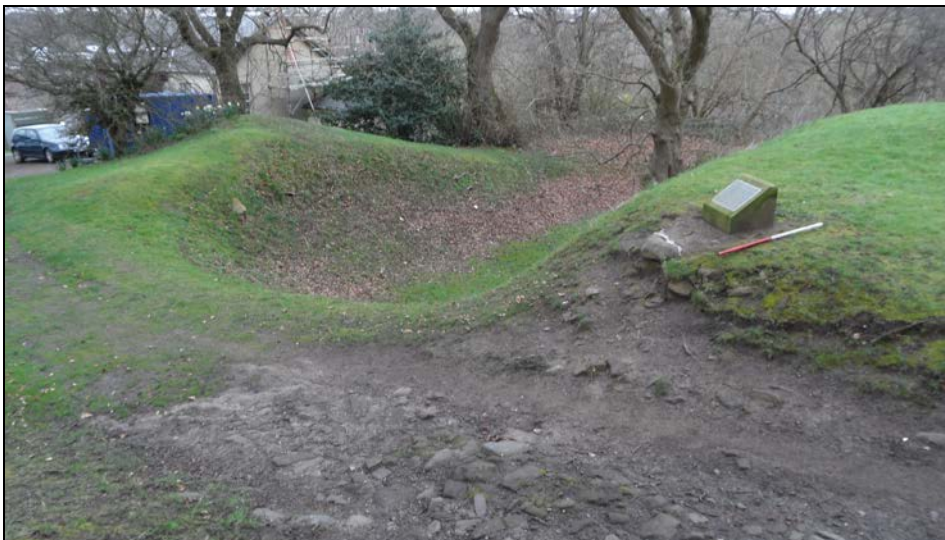
The existing stone plinth sign was located on the opposite ditch bank to the east (Plate 3). This was removed under an archaeological watching brief although the subsequent hole created was not formalised in to a trench.

Plate 3: Showing the existing position of sign CRK01.

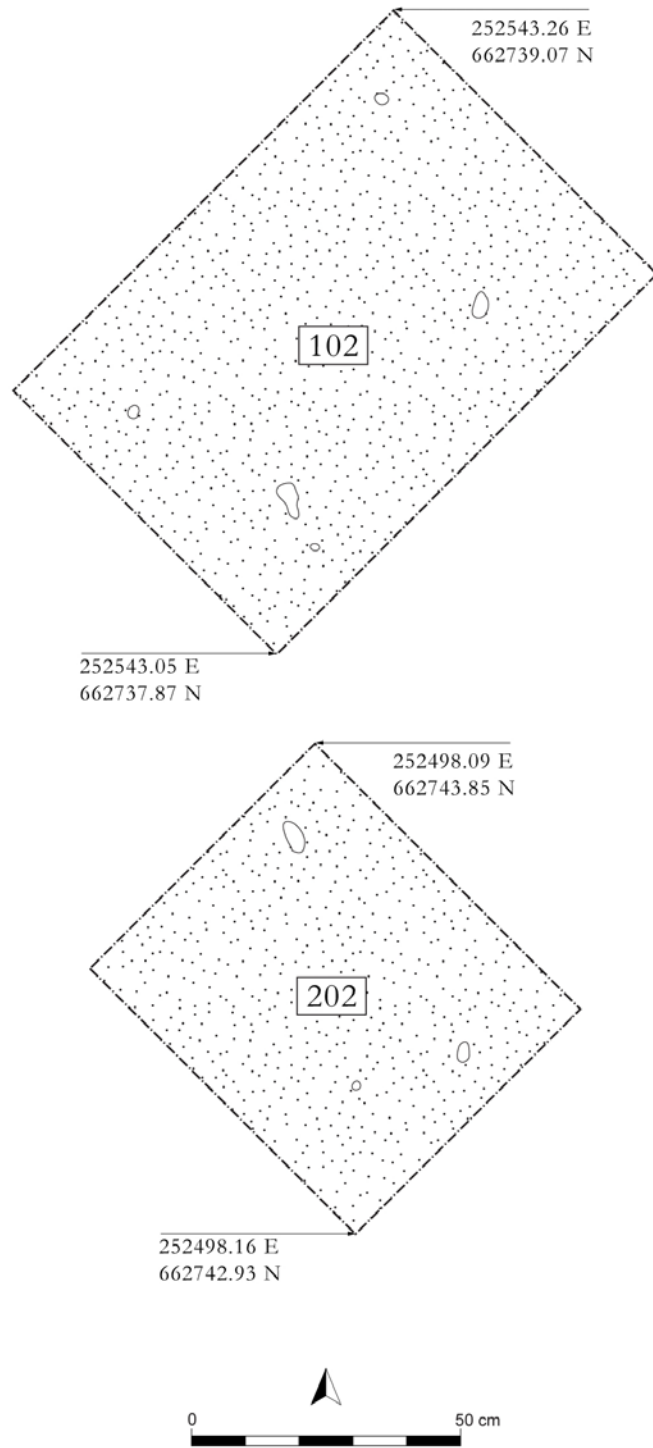
Figure 2: Post-excitation plans of Trench 1 (top) and Trench 2.

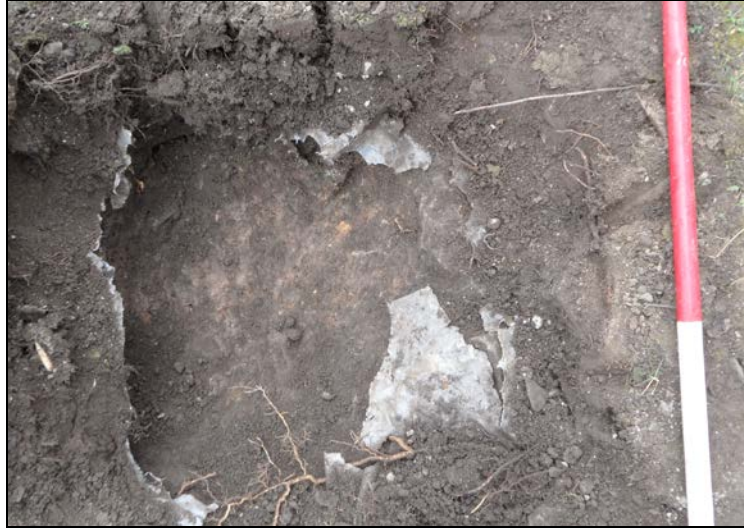
The sign was removed and was shown to have a thick concrete base. This was removed and the hole created was to be backfilled with topsoil and turf from Trenches 1 and 2. The hole measured 0.60m x 0.60m x (up to) 0.20m deep. It was noted that the foundation for this sign had partially truncated part of the upraised fabric of the inner ditch scarp, which like **202** (encountered in Trench 2) was made of re-deposited clay flecked with charcoal (Plate 4).

Plate 4: Showing the re-deposited clay forming the inner ditch scarp (truncated by CRK01).
