LOCAL AUTHODITY.	Ediaharah Cita Of	
LOCAL AUTHORITY:	Edinburgh, City Of	
PROJECT TITLE/SITE NAME:	Palace of Holyroodhouse (South Gateway, Palace Yard)	
PROJECT CODE:	HSCO-90132-2016-01	
PARISH:	Edinburgh, City Of	
NAME OF CONTRIBUTOR:	Gordon Ewart	
NAME OF ORGANISATION:	Kirkdale Archaeology	
TYPE(S) OF PROJECT:	Watching Brief and Excavation	
NMRS NO(S):	NT27SE 35.00; NT27SE 35.15	
SITE/MONUMENT TYPE(S):	Palace; Gateway	
SIGNIFICANT FINDS:	None	
NGR (2 letters, 8 or 10 figures)	NT 2686 7384	
START DATE (this season)	21 September 2016	
END DATE (this season)	7 April 2017	
PREVIOUS WORK (incl. DES ref.)		
MAIN (NARRATIVE) DESCRIPTION: (May include information from other fields)	A watching brief was maintained during excavations to locate a burst water pipe, initially estimated to lie somewhere towards the south end of the forecourt. During the excavations, at least two multi-phase, narrow, stone-walled structures, each with a series of floors, including a cobbled surface at the base. Cartographic evidence suggests that these are two possible stables which were built against the boundary wall between the South Garden and Palace Forecourt during the early 18 th century. The south bounda

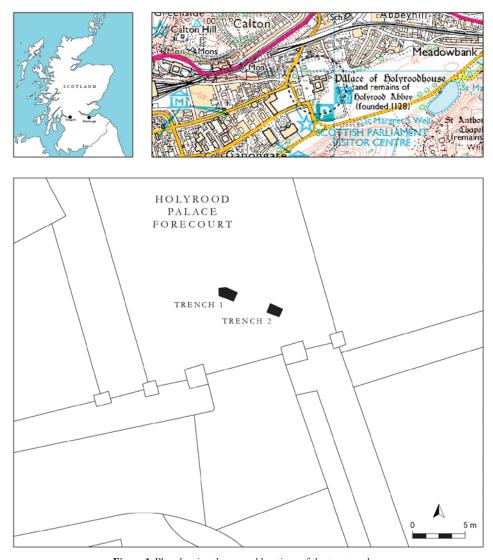
Under the terms of its PIC call-off contract with Historic Environment Scotland, Kirkdale Archaeology was asked to undertake an archaeological watching brief during the excavation of two trenches to locate a burst water pipe, estimated to lie somewhere towards the south end of the forecourt (Fig. 1).

Figure 1: Plan showing the general locations of the two trenches. Mapping © Crown copyright. All rights reserved 2016. Licence number 100036933.

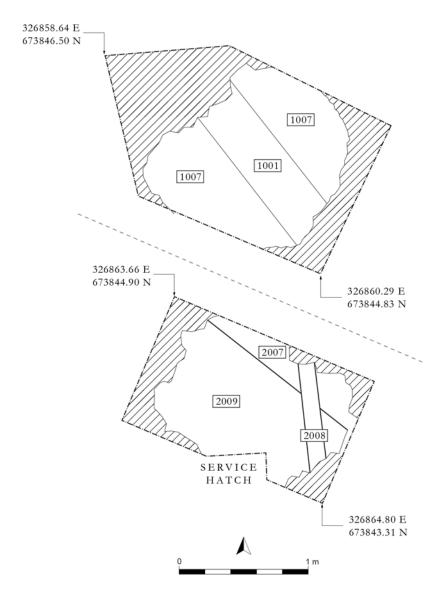
The excavation was completed by a small mechanical excavator, initially opening a trench £.1m wide aligned roughly E/W but which changed alignment to a NW/SE orientation, in an attempt to trace the buried pipe. The resulting trench measured a maximum 2.25m long x 1.5m wide. The sections were recorded, and exposed a series of road surfaces, a possible broken stone drainage channel, evidence of gardens/cultivation and an iron water pipe.

Figure 2: Trench 1 (top) and Trench 2, post-excavation plans.

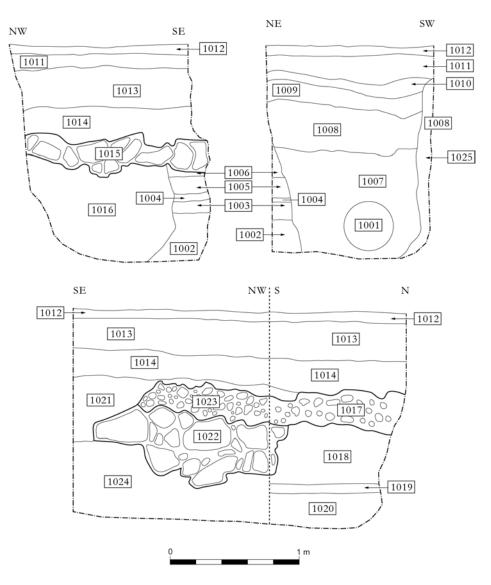
Immediately below the present surface (1012) of the Palace Forecourt, was a spread of tarmac (1011). Running roughly NE/SW were a series of tipped fills (1009, 1010, 1008, 1007) within a straight-sided, almost vertical cut (1025). These comprised loose dumps of stones in a dark silt, backfilling the cut to a total depth of 1.5m, and sealing an iron water pipe at it base (1001). This pipe trench (1025) was found to

have cut across two successive dumps of compacted angular stones (1013 and 1014), apparently road/courtyard foundation/levelling deposits, up 0.60m deep. These in turn sealed a spread of rubble and smaller, broken stone fragments – 1015, 1023, 1017, and 1022, cumulatively 0.25 – 0.65m deep. To the northern side of the trench the rubble overlay a deposit of grey/brown, stone free, silty clay (1016), ϵ .0.55m deep, which in turn was cut against a series of narrow bands of varying composition. These deposits appear to be laid surfaces. To the north, they comprised a band of charcoal (1005) 0.10m deep, a spread of white mortar (1004), 0.03m deep, a layer of orange/brown sandy silt (1003), 0.10m deep, with a clean light brown silt at the base (1002). On the southern side of the trench, there was a similar series – charcoal (1018), 0.30m deep, a clay pad (1019), 0.10m deep sealing 1020 (similar to 1003, and excavated to a depth of 0.25m).

Figure 3: Clockwise from top/left: Trench 1: SW-facing section, NW-facing section, and E / NE facing (adjoining) sections.

This trench can be described in terms of 7 phases.

The natural subsoil was revealed at a depth of ϵ .2m below the present forecourt surface, and shows no sign of a preserved old ground surface. This suggests it has been levelled or truncated in some way.

A series of relatively shallow layers were introduced, these may represent floors and domestic occupation within any of the structures known to have been in this area from later-17th – later-18th century. However, the character of these surfaces suggests they may be fragments of a mineral *parterre* associated with the 16th and early-17th palace gardens.

The cut visible against Phase 2 deposits may reflect a robbed structure – a wall or drain.

Levelling over cleared Phase 3 structures in the late- 17^{th} century using rubble to raise the forecourt level by c.0.60m. It is also possible that this deposit is a surviving element from a (redundant) *parterre* layout, simply buried by the new forecourt

Levelling for a further forecourt surface associated with new gates etc. – probably in the mid-19th century.

New water pipe laid in a deep narrow trench (early-20th century).

Present forecourt surface laid.

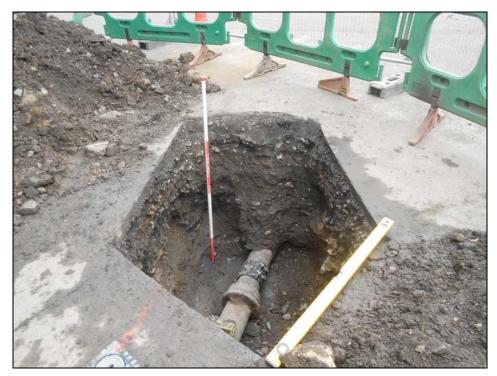
Plate 1: Trench 1, post-excavation.

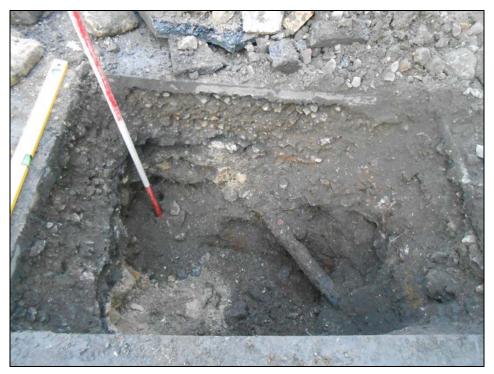
Trench 2 was excavated by small mechanical excavator in an area slightly to the south-east of Trench 1. It covered an area of 1.6m x 1.00m, was oriented NW/SE, and was intended to reveal more of the pipe noted in Trench 1.

Once the concrete (2001) was cut away, two deposits of stone chippings/road make up were noted (2002 and 2003) – similar to 1013 and 1014 – sealing a spread of rubble (2004), similar to 1015/1023. This was found to seal a pipe (2007) running roughly NW/SE, set in a deep cut (2010). The pipe trench was cut against a deep rubble deposit (2005) which in turn sealed dark, humic earth (2009) at a depth of c.1.25m below the present forecourt surface.

Plate 2: Trench 2, post-excavation.

This trench can be described in terms of 6 phases

Cultivation, defined by a deep garden soil deposit.

A deep rubble spread, suggesting demolished structures recycled as underpinning for a raised courtyard surface. It is also possible that this deposit is a linear feature or surface within a mineral *parterre*, simply buried by later courtyard.

A trench cut (and backfilled) for an iron water pipe.

Rubble and small stones laid down as underpinning for a further raised ground level.

An electricity cable was emplaced in a metal sleeve, dug against raised surfaces and backfilled.

Present forecourt surface laid.

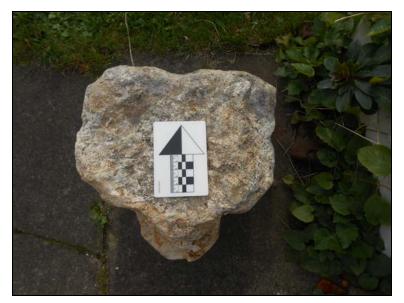
A single ashlar block – moulded pale yellow/cream coloured sandstone, probably part of a window margin was retrieved from context 2005.

Plate 3: The ashlar block from Trench 2, context 2005.

The discovery of such a large fragment suggests that at least one significant medieval building was destroyed and used within the fabric of a *parterre* and, later, as rubble footings for the new courtyard/forecourt laid alongside the developed palace of Charles II (during the 1660s).

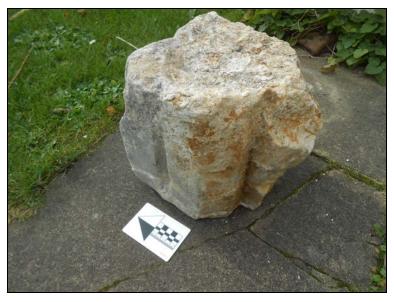
Plate 4: Another view of the ashlar block from Trench 2, context 2005.
