HISTORIC ENVIRONMENT SCOTLAND
PROPERTIES IN CARE
MINOR ARCHAEOLOGICAL WORKS 2016/2017

Huntly Castle • Monitoring • February 2017

SITE: Huntly Castle, Aberdeenshire.

DESCRIPTION: Archaeological watching brief during the excavation of a trench to house a new water treatment system serving the public toilets and mess facilities.

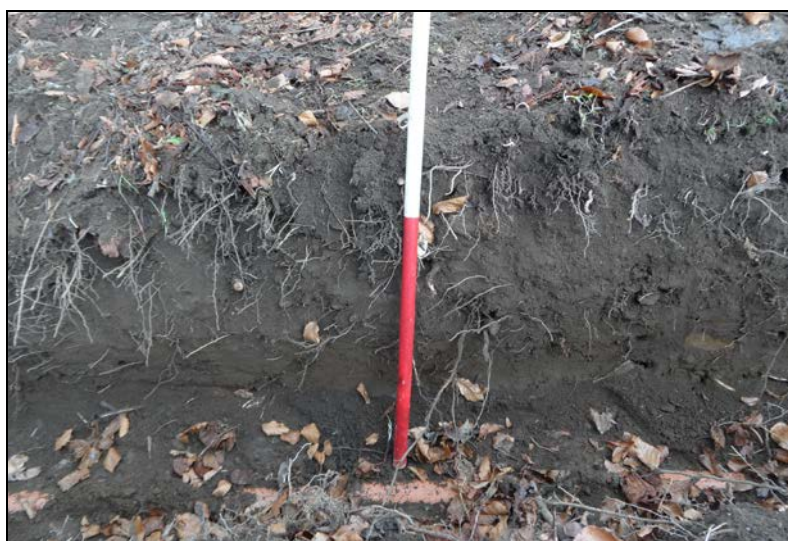
Plate 1: A typical SW-facing section of the pipe trench with pipe at the base.

The section (see Plate 1) generally consisted of a moderately compact layer of mid-brown silty topsoil **101**, $\approx 50\text{cm}$ thick and heavily cut through by tree roots. This bedded on a greyish-brown clay subsoil **102**, exposed to $\approx 15\text{cm}$ thick. These layers had been truncated in order to install the in situ plastic pipe **103**.

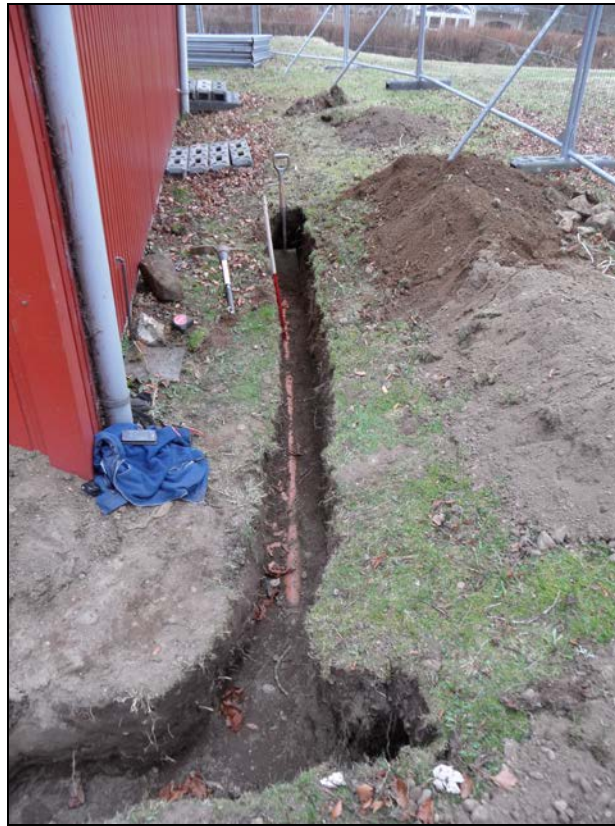
The hand-excavated portion of trench (see Plate 2) to the south-west and south-east of the mess hut consisted of a trench cut with a right-angled corner. The trench measured 2.8m NW/SE x 6.05m NE/SW x 0.30m deep to the top of the pipe. The section consisted this time of a moderately compact layer of mid-brown silty topsoil **101**, at least $\approx 30\text{cm}$ thick and heavily cut through by tree roots. This layer had been truncated in order to install the in situ plastic pipe **103**.

Plate 2: Looking north-east at the hand-excavated portion of the pipe trench.

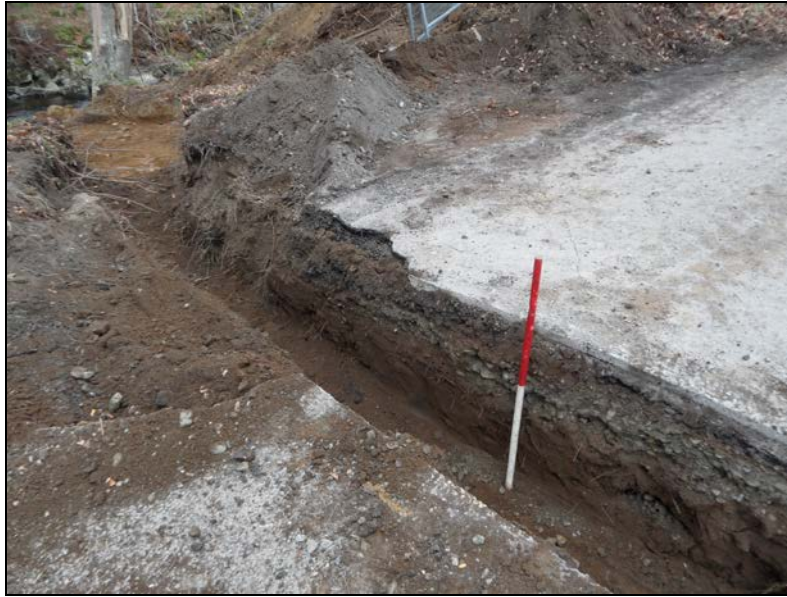
The works required a section of the road to be cut out (see Plate 3). The resultant trench measured $\approx 3.10\text{m}$ N/S x 1m wide x 0.75m deep. The section consisted of the existing road surface **104**, with a sub-base of Type 2 stone **105**, with finings within a cut **106** $\approx 35\text{cm}$ deep which had truncated the greyish-brown clay subsoil **102**, exposed to $\approx 40\text{cm}$ thick.

Plate 3: The trench as excavated through the road.

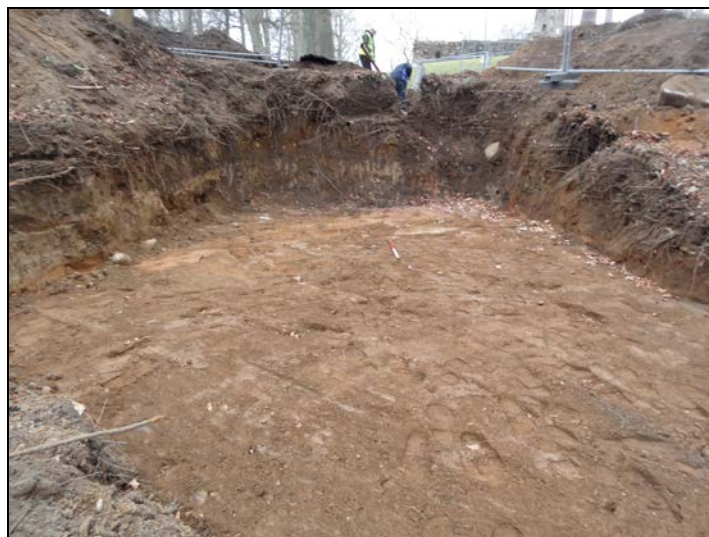
The excavation was then widened to create the necessary space for the new septic tank (see Plate 4). The trench measured 4.70m E/W x 8.80m N/S x (up to) 2.66m deep against the southern section. The section consisted of a moderately compact layer of mid-brown silty topsoil **101**, c.60cm thick heavily cut through by tree roots. This bedded on a greyish/brown clay subsoil **102**, c.50cm thick. The natural below was composed of a compact layer (c.1.1m thick, on average) of yellowish/grey sandy clay **107** containing large sub-rounded boulders which cleared in disparate patches onto the bedrock **108** below.

Plate 4: The excavation for the septic tank.
