Kinneil House • Watching Brief • March 2017

SITE: Kinneil House, near Bo'ness, West Lothian.

DESCRIPTION: Archaeological watching brief during the excavation of a large trench to remove the foundation of the leaning south orchard wall as part of stabilisation works to repair and reinstate the wall.

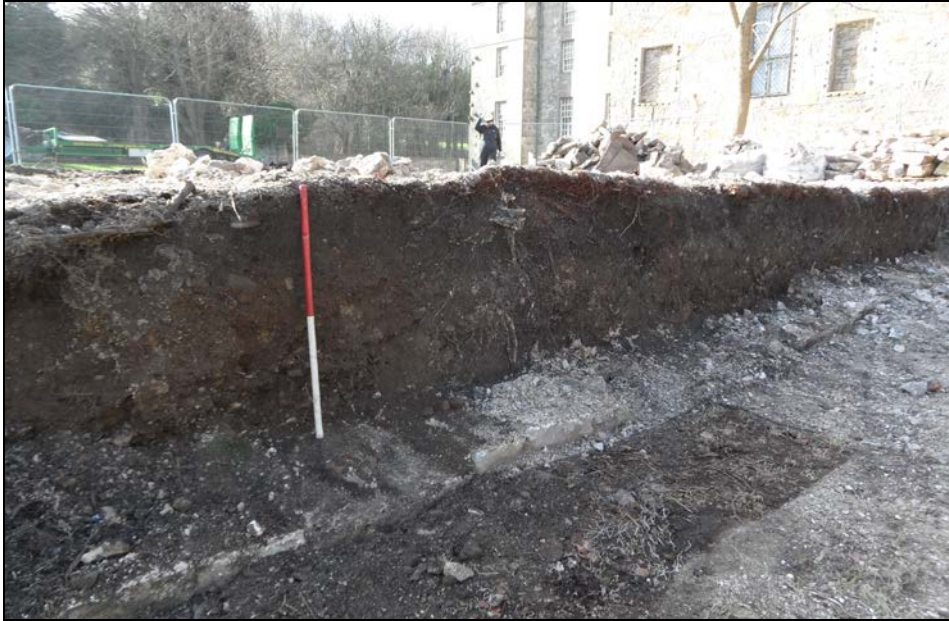
In order to remove the wall foundation and excavate the widened trench for the new stepped foundation, there was a degree of ground preparation which had to be carried out first. The level of the wall had been reduced down to the level of the orchard ground surface, but in order to be able to dig on the south side of the wall, the ground had to be dropped by *c.*1m (Plate 1).

Plate 1: The pre-excavation sequence of banked deposits and reduced wall line.

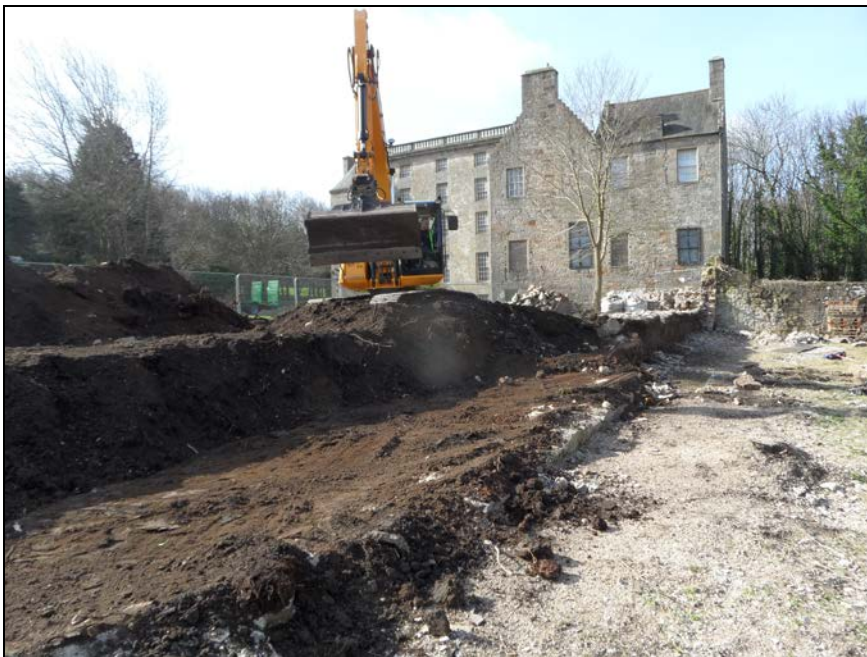
In order to achieve this, the mechanical digger had to reduce an area 1.75m wide N/S x 1m deep. A further 1m wide (N/S) strip was then battered up to the existing level of the upper terrace (Plate 2). In this way enough operating room was created to allow the excavation of the new foundation trench.

Plate 2: The working platform being excavated by the digger.

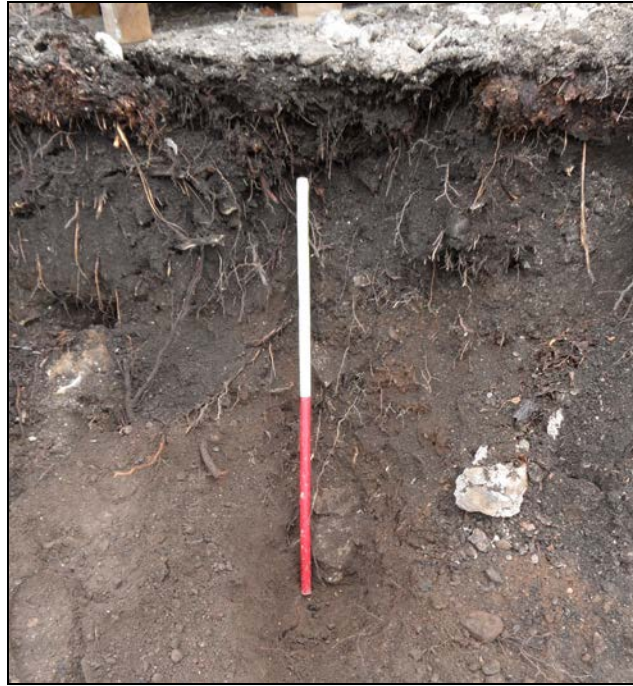
At the western end of the newly created working platform, the E-facing section showed a basic sequence of imported garden soil **101**, c.0.50m thick overlying a layer of imported charcoal-flecked brown clay **102** containing angular rubble pieces (Plate 3).

Plate 3: E-facing section on the south side of the wall.

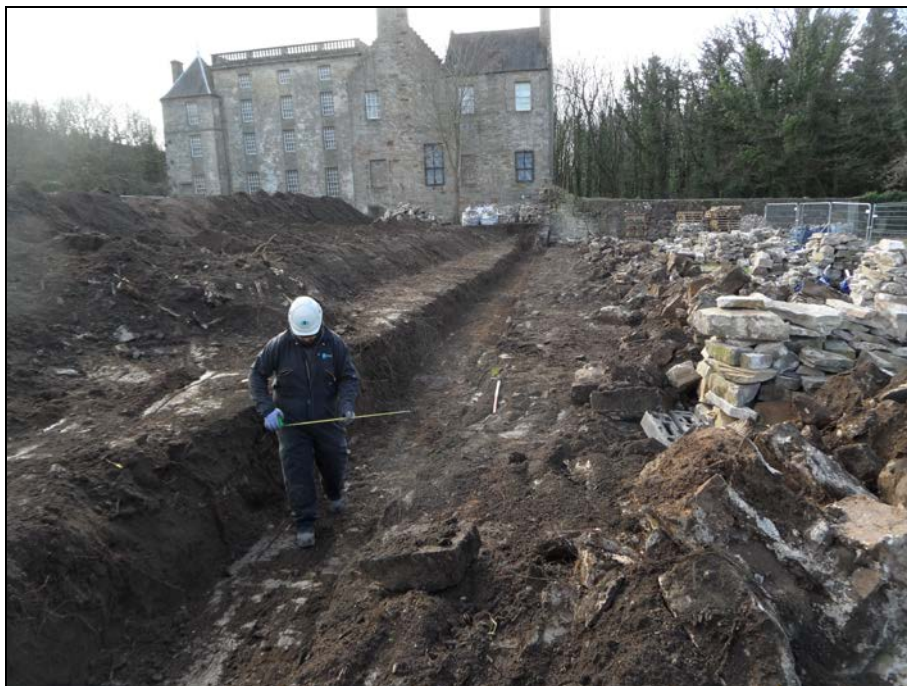
Having prepared the ground, the removal of the existing wall foundation proceeded. Soil to a depth of 0.30m was to be added to each side (north and south) of the existing wall (0.65m wide) to form a trench 1.25m wide E/W x 0.60m deep. This was again removed using a mechanical digger. The wall foundation was laid to the north so that the stone could be cleaned and reclaimed while the soft deposits were stored in a bund to the south.

Plate 4: Post-excitation shot showing the new foundation trench.

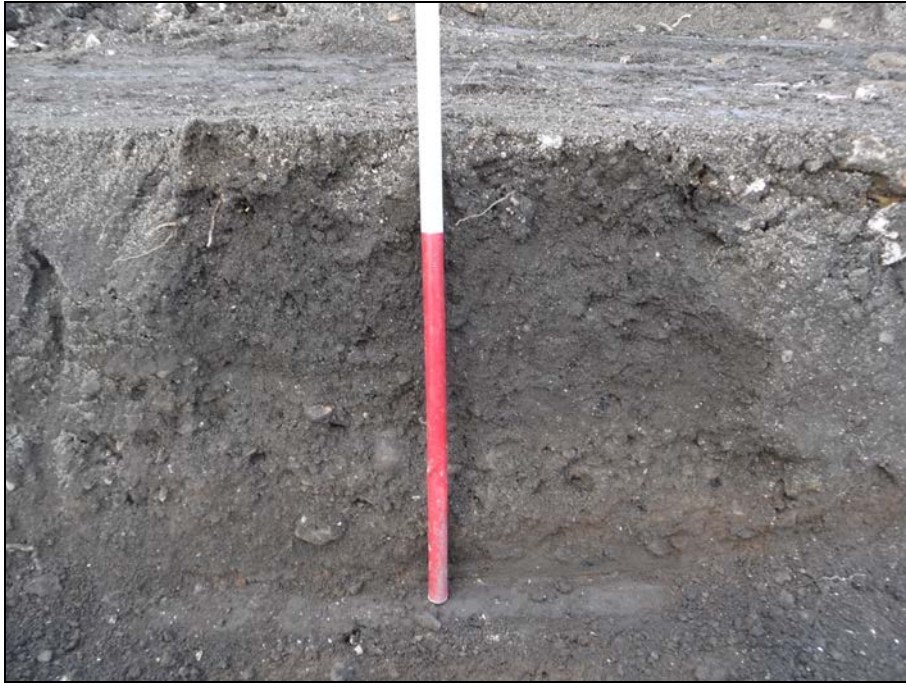
Plate 5: Post-excavation shot showing the S-facing deposits forming the ground of the orchard.

The deposits of the orchard again showed a basic sequence of imported garden soil **101**, c.0.50m thick overlying a layer of imported charcoal-flecked brown clay **102**. As **102** appeared to form the same deposit to north and south of the wall, this suggests that they were emplaced at the same time *i.e.* in the late-17th century.
