Discovery and Excavation in Scotland

HISTORIC ENVIRONEMNT SCOTLAND
PROPERTIES IN CARE
MINOR ARCHAEOLOGICAL WORKS 2016/2017

Stirling Castle • Excavation • February 2017

DESCRIPTION: Excavation of one trench and five test pits ahead of the emplacement of new hand rails in the Queen Anne Garden.

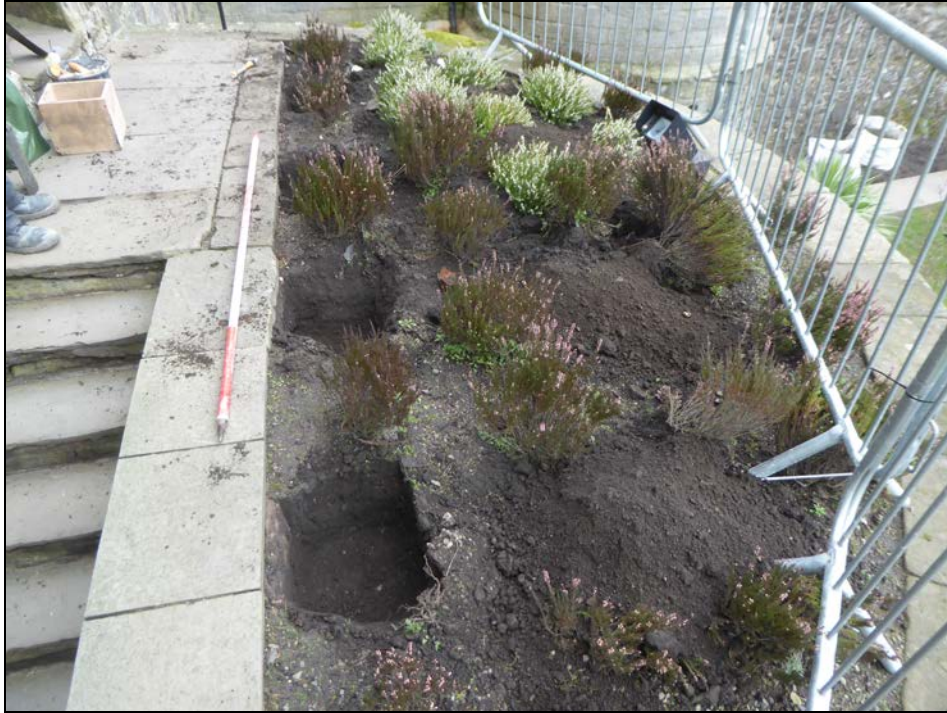
Plate 2: View of the excavated test pits.

Test pits 1-4 measured 0.40m square, while Test Pit 5 ended up being 1.5m N/S x 0.40m E/W. All were ~0.35m deep.

A similar sequence was found in all areas excavated. The top ~0.30m consisted of dark brown slightly clayey silt rich in stone and mortar. All then bottomed onto a layer comprising loose pale grey silt rich in mortar and rubble, whose base was not reached.
