**Croft-an-Righ: Archaeological Survey, November 2011.**

**DESCRIPTION:** Archaeological survey of exposed timbers over a 17<sup>th</sup>-century ceiling below.

**PROJECT CODE:** HSCO-90131-2012-01

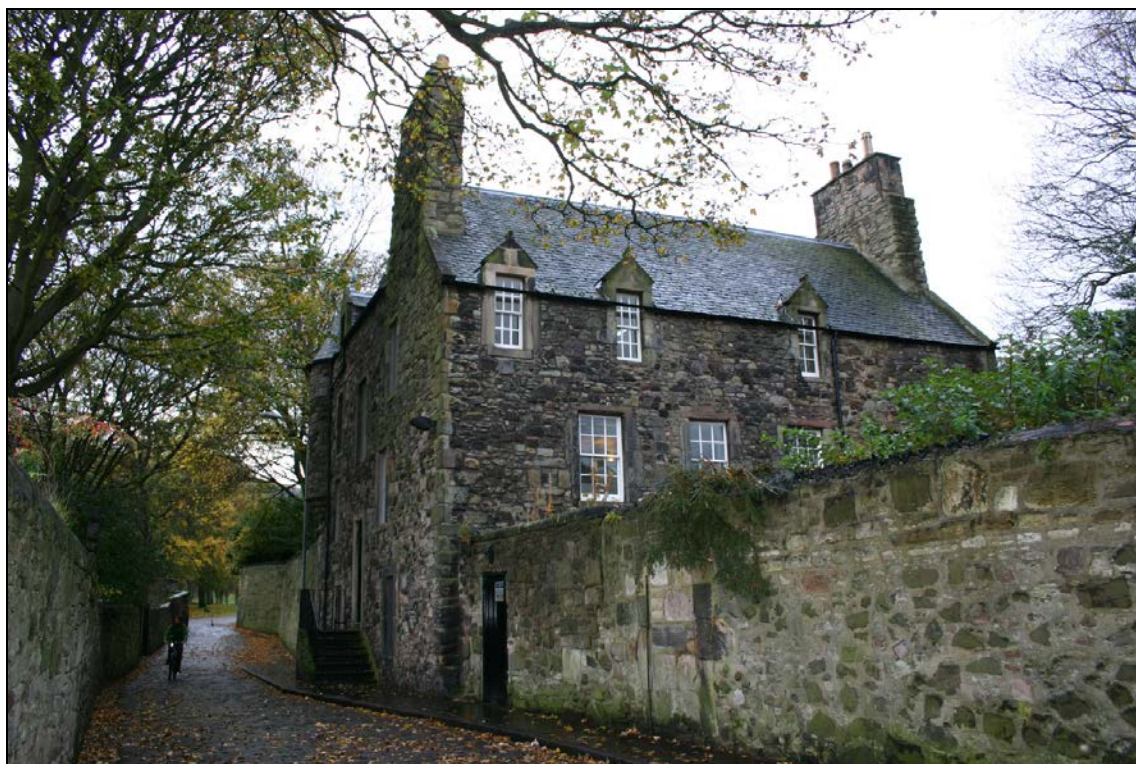
**Figure 2:** The North-Range of Croft-an-Righ House.

Croft-an-Righ House is an L-shaped edifice that is located immediately northeast of the gardens of Holyrood Abbey (Fig. 1, Fig. 2). Judging by its architectural details, the mansion was erected during the 16<sup>th</sup> century, and this view is also shared by several authors on Scottish architecture.<sup>2</sup> Stately Scottish houses of this time were characterised by '(...) large (...) room[s] with paved floor[s], plastered walls, stone fireplace[s] and open timber ceiling[s] consisting of exposed joists spanning the room at intervals of about two feet and supporting both ceiling and walking floor of the room above.'<sup>3</sup>

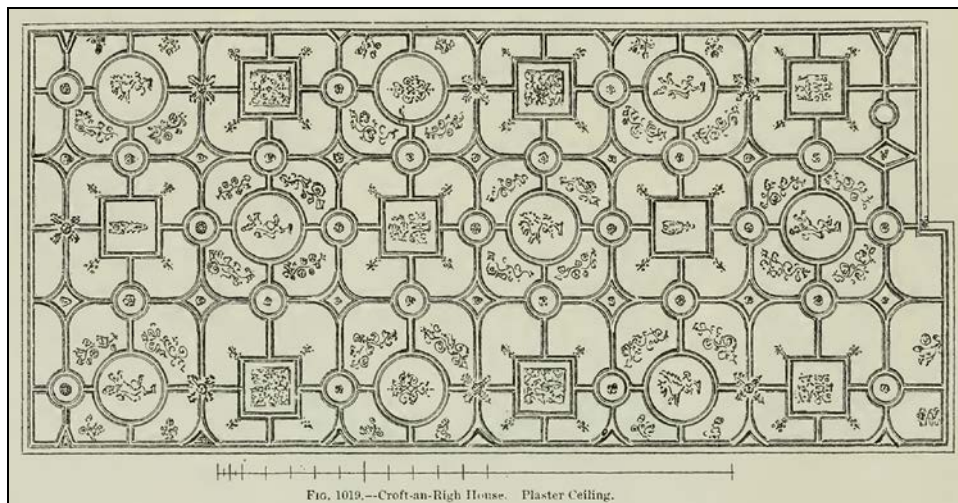
**Figure 4:** Underside elevation of the plaster ceiling (MacGibbon/Ross, 1897-92, p. 435).

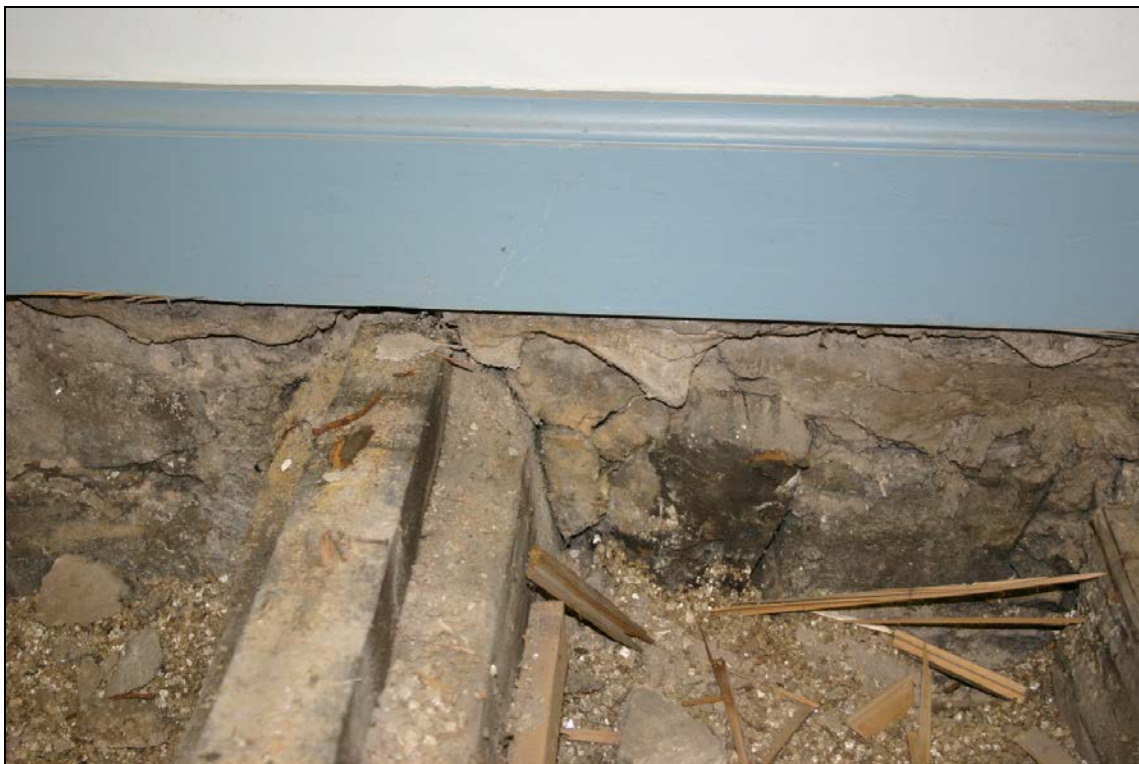
**Figure 5:** Redundant joist-stumps adjacent to joist 023.

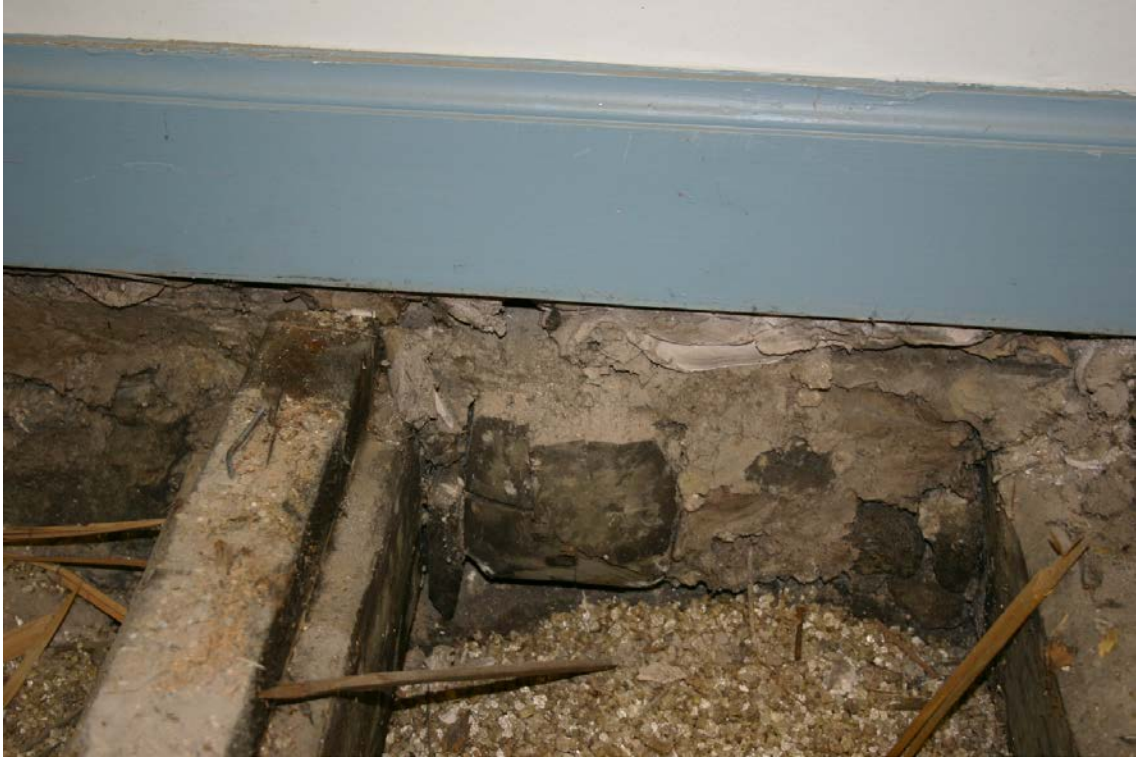
**Figure 6:** Redundant joist-stumps adjacent to joist 025.

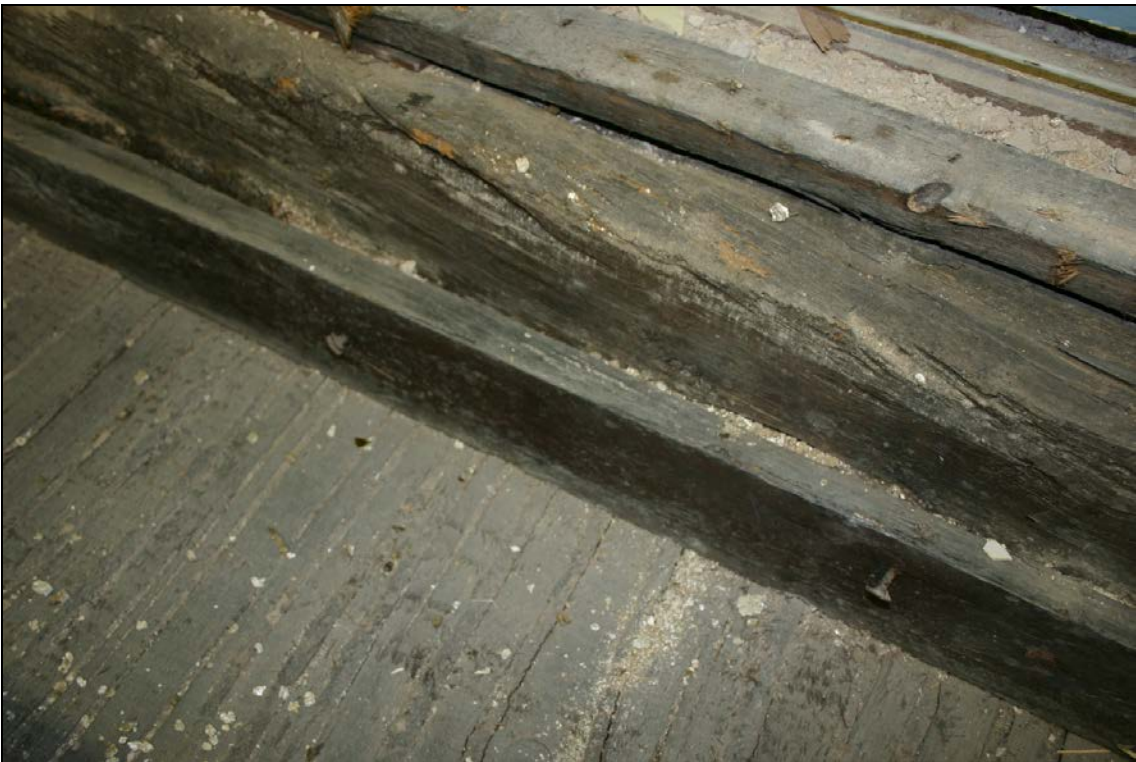
**Figure 7:** Auxiliary board, hand-made nails and lathwork at joist 057.

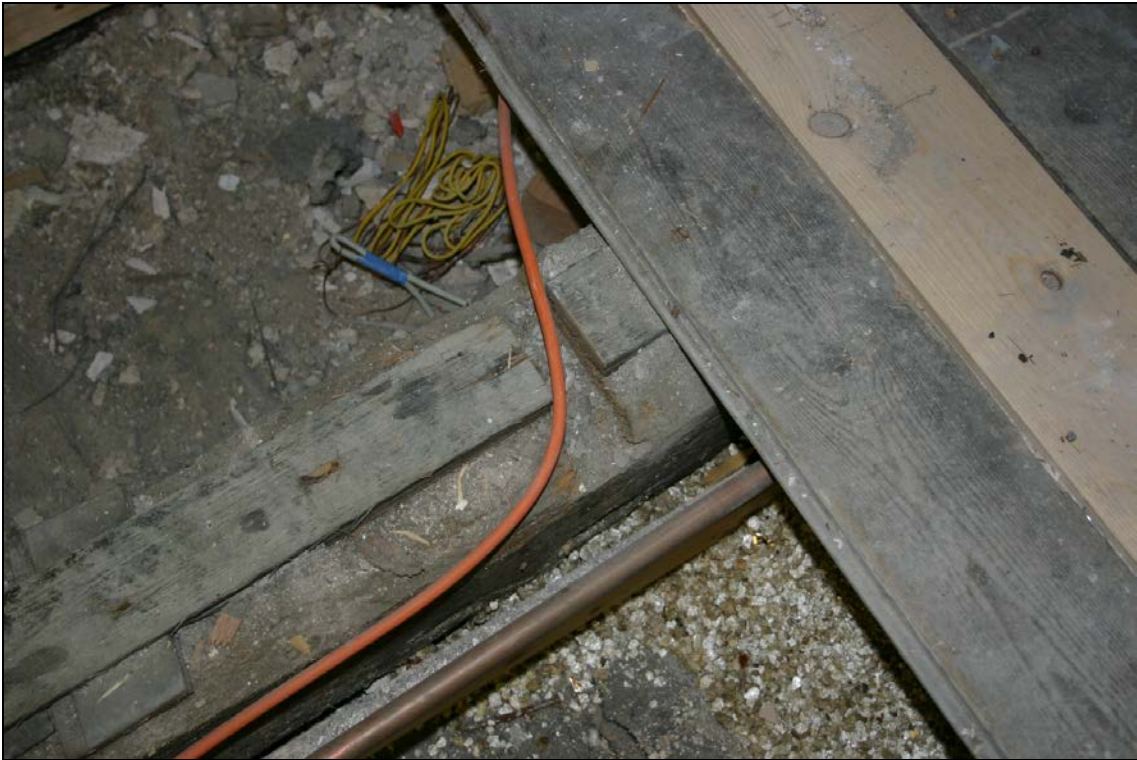
**Figure 8:** Floor boards and top of joist 047.

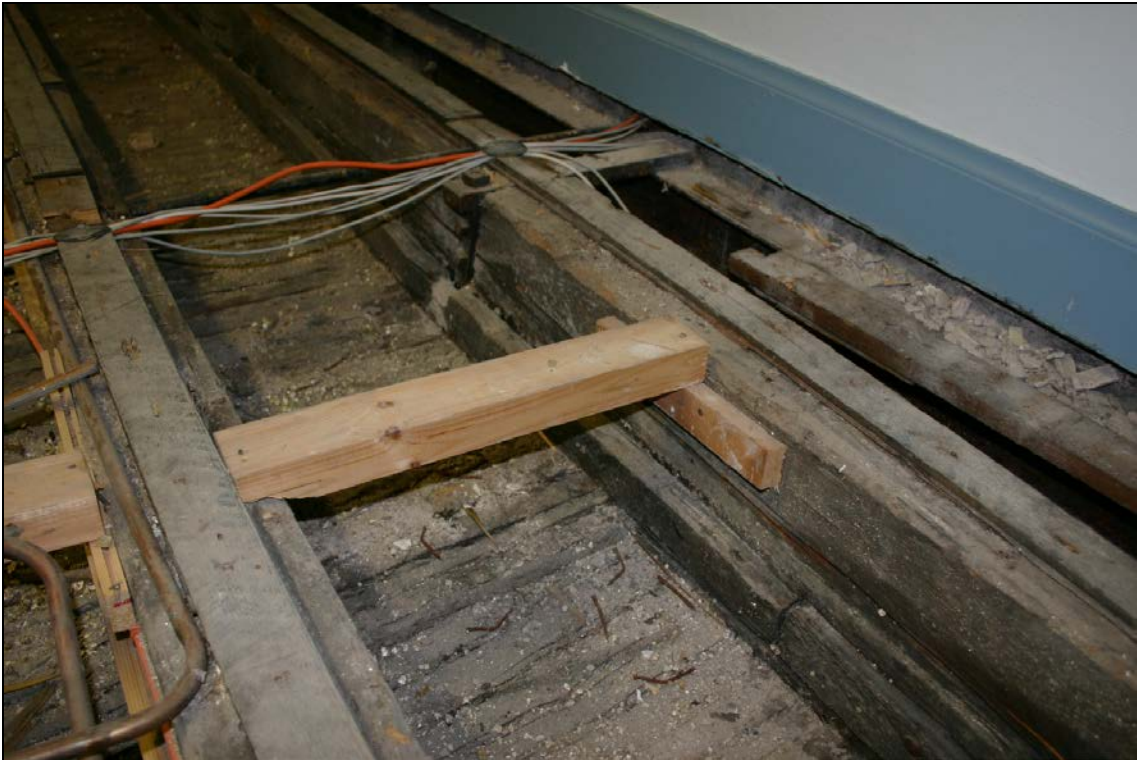
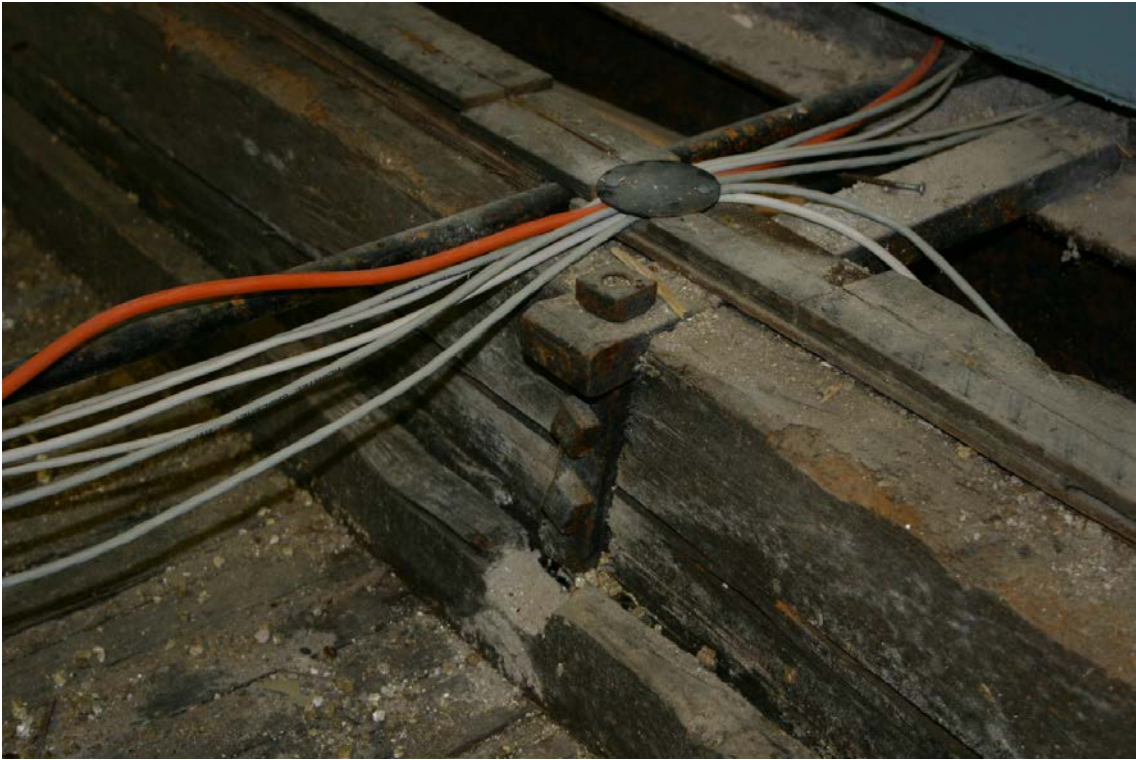
057,<sup>13</sup> also supports the partition (Figs. 9 and 10). This bracket uses the type of bolts mentioned above.

**Figure 9:** Iron bracket and partition at joist 050.

**Figure 10:** Iron bracket and partition at joist 050 (detail).

This operation probably coincided with the introduction of the partition that nowadays divides the second floor of the north-range into two separate chambers. The partition, constructed as a half-timbered wall and stretching from the north to the south wall, sits on an iron girder between joists 050 and 057, and it is only indirectly attached to the original ceiling architecture. This happens via an iron bracket, which, tying together joists 050 and

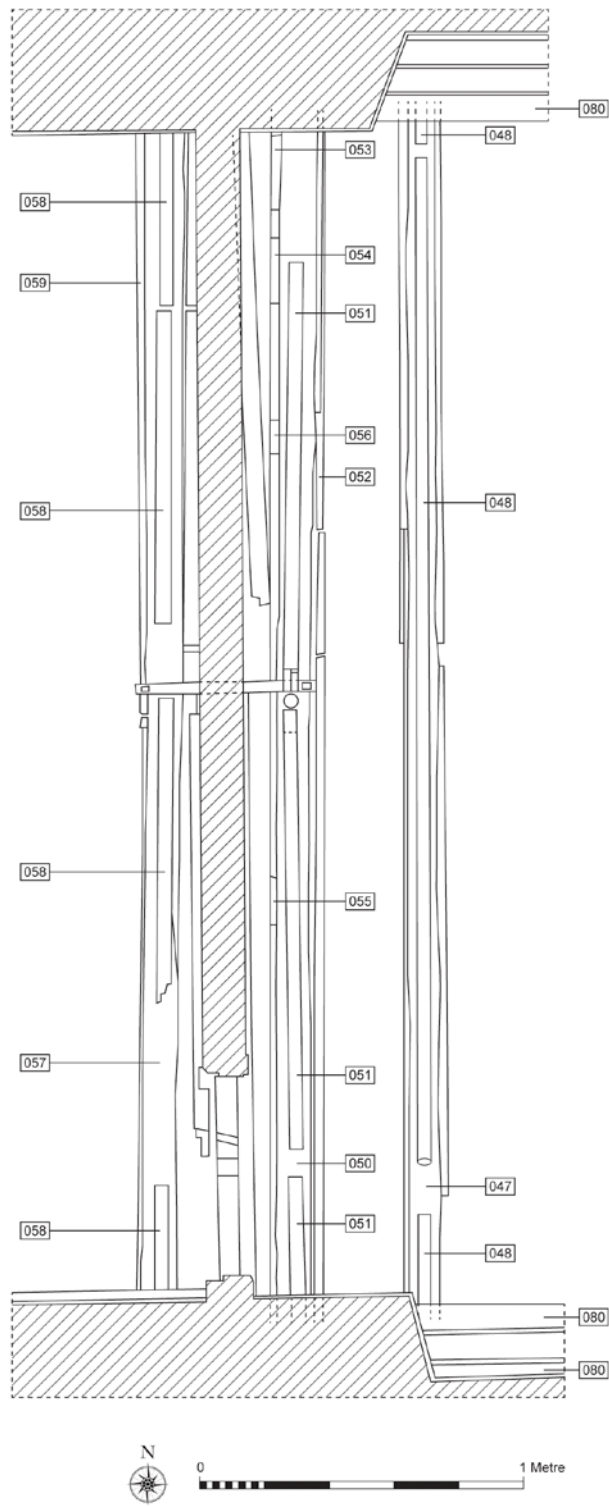
Figure 12: Detailed location of numbered features discussed in the text.

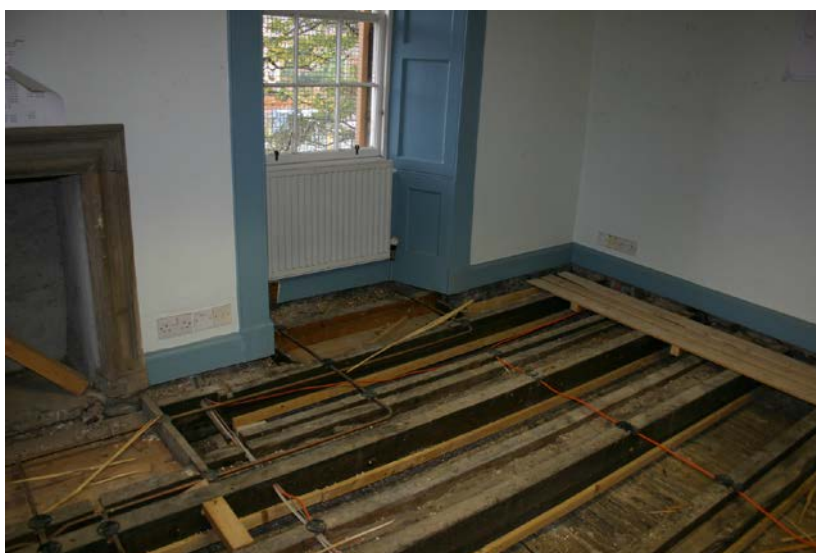
Axis 0

Item	Cross-sectional Dimension	Assembly Marks	Tool Marks	Redundant Features	Fixings
Auxiliary Joist (001)	45 x 72mm	None	Machine-sawn (vertical kerbs)	Nails and nail holes (top)	Nails (round head)
Auxiliary Joist (002)	45 x not ascertainable <sup>14</sup>	Not ascertainable	Not ascertainable	Not ascertainable	Not ascertainable

No.001: View from northwest showing auxiliary joist 001 (axis within window-bay).

<sup>14</sup> Auxiliary joist 001 sits on top of auxiliary joist 002 and conceals it entirely.

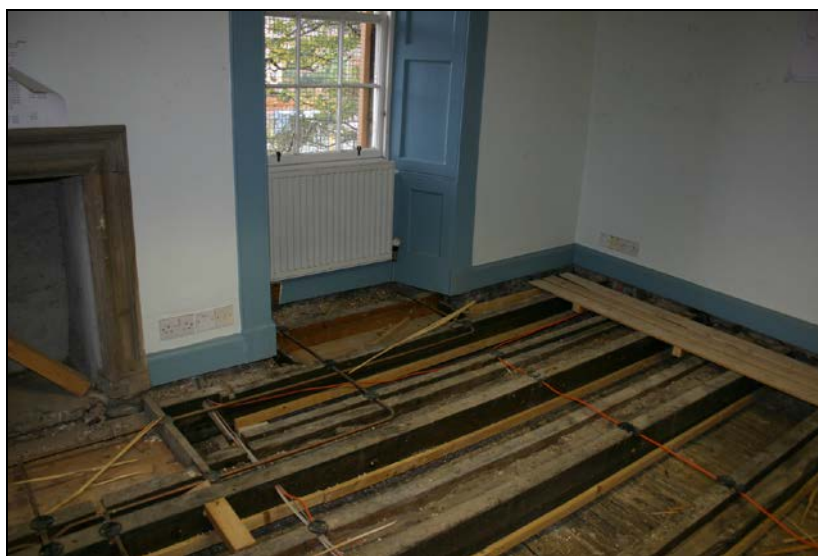
Axis 1

Item	Cross-sectional Dimension	Assembly Marks	Tool Marks	Redundant Features	Fixings
Joist (003) <sup>15</sup>	130 x 175mm	None	Adzed	None	None
Auxiliary Joist (004)	32 x 165mm	None	Machine-sawn (vertical kerbs)	Nails and nail holes (top)	Nails (round head)
Furring Piece (005)	65 x 50mm	None	Machine-sawn (vertical kerbs)	None	Nails (round head)
Furring Piece (006)	65 x 10mm	None	Machine-sawn (circular kerbs)	None	Nails (round head)
Trimmer (007)	30 x 160mm	None	Machine-sawn (vertical kerbs)	None	Not ascertainable
Trimmer (008)	30 x 160mm	None	Machine-sawn (vertical kerbs)	None	Not ascertainable

Nos 003, 004 & 008: View from north-west showing joist 003, auxiliary joist 004 and trimmer 008 (first axis in front of e-wall).

<sup>15</sup> Joist 003 is lowered to a dimension of 32 – 88mm in front of chimney. This treatment obviously provided space for some sort of substructure that must have been related to the floor-area immediately in front of the fireplace. It is impossible to say unequivocally whether this happened by the time of the construction of the ceiling or at some later stage – both are possible. The two trimmers (007 and 008) linking the chimneypiece with joist 009, however, are machine-sawn and it may thus be concluded that the fireplace is not contemporary with the original ceiling but was incorporated at a later date.

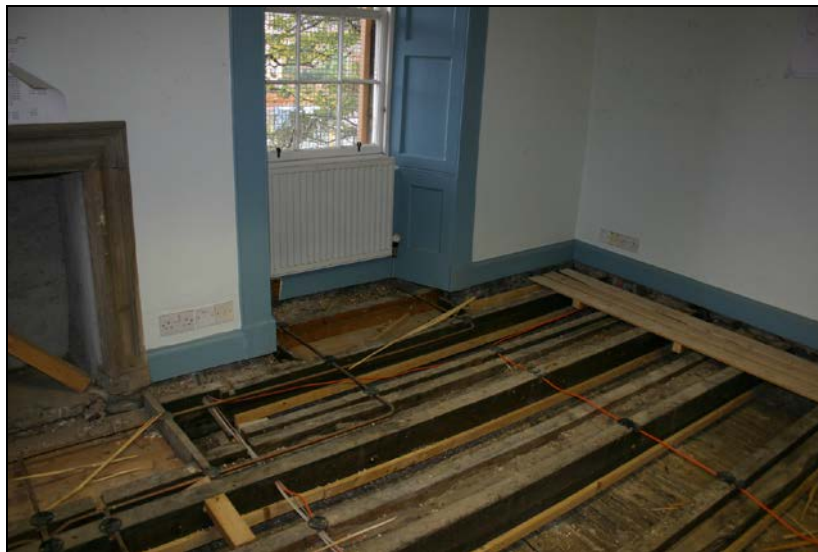
Axis 2

Item	Cross-sectional Dimension	Assembly Marks	Tool Marks	Redundant Features	Fixings
Joist (009) <sup>16</sup>	115mm x unascertainable	None	Adzed	Handmade nails <sup>17</sup>	None
Auxiliary Joist (010)	75 x 180mm	None	Machine-sawn (vertical kerbs)	Nail holes (top) <sup>18</sup>	Bolts <sup>19</sup>
Auxiliary Joist (011)	65 x 150mm	None	Machine-sawn (vertical kerbs)	Nail holes (top) <sup>20</sup>	Not ascertainable <sup>21</sup>
Auxiliary Joist (012)	50 x 65mm	None	Machine-sawn (vertical kerbs)	Nail holes (top) <sup>22</sup>	Nails (round head)
Furring Piece (013) <sup>23</sup>	66 x 45mm	None	Machine-sawn (vertical kerbs)	None	None
Furring Piece (014) <sup>24</sup>	65 x 10mm	None	Machine-sawn (vertical kerbs)	None	None

Nos. 009-011: View from northwest showing joist 009 and auxiliary joists 010-011 (second axis from left).

<sup>16</sup> Joist 009 is partially lowered by a range of 45mm in front of chimney. For interpretation, see FN 2.

<sup>19</sup> Bolts match those bolts found at axis 3, 10, 11, 15 and 16. Size of head 22 x 22mm. Joist bolted with six bolts set at a distance of c.820mm.

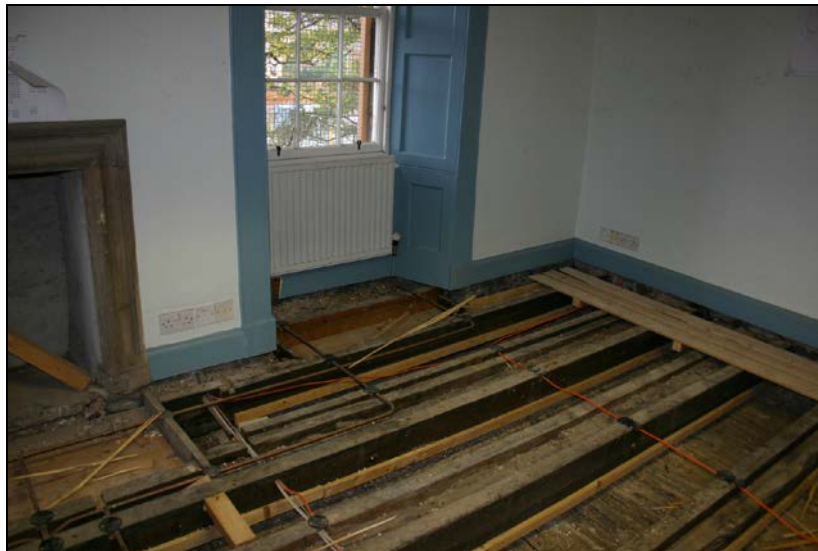
Axis 3

Item	Cross-sectional Dimension	Assembly Marks	Tool Marks	Redundant Features	Fixings
Joist (015)	130mm x unascertainable	None	Adzed	None	None
Auxiliary Joist (016)	75 x 180mm	None	Machine-sawn (vertical kerbs)	Nail holes (top) <sup>25</sup>	Bolts <sup>26</sup>
Auxiliary Joist (017)	65 x 150mm	None	Machine-sawn (vertical kerbs); hand-sawn (irregular kerbs) <sup>27</sup>	None	Nails (round shaft) <sup>28</sup>

Nos. 015-017: View from northwest showing joist 015 and auxiliary joists 016-017 (third axis from left).

<sup>27</sup> The sides of the joist are machine-sawn, the top is obviously hand-sawn.

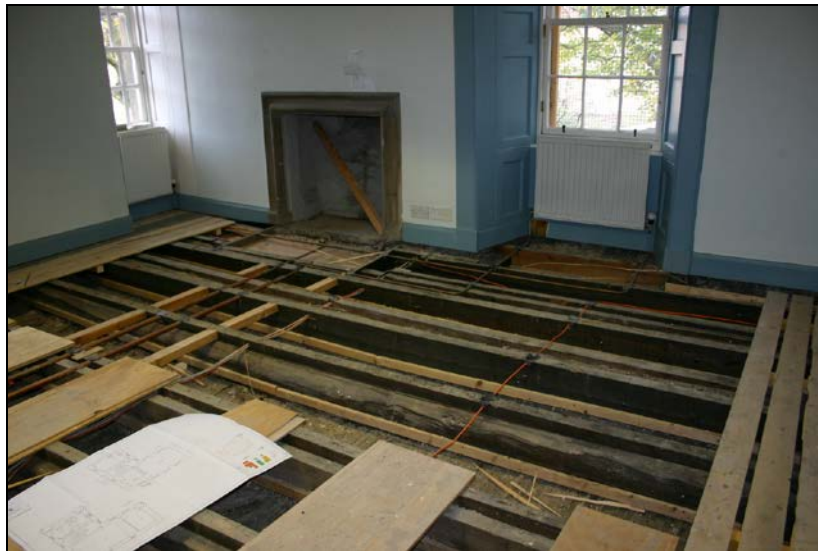
Axis 4

Item	Cross-sectional Dimension	Assembly Marks	Tool Marks	Redundant Features	Fixings
Joist (018)	175 x 200mm	None	Adzed	None	None
Furring Piece (019)	65 x 32-57mm	None	Machine-sawn (vertical kerbs)	Nail holes (top) <sup>29</sup>	Nails (round head) <sup>30</sup>

Nos. 018 and 019: View from northeast showing joist 018 and furring piece 019 (third axis from right).

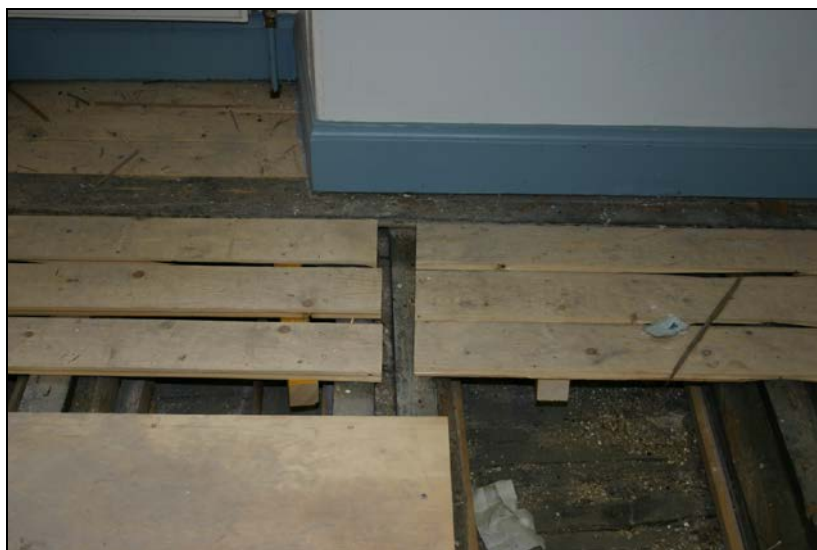
Axis 5

Item	Cross-sectional Dimension	Assembly Marks	Tool Marks	Redundant Features	Fixings
Joist (020)	130 x 190mm	None	Adzed	None	None
Auxiliary Joist (021)	65 x 150mm	None	Machine-sawn (vertical kerbs); hand-sawn (irregular kerbs) <sup>31</sup>	Nail holes (top) <sup>32</sup>	Nails (round head) <sup>33</sup>
Furring Piece (022) <sup>34</sup>	62 x 36-65mm	None	Machine-sawn (vertical kerbs)	Nail holes (top) <sup>35</sup>	Nails (round head) <sup>36</sup>

Nos. 020-022: View from south showing joist 020, auxiliary joist 021 and furring piece 022 (second axis from left).

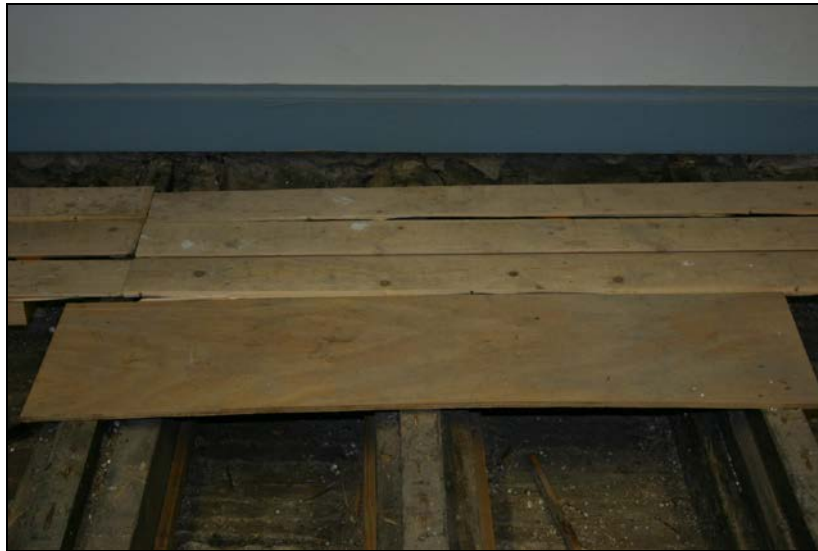
Axis 6

Item	Cross-sectional Dimension	Assembly Marks	Tool Marks	Redundant Features	Fixings
Joist (023)	160 x 205mm	None	Adzed	None	None
Furring Piece (024)	62 x 36-55 m	None	Machine-sawn (vertical kerbs)	Nail holes (top) <sup>37</sup>	Nails (round head) <sup>38</sup>

Nos. 023 and 024: View from north showing joist 023 and furring piece 024 (second axis from left).

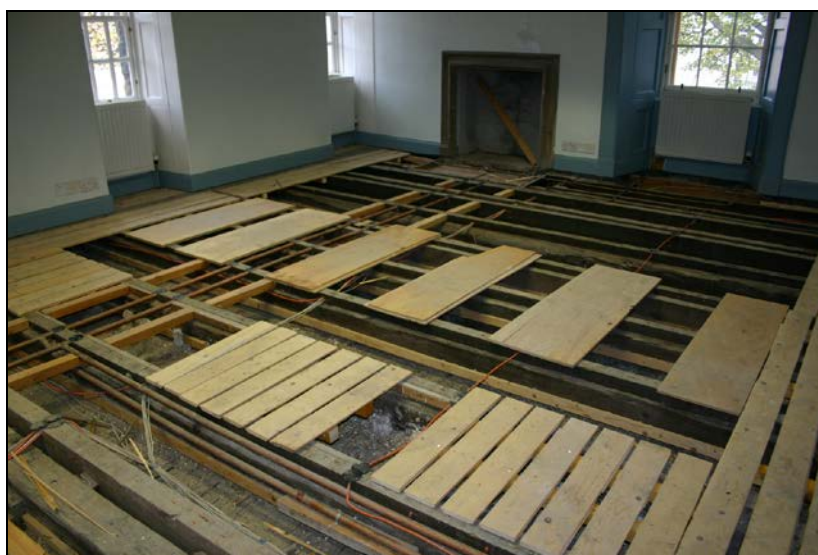
Axis 7

Item	Cross-sectional Dimension	Assembly Marks	Tool Marks	Redundant Features	Fixings
Joist (025)	140 x 190mm	None	Adzed	None	None
Furring Piece (026)	65 x 35-65mm	None	Machine-sawn (vertical kerbs)	Nail holes (top) <sup>39</sup>	Nails (round head) <sup>40</sup>
Auxiliary Board (027)	29 x 70-115mm	None	Sawn (irregular diagonal kerbs)	None	Nails (square shaft, handmade) <sup>41</sup>

Nos. 025 and 026: View from northwest showing of joist 025 and furring 026 (third axis from left).

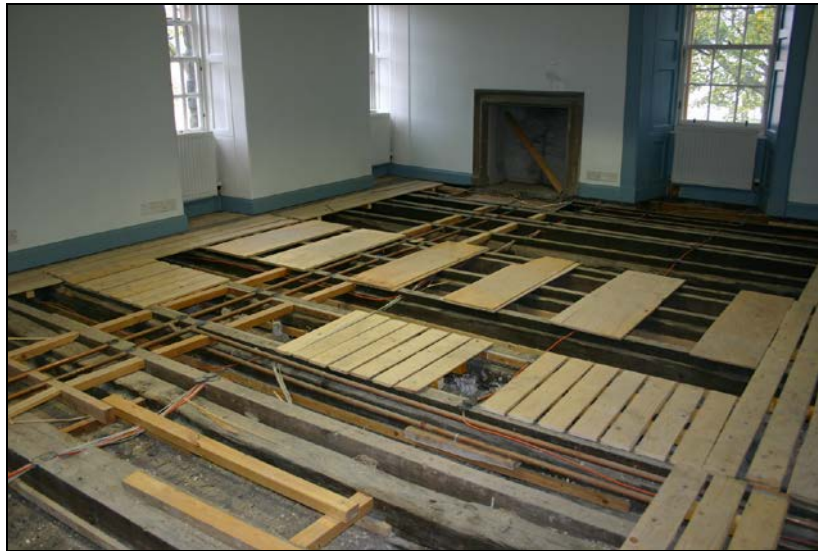
Axis 8

Item	Cross-sectional Dimension	Assembly Marks	Tool Marks	Redundant Features	Fixings
Joist (028)	165 x 180mm	None	Adzed	None	None
Furring Piece (029)	65 x 40-55mm	None	Machine-sawn (vertical kerbs)	Nail holes (top) <sup>42</sup>	Nails (round head) <sup>43</sup>

Nos. 028 and 029: View from northwest showing joist 028 and furring 029 (second axis from left).

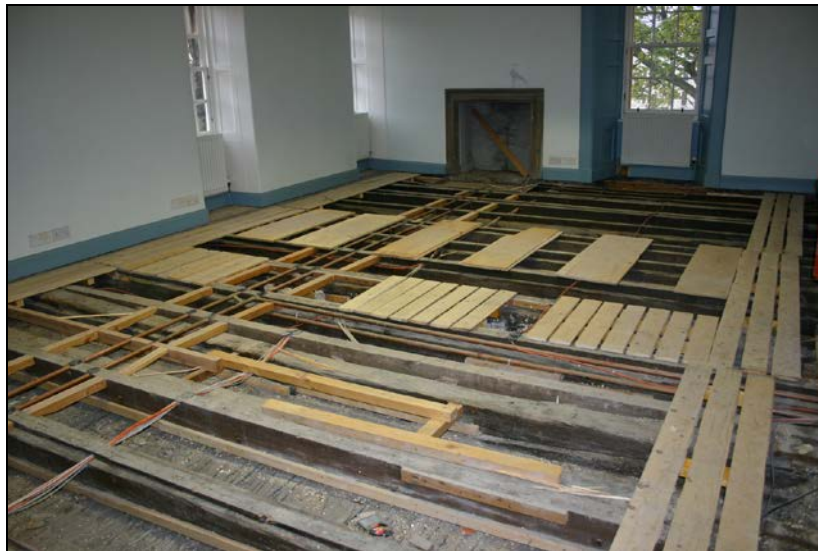
Axis 9

Item	Cross-sectional Dimension	Assembly Marks	Tool Marks	Redundant Features	Fixings
Joist (030)	175 x 195mm	None	Adzed	None	None
Furring Piece (031) <sup>44</sup>	65 x 30-62mm	None	Machine-sawn (vertical kerbs)	Nail holes (top) <sup>45</sup>	Nails (round head) <sup>46</sup>
Auxiliary Joist (032) <sup>47</sup>	60 x 170mm	None	Machine-sawn (vertical kerbs)	Nail holes (top) <sup>48</sup>	Nails (round head) <sup>49</sup>

No. 030: View from northwest showing joist 030 (second axis from left).

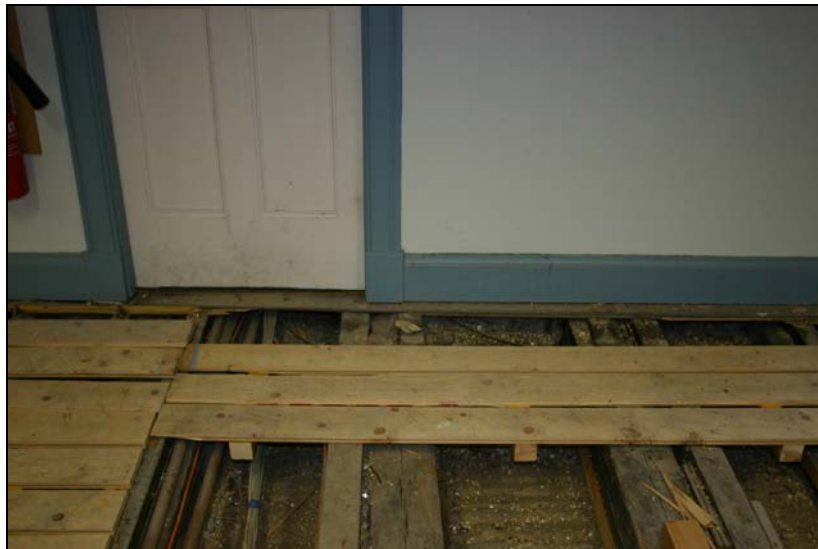
Axis 10

Item	Cross-sectional Dimension	Assembly Marks	Tool Marks	Redundant Features	Fixings
Joist (033)	150 x 220mm	None	Adzed	3 holes (top) <sup>50</sup>	None
Auxiliary Joist (034)	75 x ca. 180mm	None	Machine-sawn (vertical kerbs)	Nail holes (top) <sup>51</sup>	Bolts <sup>52</sup>
Furring Piece (035) <sup>53</sup>	65 x 25mm	None	Machine-sawn (vertical kerbs)	None	None
Auxiliary Board (036) <sup>54</sup>	35 x 115mm	None	Sawn (irregular diagonal kerbs)	None	Nails (square shaft, handmade)
Auxiliary Board (037) <sup>55</sup>	25 x 80mm	None	Sawn (irregular diagonal kerbs)	None	Nails (square shaft, handmade)

Nos. 033 and 034: View from north showing joist 033 and auxiliary joist 034 (second axis from right).

<sup>50</sup> Hole 1: square cross-section, c.20 x 22mm, depth: c.30mm; hole 2: round cross-section, diameter c.18mm, depth c.35mm; hole 3: round cross-section, diameter c.18mm, depth c.35mm.

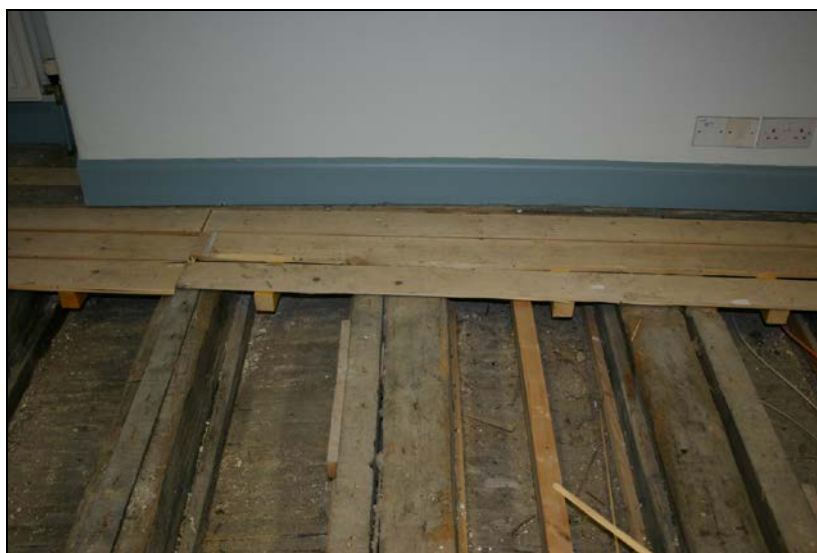
Axis 11

Item	Cross-sectional Dimension	Assembly Marks	Tool Marks	Redundant Features	Fixings
Joist (038)	150 x 210mm	None	Adzed	None	None
Auxiliary Joist (039)	75 x 165mm	None	Machine-sawn (vertical kerbs)	Nail holes (top) <sup>56</sup>	Bolts <sup>57</sup>
Furring Piece (040) <sup>58</sup>	65 x 18mm	None	Machine-sawn (vertical kerbs)	None	None

Nos. 038 and 039: View from south showing joist 038 and auxiliary joist 039 (second axis from left).

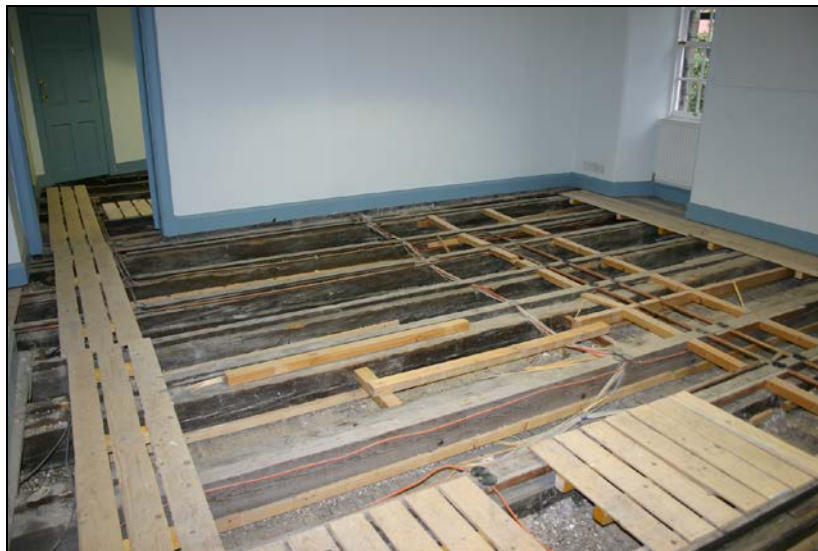
Axis 12

Item	Cross-sectional Dimension	Assembly Marks	Tool Marks	Redundant Features	Fixings
Joist (041)	145 x 220mm	None	Adzed	None	None
Furring Piece (042) <sup>59</sup>	65 x 38mm	None	Machine-sawn (vertical kerbs)	Nail holes (top) <sup>60</sup>	Nails (round head) <sup>61</sup>
Auxiliary Board (043) <sup>62</sup>	28 x 70mm	None	Sawn (irregular diagonal kerbs)	None	Nails (square shaft, handmade)

Nos. 041 and 042: View from southeast showing joist 041 and furring 042 (fourth axis from left).

<sup>59</sup> Furring piece 042 is composed of five layers of "strips" ranging in thickness between 8 and 15mm.

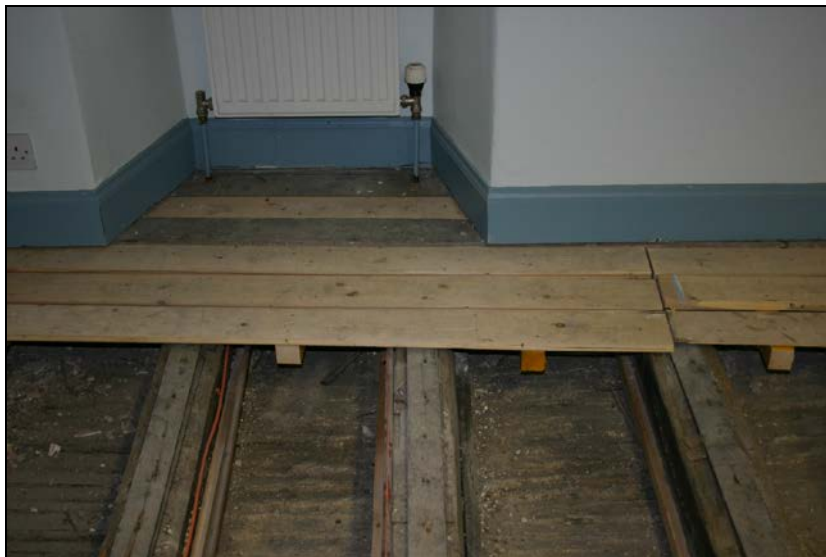
Axis 13

Item	Cross-sectional Dimension	Assembly Marks	Tool Marks	Redundant Features	Fixings
Joist (044)	120 x 230mm	None	Adzed	None	None
Furring Piece (045) <sup>63</sup>	65 x 35mm	None	Machine-sawn (vertical kerbs)	Nail holes (top) <sup>64</sup>	Nails (round head) <sup>65</sup>
Auxiliary Board (046)	30 x 40-90mm	None	Sawn (irregular diagonal kerbs)	None	Nails (square shaft, handmade)

Nos. 044, 045 and 046: View from south showing joist 044, furring 045 and auxiliary board 046 (second axis from left).

<sup>63</sup> Furring piece 045 is composed of three layers of 'strips' ranging in thickness between 8 and 15mm.

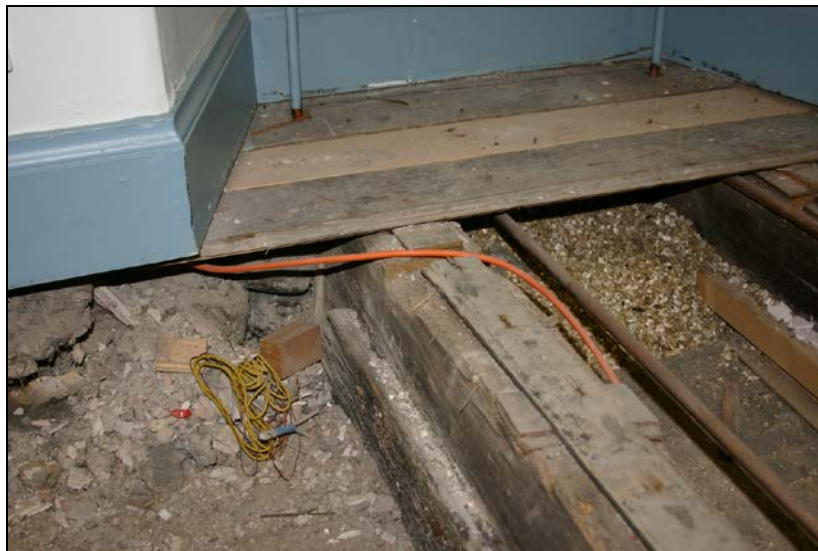
Axis 14

Item	Cross-sectional Dimension	Assembly Marks	Tool Marks	Redundant Features	Fixings
Joist (047)	130 x 230mm	None	Adzed	None	None
Furring Piece (048) <sup>66</sup>	60 x 32mm	None	Machine-sawn (vertical kerbs)	Nail holes (top) <sup>67</sup>	Nails (round head) <sup>68</sup>
Auxiliary Board (049) <sup>69</sup>	70 x 28mm	None	Sawn (irregular diagonal kerbs)	None	Nails (square shaft, handmade)

Nos. 047, 048 and 049: View from south showing joist 047, furring 048 and auxiliary board 049 (second axis from right).

<sup>66</sup> Furring piece 048 is composed of three layers of 'strips' ranging in thickness between 8 and 150mm.

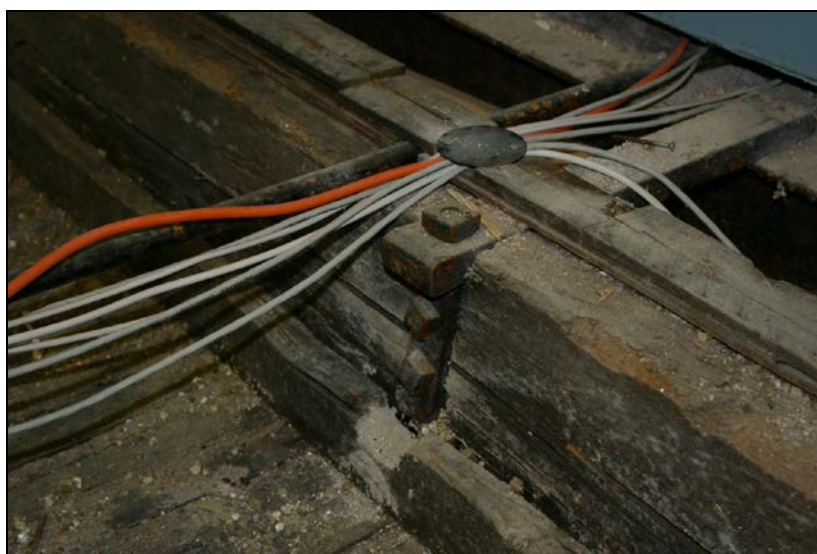
Axis 15

Item	Cross-sectional Dimension	Assembly Marks	Tool Marks	Redundant Features	Fixings
Joist (050) <sup>70</sup>	155 x 215mm	None	Adzed	None	None
Furring Piece (051)	62 x ca. 2 – 8mm	None	Machine-sawn (vertical kerbs)	Nail holes (top) <sup>71</sup>	Nails (round head) <sup>72</sup>
Auxiliary Board (052)	30 x ca. 100mm	None	Sawn (irregular diagonal kerbs)	None	Nails (square shaft, handmade)
Board (053) <sup>73</sup>	30 x 70mm	None	Sawn	None	Unascertainable
Board (054) <sup>74</sup>	30 x 70mm	None	Sawn	None	Unascertainable
Board (055) <sup>75</sup>	30 x 70mm	None	Sawn	None	Unascertainable
Board (056) <sup>76</sup>	30 x 110mm	None	Sawn	Nails (square shaft)	Unascertainable

Nos. 050, 051 and 052: View from northwest showing joist 050, furring 051 and auxiliary board 052.

<sup>70</sup> Joist 15 (050) is linked to joist 16 (057) by means of a metal bracket that is fastened to both joists with bolts that are identical to those employed at joists 2, 3, 10 and 11. The bracket serves as load-bearing substructure for a partition wall that divides the formerly undivided space into two rooms.

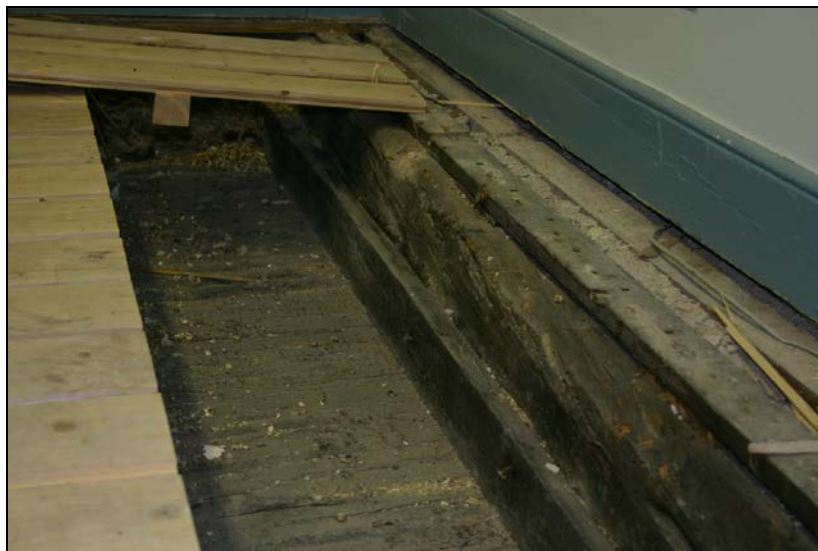
Axis 16

Item	Cross-sectional Dimension	Assembly Marks	Tool Marks	Redundant Features	Fixings
Joist (057) <sup>77</sup>	145 x 210mm	None	Adzed	None	None
Furring Piece (058) <sup>78</sup>	62 x 25mm	None	Machine-sawn (vertical kerbs)	Nail holes (top) <sup>79</sup>	Nails (round head) <sup>80</sup>
Auxiliary Board (059)	ca. 30 x ca. 100mm	None	Sawn (irregular diagonal kerbs)	None	Nails (square shaft, handmade) <sup>81</sup>

Nos. 057, 058 and 059: View from southwest showing of joist 057, furring 058 and auxiliary board 059.

<sup>78</sup> The furring piece consists of four parts. Length of part a: 760mm, length of part b: 1520mm, length of part c: 1290mm, length of part d: 500mm.

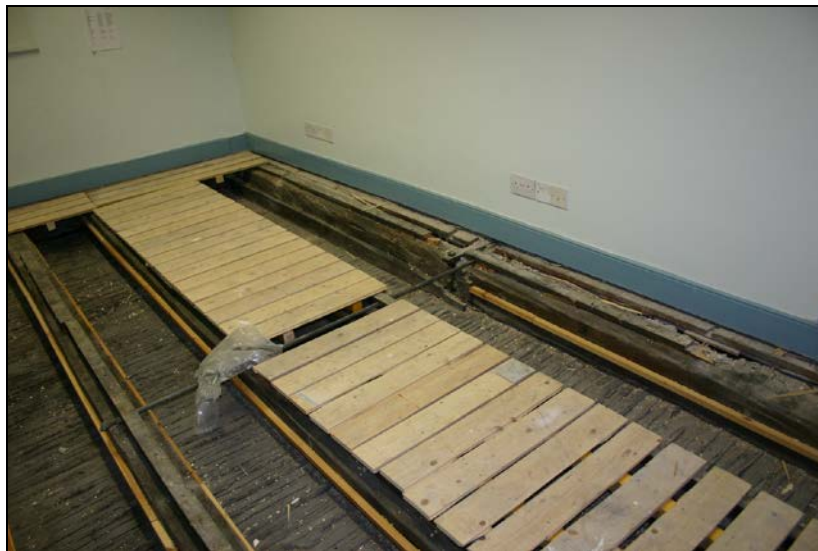
Axis 17

Item	Cross-sectional Dimension	Assembly Marks	Tool Marks	Redundant Features	Fixings
Joist (060)	145 x 205mm	None	Adzed	None	None
Furring Piece (061) <sup>82</sup>	52 x 57mm	None	Machine-sawn (vertical kerbs)	Nail holes (top) <sup>83</sup>	Nails (round head) <sup>84</sup>
Auxiliary Board (062) <sup>85</sup>	25 x ca. 150mm	None	Sawn (irregular diagonal kerbs)	None	Nails (square shaft, handmade)

Nos. 060 and 061: View from southwest showing joist 060 and furring 061 (second axis from right).

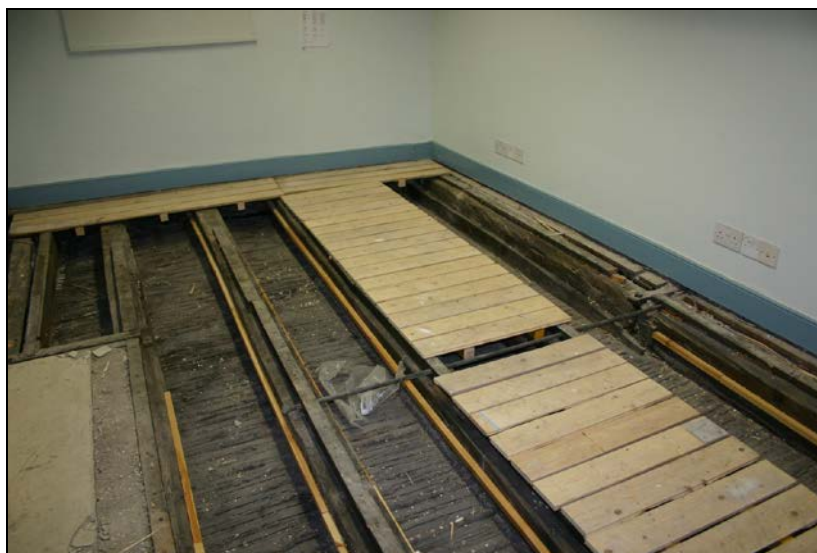
Item	Cross-sectional Dimension	Assembly Marks	Tool Marks	Redundant Features	Fixings
Joist (063)	140 x 155mm	None	Adzed	None	None
Furring Piece (064) <sup>86</sup>	65 x 28-48mm	None	Machine-sawn (vertical kerbs)	Nail holes (top) <sup>87</sup>	Nails (round head) <sup>88</sup>
Furring Piece (065) <sup>89</sup>	Unascertainable	Unascertainable	Unascertainable	Unascertainable	Unascertainable

Nos. 063 and 064: View from southwest showing joist 063 and furring 064 (third axis from right).

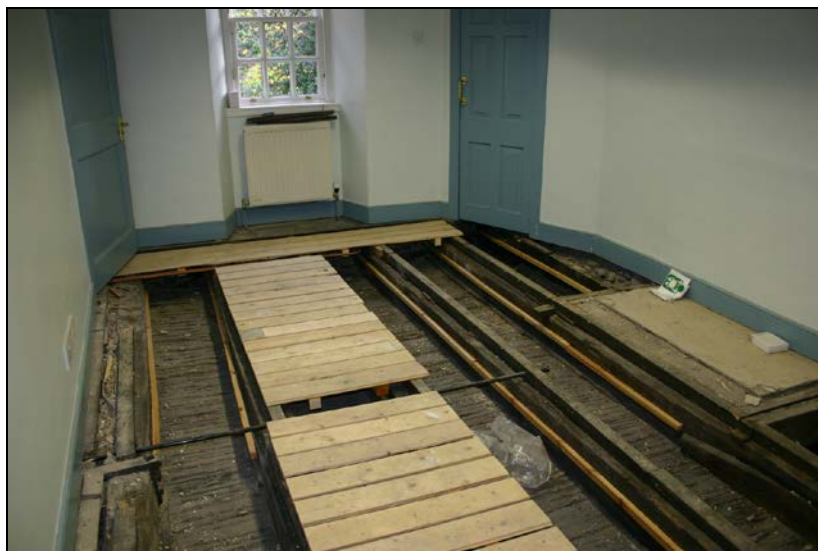
Item	Cross-sectional Dimension	Assembly Marks	Tool Marks	Redundant Features	Fixings
Joist (066)	135 x 215mm	None	Adzed	None	None
Furring Piece (067) <sup>90</sup>	65 x 25-55mm	None	Machine-sawn (vertical kerbs)	Nail holes (top) <sup>91</sup>	Nails (round head) <sup>92</sup>
Furring Piece (068) <sup>93</sup>	55 x 55-68mm	None	Machine-sawn (vertical kerbs)	Nail holes (top) <sup>94</sup>	Nails (round head) <sup>95</sup>

Nos. 066 and 067: View from north showing joist 066 and furring 067 (fourth axis from left).

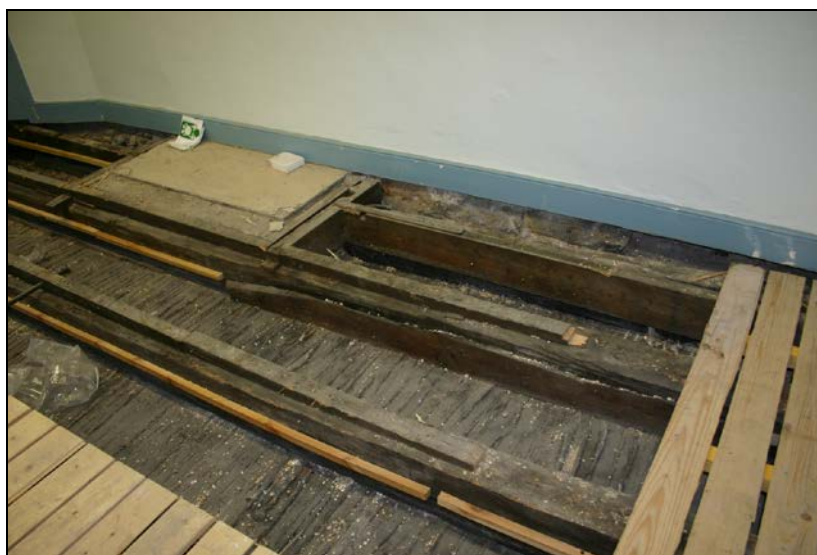
Item	Cross-sectional Dimension	Assembly Marks	Tool Marks	Redundant Features	Fixings
Joist (069)	150 x 215mm	None	Adzed	None	None
Furring Piece (070) <sup>96</sup>	67 x 20mm 65 x 38-55mm 52 x 58mm 50 x 60mm	None	Machine-sawn (vertical kerbs)	Nail holes (top) <sup>97</sup>	Nails (round head) <sup>98</sup>
Furring Piece (071) <sup>99</sup>	65 x 38-55mm	Unascertainable	Unascertainable	Unascertainable	Unascertainable
Auxiliary Board (072) <sup>100</sup>	15 x 140mm	None	Sawn (irregular diagonal kerbs)	None	Nails (square shaft, handmade)

Nos. 069, 070, 071, 075 and 076: View from northeast showing joist 069, furring 070, auxiliary board 071 and trimmers 075 and 076 (second axis from right).

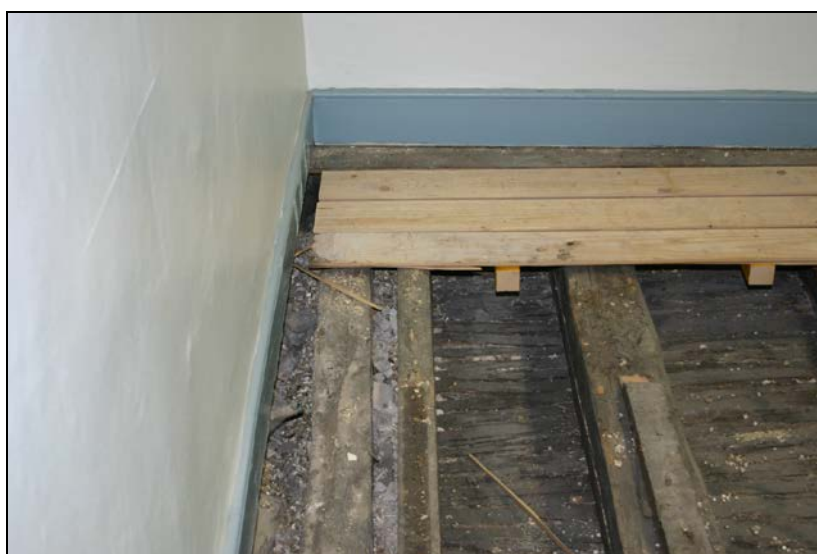
Item	Cross-sectional Dimension	Assembly Marks	Tool Marks	Redundant Features	Fixings
Joist (073)	100 x 175mm	None	Adzed	None	None
Auxiliary Joist (074) <sup>101</sup>	65 x 170mm	None	Sawn (regular vertical kerbs)	Nail holes (top) <sup>102</sup>	Nails (square shaft)
Auxiliary Joist (075) <sup>103</sup>	65 x 170mm	None	Sawn (regular vertical kerbs)	Nail holes (top) <sup>104</sup>	Nails (square shaft)
Trimmer (076)	65 x 168mm	None	Machine-sawn (vertical and circular kerbs)	Notch <sup>105</sup>	None
Trimmer (077)	65 x 168mm	None	Machine-sawn (vertical and circular kerbs)	Notch <sup>106</sup>	None

Nos. 073 and 075: View from south showing joist 073 and auxiliary joist 075 (first axis from left).

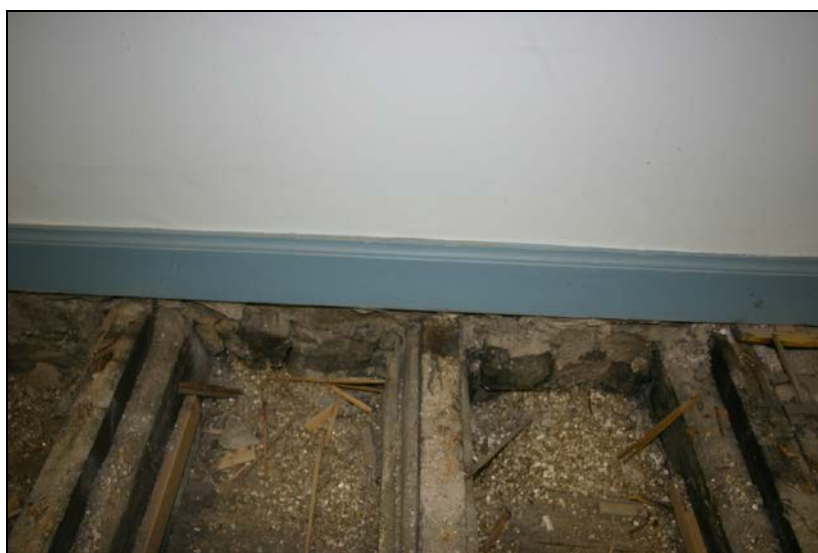
Item	Cross-sectional Dimension	Assembly Marks	Tool Marks	Redundant Features	Fixings
Joist-stump (078)	140 x 150mm	Not ascertainable	Not ascertainable <sup>107</sup>	None	None
Joist-stump (079)	140 x 150mm	Not ascertainable	Not ascertainable <sup>108</sup>	None	None

**Nos. 078 and 079:** View from north showing joist-stumps 078 and 079.
