**Croft-an-Righ: Archaeological Survey, November 2011.**

**DESCRIPTION:** Archaeological survey of exposed timbers over a 17<sup>th</sup>-century ceiling below.

**PROJECT CODE:** HSCO-90131-2012-01

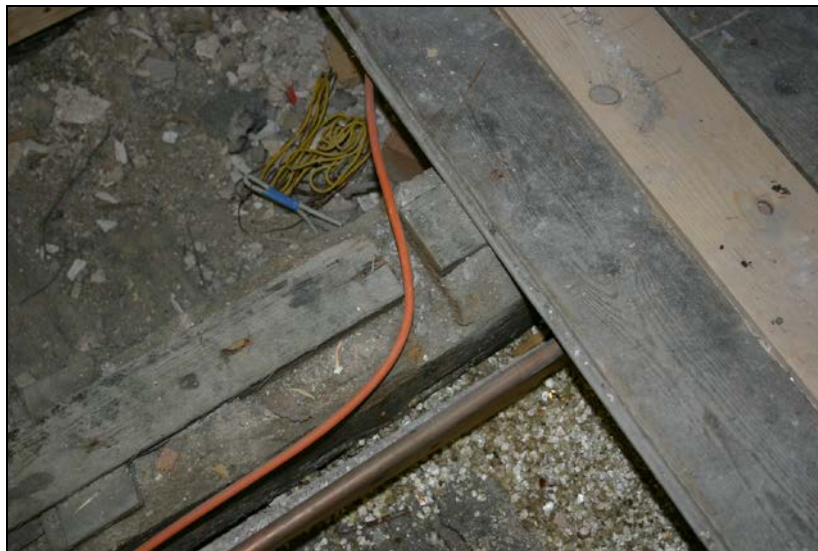
Item	Cross-sectional Dimension	Assembly Marks	Tool Marks	Redundant Features	Fixings
Floorboard (080)	113 x 20mm	None	Machine-sawn	None	Modern Nails

No. 080: View from northeast showing floor-board 080 at axis 14.

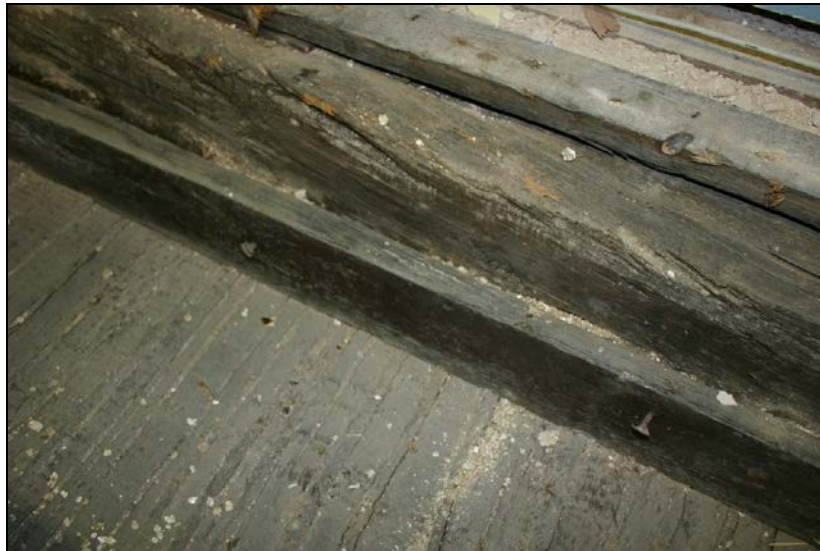
Item	Cross-sectional Dimension	Assembly Marks	Tool Marks	Redundant Features	Fixings
Laths (081)	20 – 80mm x unascertainable	None	Split	None	Not ascertainable

No. 081: View from northeast showing lathwork 081 at axis 16.
