**HISTORIC SCOTLAND PROPERTIES IN CARE
MINOR ARCHAEOLOGICAL WORKS 2012**

Elcho Castle: Watching Brief, May 2012

SITE: Elcho Castle, Perthshire

DESCRIPTION: Watching Brief during the excavation of a trench to house new signage on the NE side of the car park

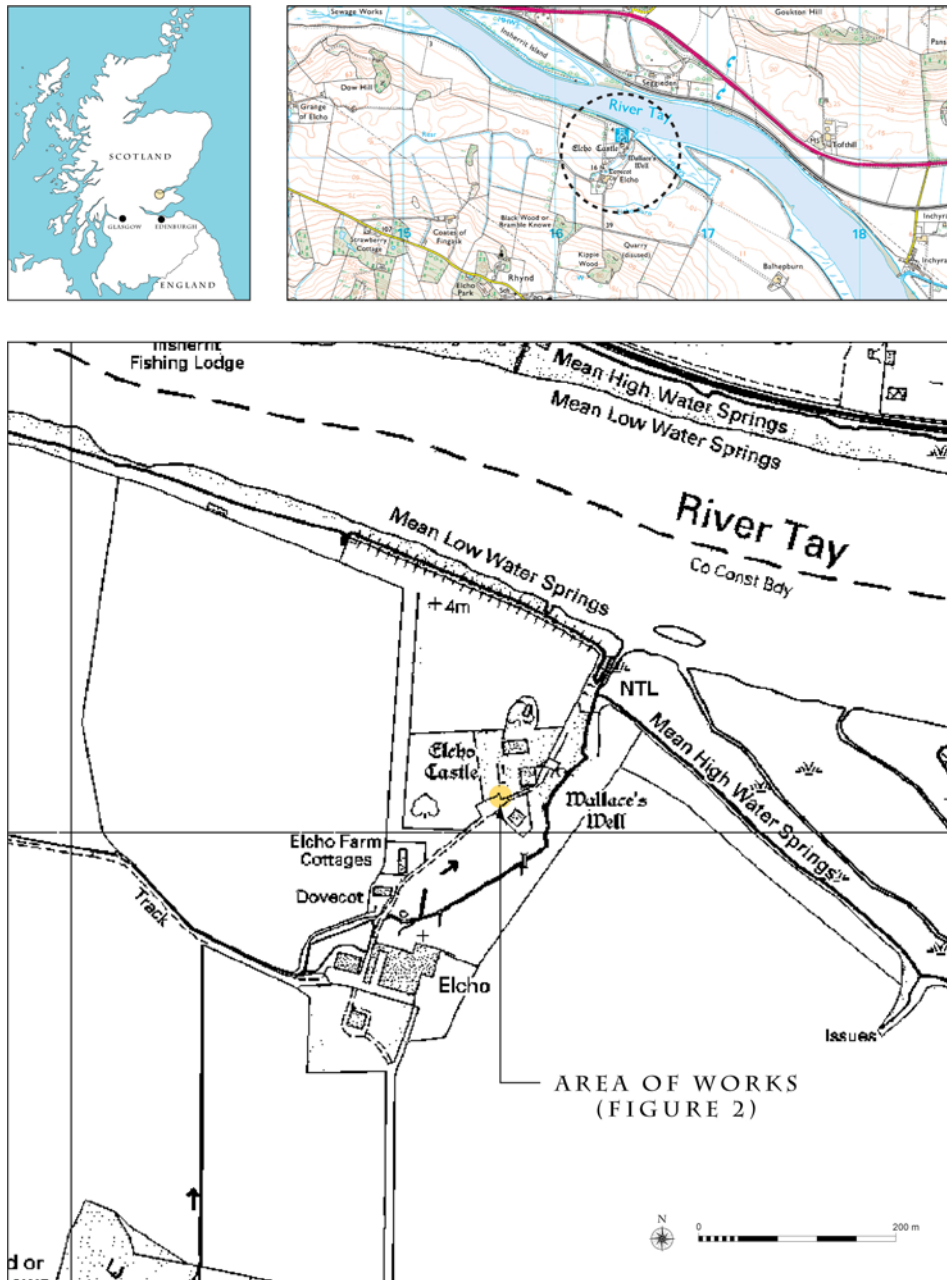
Figure 1: Plan showing the location of Elcho Castle, and the area of works.
Inset Nos. 2 and 3 © Crown copyright. All rights reserved 2012. Licence number 100036933.

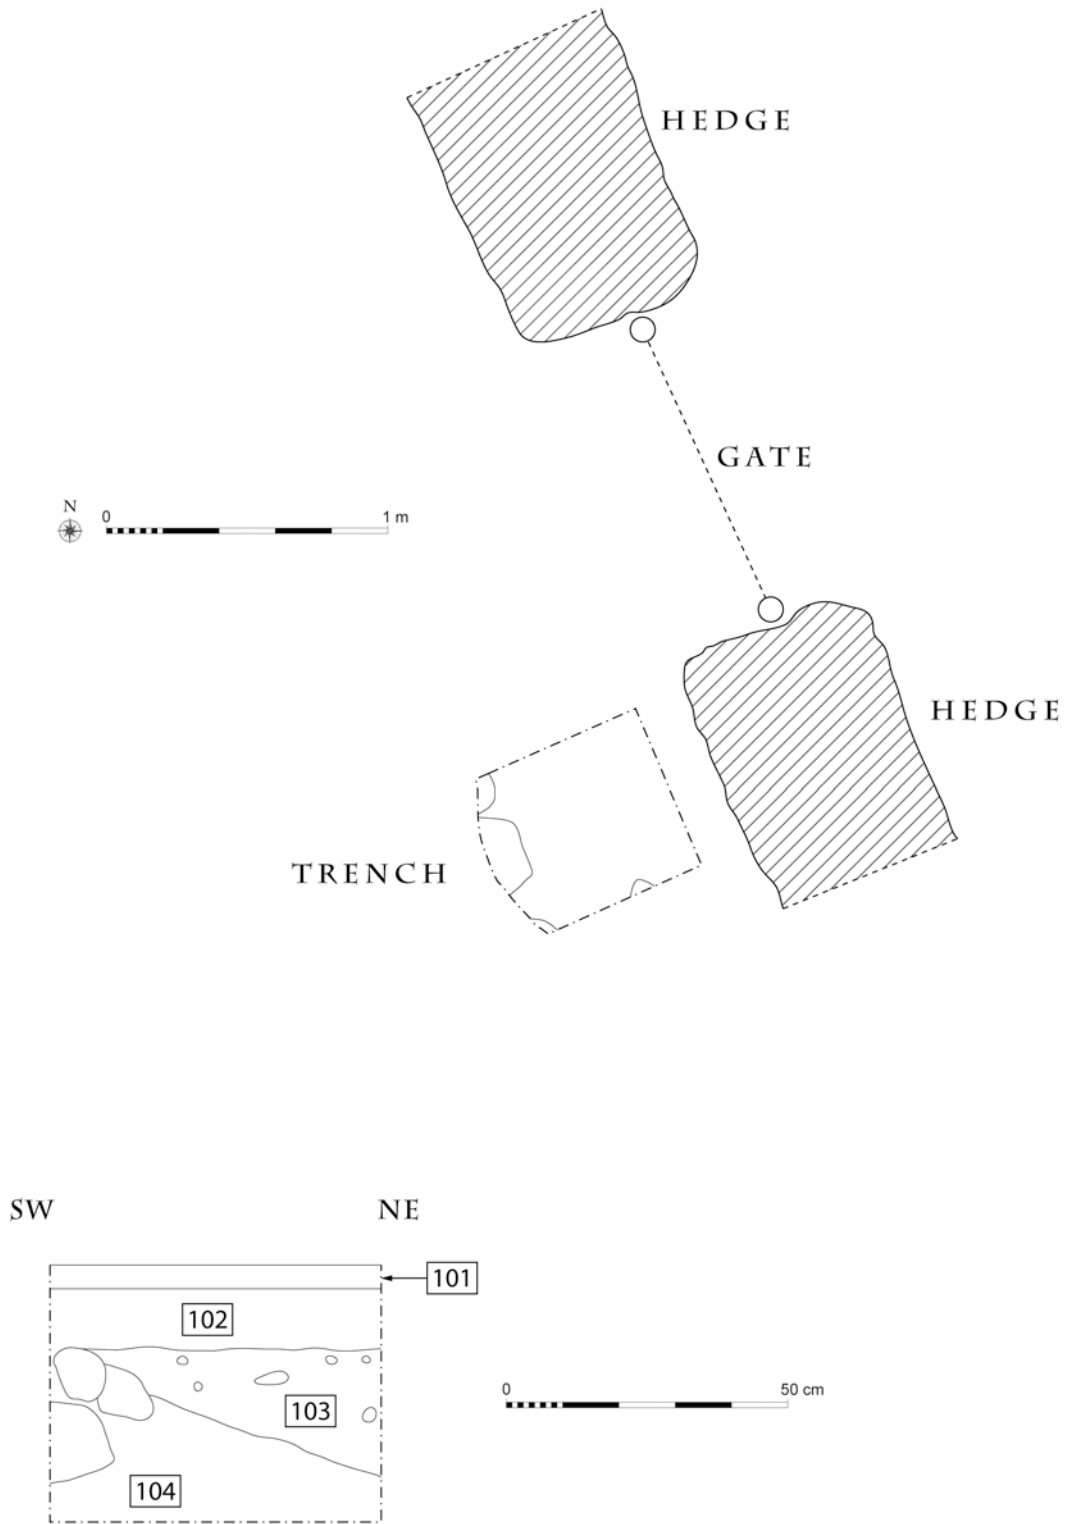
The trench measured 0.6m NW/SE x 0.68m NE/SW x 0.45m deep. The car park hard standing consisted of a layer of pea gravel 101, some 0.04m thick, overlying a 0.1m thick layer of greyish Type 2 stone with finings (102). Below this layer was a layer of compact orange-brown clay (103), up to 0.25m thick to the NE. This rose to the SW to meet the upper portion of the layer below, a stony grey silty clay (104), flecked with charcoal. The presence of charcoal and the general re-deposited feel of the layers suggested that both 103 and 104 were earlier landscaping layers, possibly associated with levelling of the ground surrounding the castle courtyard. No artefacts were retrieved that may have helped to indicate a date for this levelling.

The excavation reached the required depth of 0.45m without encountering any further archaeological deposits.

Figure 2: Post-excitation plan (top) and SE-facing section

Although nothing of archaeological interest was uncovered during this particular period of work, the presence of outworks and the possibility of buried external structures suggests that any further ground-breaking works should be accompanied by an archaeological watching brief.

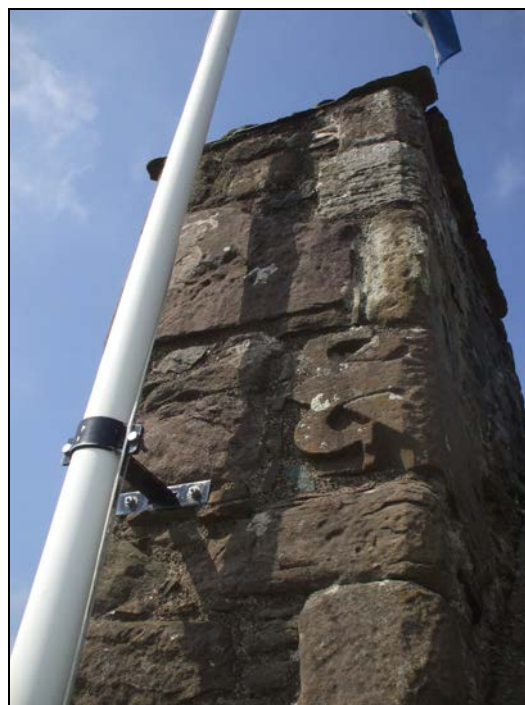
A previously unrecognised carved, re-used stone, was noted on the E side of the S chimney of the entrance tower (Figs. 3 and 4). The design bore certain similarities to the *fleur-de-lis* decoration on the 16th Century plasterwork within the tower house, but was not identical. The sandstone block on which it sat was a substantial piece of masonry, and it is therefore unlikely to be part of an armorial, and was originally probably part of a larger decorative scheme. Tool marks were visible on the NE corner, where the design had been clawed-back.

Figure 3: The carved stone

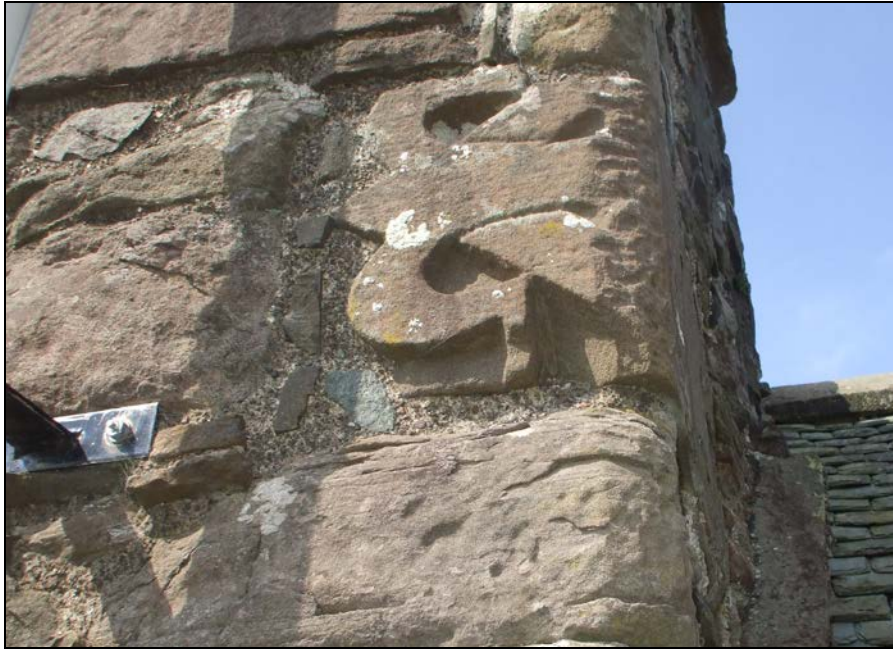
Figure 4: The carved stone (close-up)
