**HISTORIC SCOTLAND PROPERTIES IN CARE
MINOR ARCHAEOLOGICAL WORKS 2012**

Elgin Cathedral: Watching Brief, June 2012

SITE: Elgin Cathedral

DESCRIPTION: Watching Brief during the excavation of a trench to house new signage inside the entrance gateway to the W of the cathedral

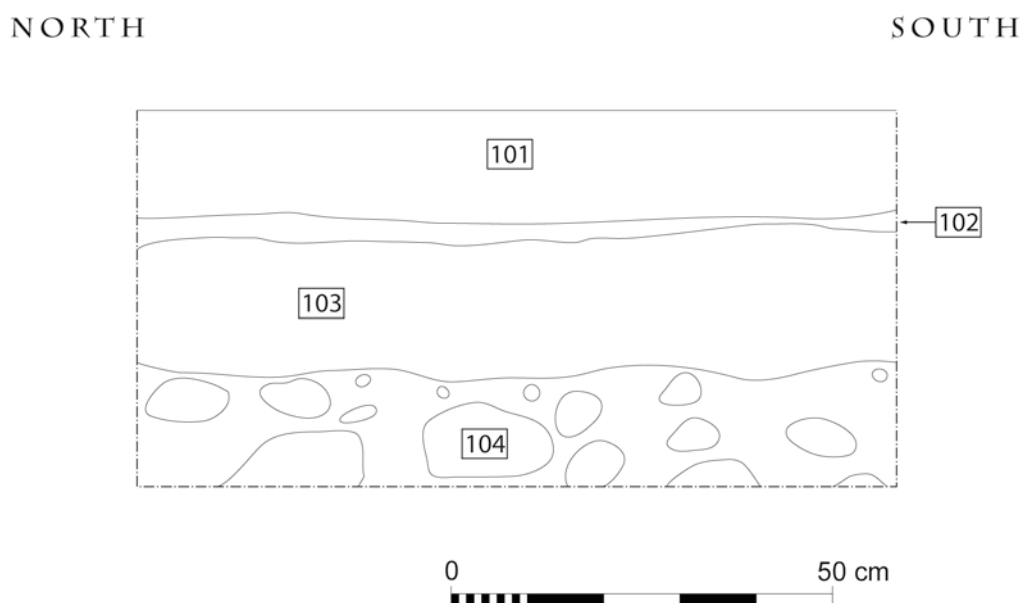
Figure 2: W-facing sections in Trench 1

Trench 1 measured 1m N/S x 0.6m E/W x 0.5m deep. The S edge of the trench lay 4.5m from the N door of the ticket office, the trench itself lying on the grass verge on the E side of the path, some 0.2m in from the path edging. The turf and mid-brown silty topsoil **101** was 0.15m thick, and had been bedded on a thin base of sand **102**, some 2-3cm thick.

Below this modern landscaping was an earlier, probably mid-19th century, capping of dark brown silt **103**, up to 15cm thick, containing white glazed transfer-printed pottery and pieces of bottle glass. This was a levelling layer over **104**, a layer of mixed make-up comprising pieces of broken sandstone in a mid-brown silty matrix, containing mortar flecks, charcoal, and pieces of disarticulated human bone. This layer seems to be associated with the general landscaping of the site and demolition of subsidiary buildings of the cathedral precinct that

took place between 1847 and 1868. The disarticulated human bone fragments (including a piece of human skull) were re-buried once the excavation had reached its required depth.
