Newark Castle • Watching Brief • August 2012

SITE: Newark Castle, Port Glasgow

DESCRIPTION: Watching Brief during the excavation of a trench to house new signage inside the modern entrance gateway to the SW of the castle

PROJECT CODE: HSCO-90230-2012-01

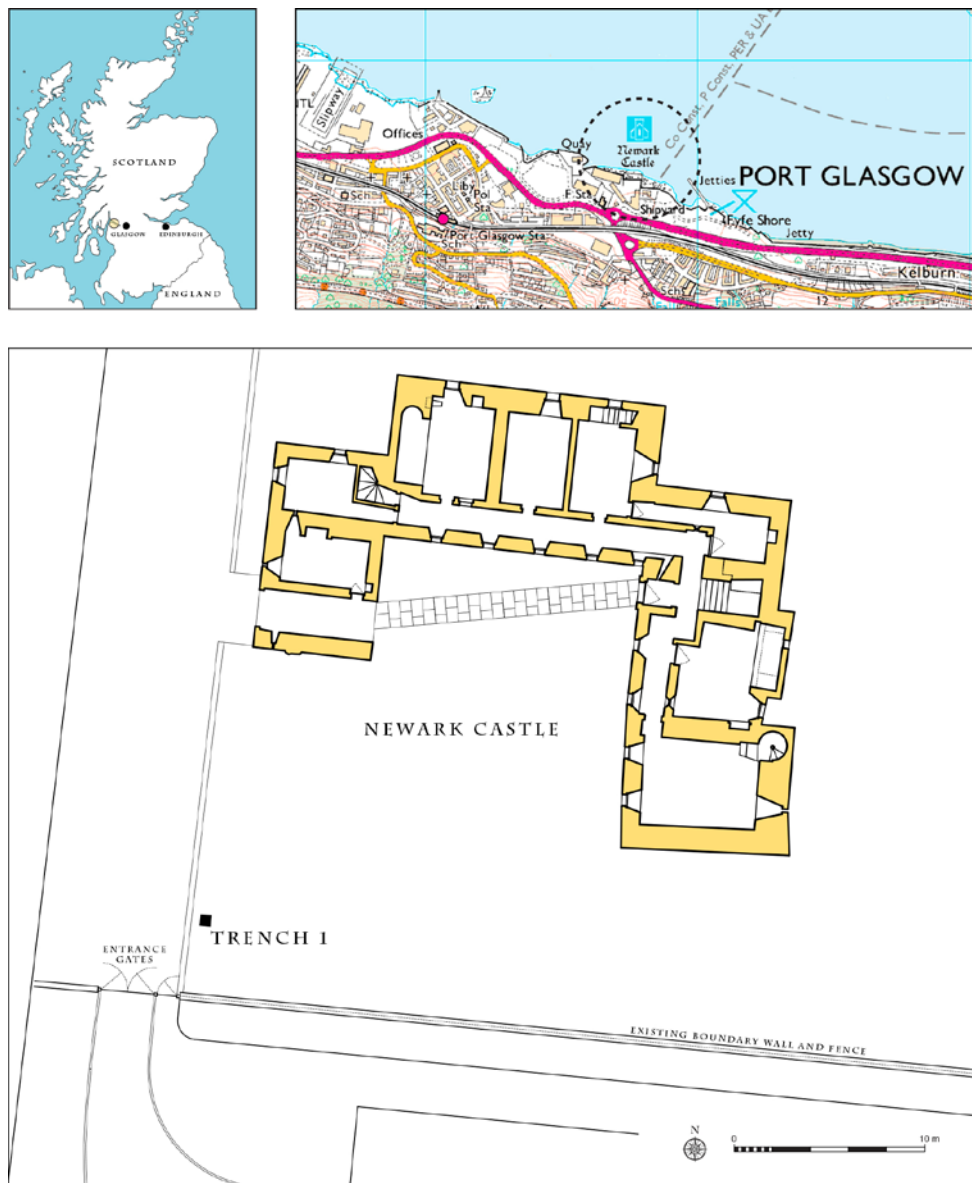
Under the terms of its PIC Call-Off contract with Historic Scotland, Kirkdale Archaeology was asked to undertake an archaeological watching brief at Newark Castle during the excavation of a trench to house a new information board. The trench was located on the E side of the path running N from the modern gated entrance (Fig.1).

Figure 1: Plan showing the location of Newark Castle, and the area of works.
Inset No. 2 © Crown copyright. All rights reserved 2012. Licence number 100036933.
