HISTORIC SCOTLAND PROPERTIES IN CARE MINOR ARCHAEOLOGICAL WORKS 2015/2016

Blackness Castle • Watching Brief • July 2015

HS PIC Index Number: 90036

SITE:	Blackness Castle, near Blackness.
N.G.R.:	NT 055 822
DESCRIPTION:	Archaeological watching brief during the installation of three lectern-style interpretation panels.
PROJECT CODE:	HSCO-90036-2015-01
CONTENTS:	Introduction1
	Description2
	Conclusions5
	List of Contexts8
	List of Drawings8
	List of Digital Photographs9
	List of Finds9

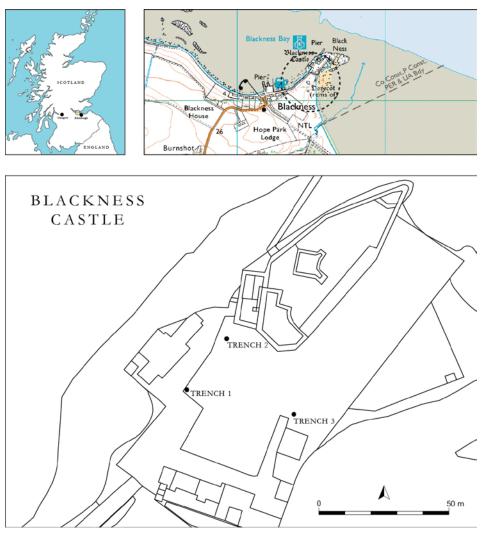
Figure 1: Plan showing the general locations of the trenches. Inset No. 2 © Crown copyright. All rights reserved 2015. Licence number 100036933.

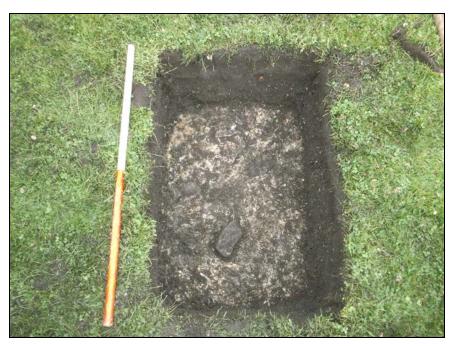
The removal of deposit **009** revealed **010**, a rubble construction bonded with a cream coloured lime mortar covering the entire trench at a depth of *c*.0.31m. The material was hard-packed and structural in nature, likely the foundation of a wall. The *c*.1690 'Military Plan of the Castle of Blackness' shows the northern corner of a garden wall in this location. The presence of the wall was at a depth unsuitable for the foundations of the new lectern, so in order to protect the wall and provide a trench with adequate depth, the location of BKN01 was moved *c*.1m to the northeast; and the secondary trench's cut was designated **011**.

Plate 1: Post-excavation view of the initial Trench 1, showing the wall 010.

Trenches 2 and 3 revealed evidence of gardening and ground levelling respectively. Trench 1 exposed the remnants of a wall known from a 17th century military plan. Due to the presence of an archaeological feature of some significance, the location of the trench was moved to the northeast. The presence of the remnants of this wall suggests that caution should be exercised should any further ground breaking works in this area be considered, especially given the shallow depth at which the archaeology was encountered (*c*.0.3m).

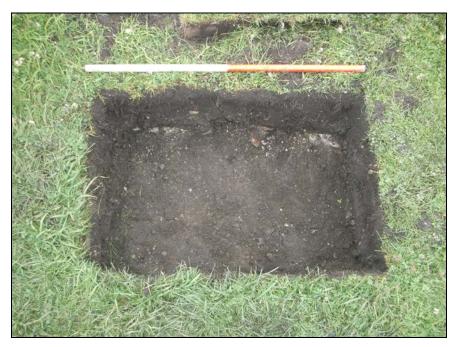
The cut for the repositioned trench measured 0.95m NW/SE x 0.65m NE/SW x 0.45m. The topsoil **001** was removed; it extended to a depth of 12 - 18cm across the trench. Below **001** was deposit **013**, a dark brown/black rubble filled loose silty-sandy soil 0.27m deep. This deposit contained a large amount of stone rubble (typically) measuring *c*.20cm x 15cm x 10cm, along with gravel, smaller stones and crumbling lime mortar. As this deposit was removed, a fragment of ceramic pipe (**SF007**) within the mortar was

revealed in the northwestern section. The lime mortar in deposit **013** is likely related to this, and the entire deposit may be the disturbed rubble backfill from the pipe's installation.

The excavation of **013** exposed deposit **014**, a mid-grey/brown gravel rich sandy soil. This deposit was revealed to a depth of 0.45m (at which point the limit of excavation was reached); it appeared to be a clean deposit and likely represents the natural subsoil layer.

Plate 2: Post-excavation view of the relocated Trench 1.

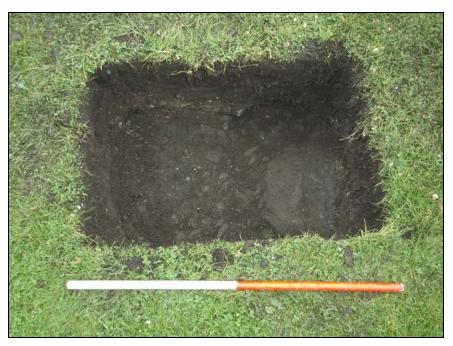
The cut for Trench 2 was designated **004** and measured 0.99m NW/SE x 0.68m NE/SW x 0.48m. The turf and topsoil **001** was removed and was revealed to be *c*.15cm deep. Below **001** was a dark black/brown silty-sandy soil, **006**, which closely resembled the topsoil but with a greater number of small stony inclusions.

The removal of **006** exposed a mid-grey loose sandy gravel and stone layer, **003**. This deposit was filled with stones (typically) measuring c.15cm x 10cm x 5cm, along with smaller stony inclusions and some possible lime mortar debris. The deposit's depth varied between 15 - 20cm, and it seems likely to be a levelling layer related to **007**, the natural bedrock and dark-brown gravel rich soil deposit below. This may be connected to the 19th century levelling of the area, ahead of the creation of a military parade ground.

Plate 2: Post-excavation view of Trench 2.

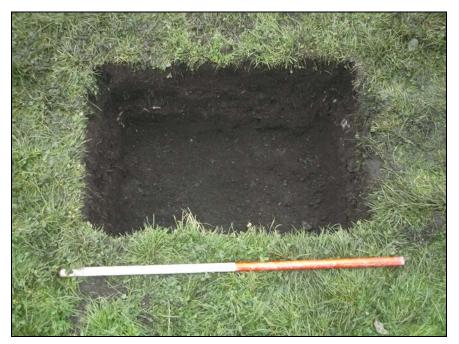
The cut for Trench 3 was designated **005** and was located close to the original lectern sign; it measured 0.99m NE/SW x 0.67m NW/SE x 0.44m. The topsoil and turf **001** measured *c*.15cm deep, and immediately below, **008** was a loose silty black soil containing fragments of bone and ceramic. This was a humic soil and thus likely to be a garden soil deposit (Trench 3 is located in an area of known gardens and the deposits revealed were in line with expectations). The cut for the trench did not reach as far as the base of **008**.

Plate 3: Post-excavation view of Trench 3.

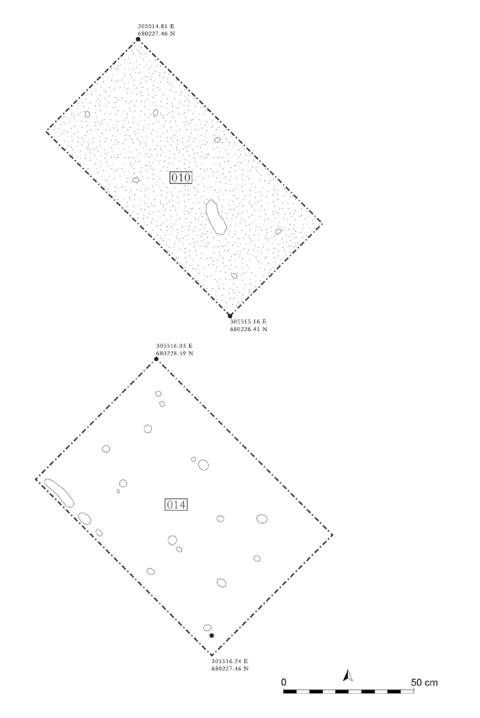
Figure 2: Post-excavation plan of Trench 1 (the plan for the initial location is at the top).

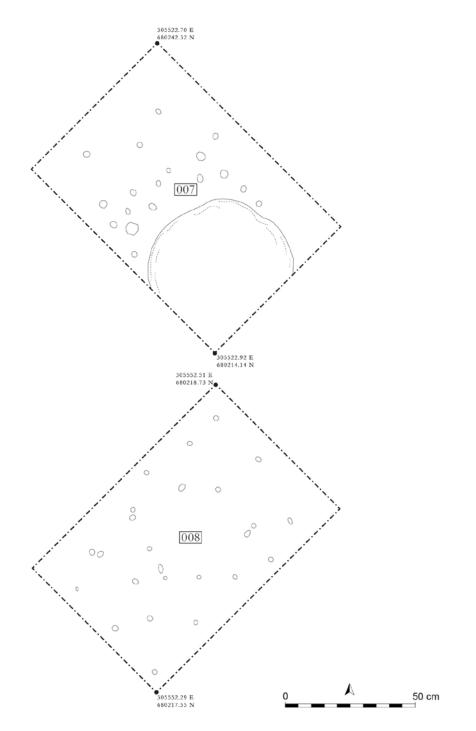
Figure 3: Post-excavation plan of Trench 2 (top) and Trench 3.

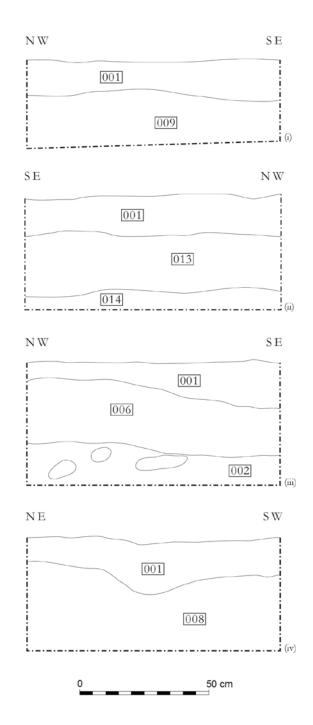
Figure 4: i) Trench 1 (initial location), SW-facing section; ii) Trench 1 (final location), NE-facing section; iii) Trench 2, SW-facing section; and, iv) Trench 3, NW-facing section.
