**HISTORIC SCOTLAND PROPERTIES IN CARE
MINOR ARCHAEOLOGICAL WORKS 2014/2015**

Duffus Castle • Excavation • October 2014

SITE: Duffus Castle, Morayshire

DESCRIPTION: Archaeological investigation of the the make-up of the motte

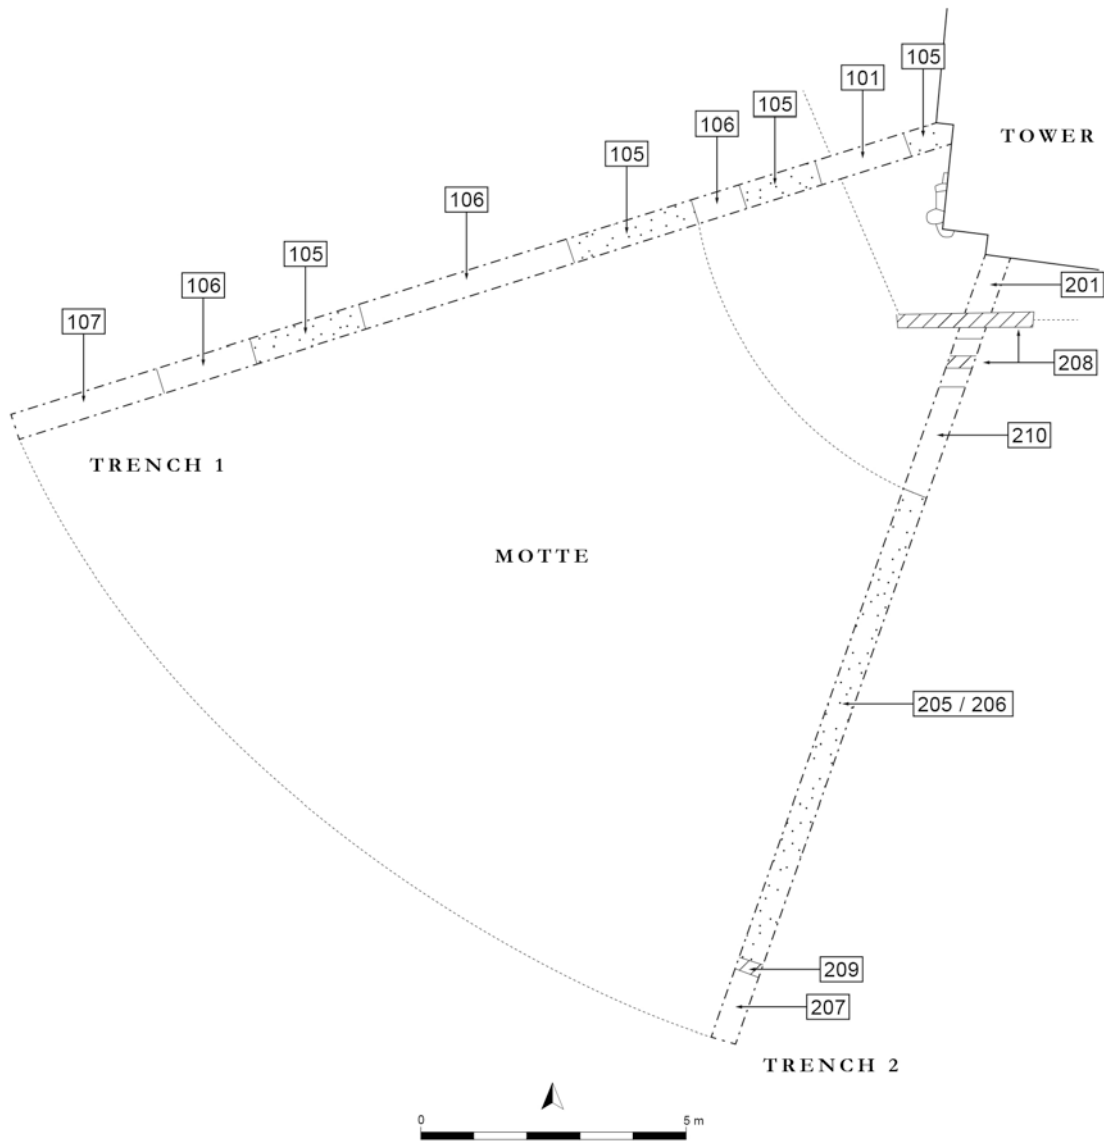
Figure 2: Post-excavation trench plan

Trench 1 was set back 1.5 - 2m to the N from the SW corner of the tower (the corner formed by the wall masonry, as the base course is missing here) and measured 0.5m wide. The trench measured 19.10m long, running from the NE where it abutted the tower, to the base of the motte slope to the SW. The turf and mid-brown silty topsoil **101** had been replaced during the works of 2001 for a total of 16.90m running SW from the tower. This layer was generally 10 - 15cm deep and contained modern detritus (pieces of crisp packets and cigarette butts). The topsoil **101** had been placed over a woven black plastic mesh **102** which was held in place by iron hook pins bedded to a depth of *c.*35cm through the layers below, including exposed areas of the motte scarp. The mesh had been placed over a further mid-brown silty topsoil **103** which had been added during the 1920s works; this survived as turf *and* topsoil in the non-truncated 2.4m of the SW end of the trench. This topsoil generally survived to a depth of 10 - 20cm and had in turn been truncated by the preparation scarping for the 2001 works. Towards the summit of the motte, this introduced material was deeper (up to 30cm as truncated), as the cut **104** for the 1920s work had included three 50cm wide x 10cm deep 'steps' which were presumably terraces formed to help hold the material being introduced at the apex of the motte slope. An area of introduced 1920s topsoil **103** was left unexcavated at the top of the slope due to concerns about slippage. The removal of 1920s topsoil **103** revealed something of the nature of the 1920s consolidation works. It was clear from pre-consolidation work photographs that the motte slope was grassed, as well as squatter and more undulating. The exposure of the surface below the topsoil introduced in the 1920s shows that a considerable amount of preparation work was carried out in order re-face the motte scarp. Rather than a buried turf/topsoil, there was a combination of exposed motte fabric **105** with traces of an introduced subsoil/capping **106** above, which had been severely truncated. The introduced subsoil **106** was a historic rather than a recent horizon and was composed of a mixed mottled light-brown silty clay; no artefacts were recovered which could have dated it. This layer intermittently covered the motte fabric **105** which was exposed in several places, and consisted of a light-brown gritty angular gravel. This clearly suggests that the 1920s work cut away (via **104**) the lumps and bumps in the motte (eating into the motte material and truncating the historic introduced sub-soil above) to create the more regular linear incline that we see today. At the base of the slope, an area of mottled re-deposited silty clay **107** was exposed at a depth of 10 - 15cm, which may represent the backfill of the motte ditch or possibly even material derived from the 1920s excavations spread along the down slope; it was not excavated as it could not be discounted as a modern infill. The spread extended for at least 3.4m from the SW edge of the trench.

Trench 2 was set back 0.9m - 1.4m E from the SW corner of the tower (the corner again formed by the wall masonry, as the base course is missing here) and was 0.5m wide. The trench measured 16.10m long running from the NE where it abutted the tower to the base of the motte slope to the SW. The turf and mid-brown silty topsoil **201** had been replaced during the works of 2001 for a total of 15m running SW from the tower. This layer was generally 8 - 14cm deep and contained pieces of modern plastic debris.

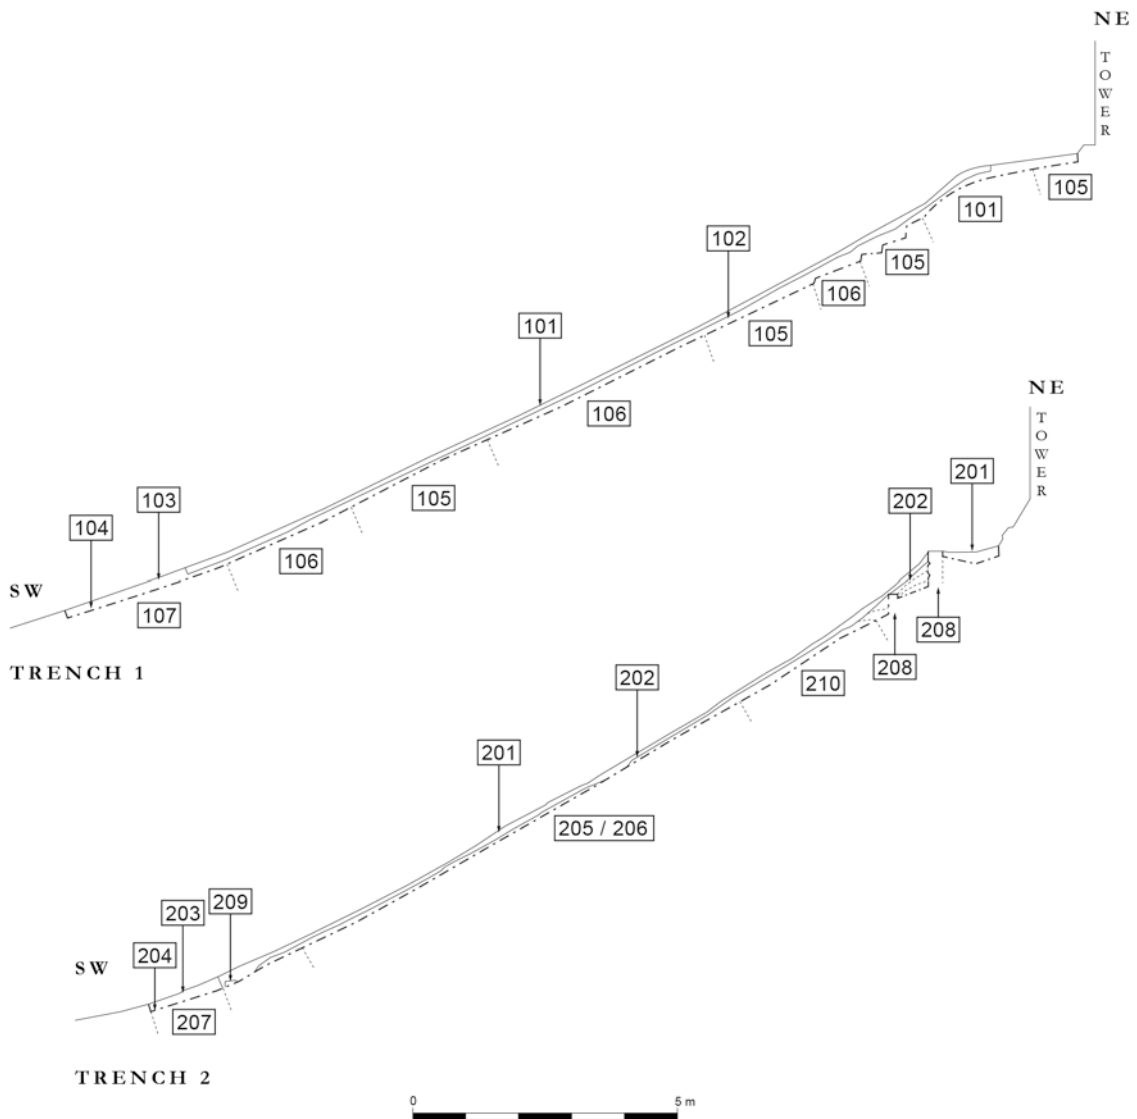
Figure 3: SE-facing sections from both trenches

end of the trench. This topsoil **203** generally survived to a depth of 5 - 10cm and had in turn been truncated by the preparation scarping for the 2001 works. The cut **204** for the 1920s work was concentrated on the scarp slope. The apex of the slope had to be substantially made-up as so much material had slipped away exposing a large amount of the base course at the SW angle of the tower. A compact mid-brown silty clay layer **210** was added above the motte fabric to create the artificial summit and three 50cm wide x 10cm deep steps were created to form terraces to help hold the topsoil introduced at the apex of the motte slope. The 2001 works then further introduced a two-tier revetment **208** (through the steps created as part of the 1920s cut) composed of railway sleepers kept in place by L-brackets driven into the mound (to what depth was not clear).

The upper revetment was composed of at least three sleepers stacked vertically, while the lower revetment had only one. An area of introduced 1920s topsoil **203** was left unexcavated at the top of the slope due to concerns about slippage. The removal of 1920s topsoil **203** again showed that a considerable amount of preparation work had been carried out in order re-face the motte scarp. Rather than a buried turf/topsoil there was a combination of exposed motte fabric **205** with traces of an introduced subsoil/capping **206** above, which had been severely truncated. The introduced subsoil **206** was a historic rather than a recent horizon, and was composed of a mixed mottled light-brown silty clay; no artefacts were recovered which could have dated it. This layer intermittently covered the motte fabric **205** which was exposed mainly on the lower slope, consisting of a light-brown gritty angular gravel. This again suggests that the 1920s work cut away (via **204**) the 'lumps and bumps' in the motte (eating into the motte material and truncating the historic introduced sub-soil above) in order to create the more regular linear incline that we see today.

At the base of the slope, an area of mottled silty clay **207** was exposed at a depth of 10 - 20cm, which may represent the backfill of the motte ditch or possibly even material derived from the 1920s excavations spread along the down slope; it was not excavated so it cannot be discounted as a modern infill. The spread extended for at least 1.6m from the SW edge of the trench. This spread and its interface with the motte material **205** to the NE had been truncated by the insertion of a further single railway sleeper **209** kept in place by L-brackets, again driven into the mound as part of the 2001 works.

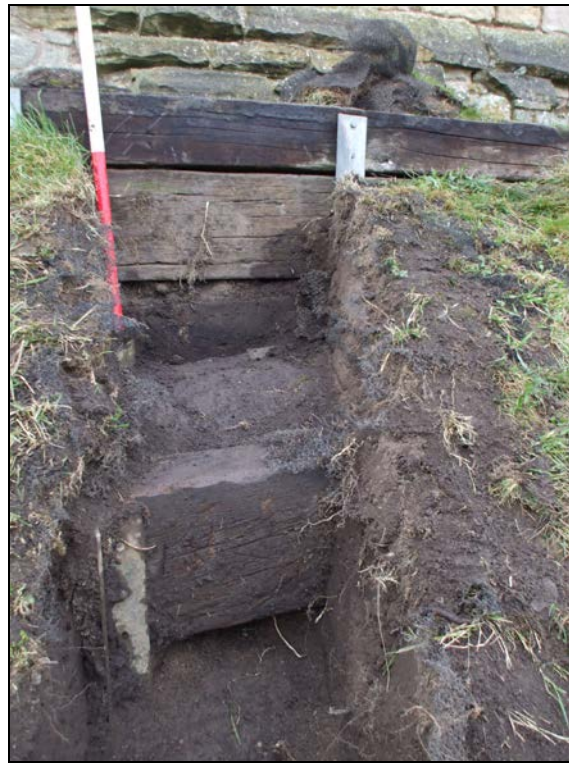
Plate 1: The wooden sleepers at the summit of Trench 2

is one of a series extending along the lower slope to the S (there was no lower sleeper in Trench 1). If this is the case and there is a requirement for them to be removed, the associated work may require archaeological monitoring since they are cut into the fabric of the motte itself (context **205**).

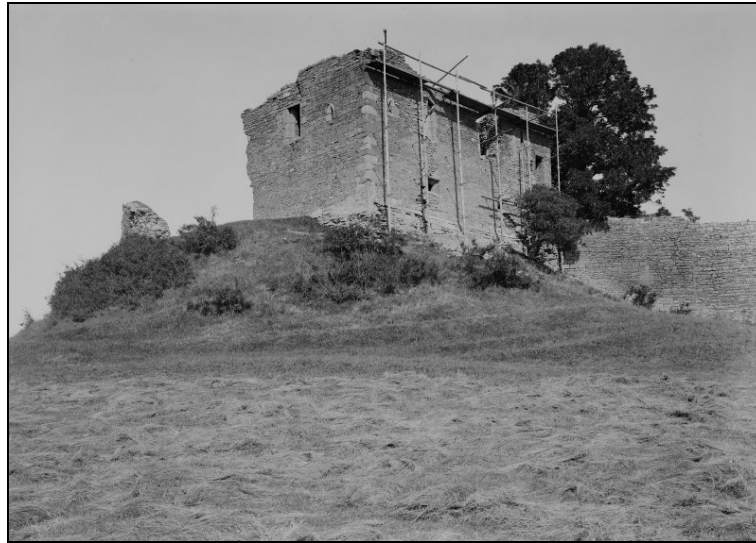
Plate 2: The motte and tower in the 1920s prior to the dressing of the motte

Plates 2 and 3 show the contrasting motte profiles between the 1920s pre-consolidation phase with exposed tower base course (Plate 2) and the current heavily-altered configuration (Plate 3). Considerable effort has clearly gone into not only attempting to recreate a more 'authentic' motte profile, but to create a motte profile that structurally helps to bolster and support the stone tower above. The proposed works to prevent further slippage will see the removal of the sleepers and support stakes, some of which are currently exposed, to 300mm below the proposed finished ground level. Introduced top soil will then be spread over the area. As the summit at the SW angle is largely an artificial creation deriving from the 1920s consolidation works, there is no concern from an archaeological perspective regarding their removal. It may be more problematic if the sleeper **209** noted at the base of the motte scarp in Trench 2

Having passed into state care in 1926, the castle was subject to clearance and consolidation works designed to stabilise the structure. This work also appears to have included some dressing of the motte scarp, although the exact extent of such work is unclear. Photos of the 1920s consolidation work indicate that a sizeable portion of the projecting base course of the tower was exposed at this time – in its entirety along the S wall of the tower with around one third visible running from the SW corner along the W wall. The photos also show the motte scarp bulging-out and 'rolling' in places, and there is no flat platform on the W and S sides of the tower. This is a very different profile to that which can be seen today, where the diminutive rolling mound has been replaced with a flatter, taller, more severely inclined scarp with a flared top providing the missing platform on the W and S sides of the tower. It is therefore likely that the modern shape of the motte was created in the 1920s by a combination of scarping of the motte in some places, and the addition of soil in others. This provided further buttressing for the W and S portions of the tower and created a platform around these sides of the building.

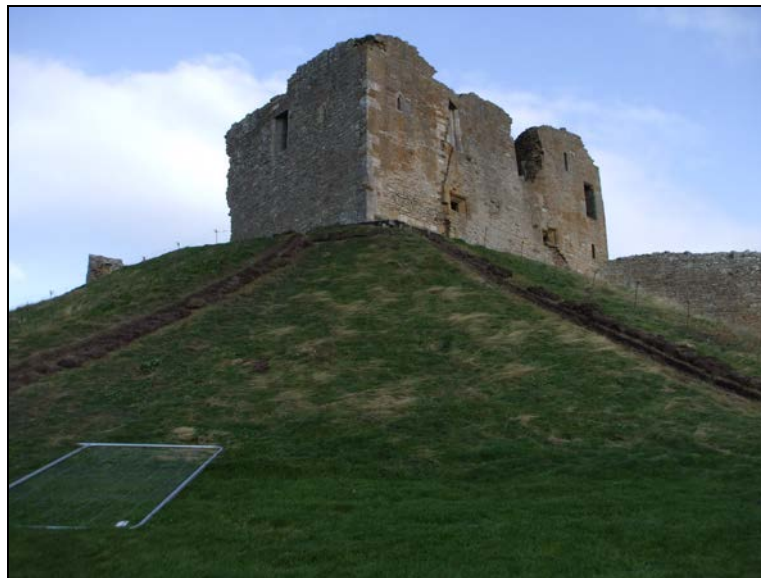
Plate 3: The motte and tower today
