**Dunkeld Cathedral • Watching Brief • May 2015**

**SITE:** Dunkeld Cathedral, Dunkeld, Perthshire

**DESCRIPTION:** Archaeological watching brief during i) the excavation of a trench to install a memorial marker stone for the Battle of Dunkeld,, ii) the removal of an existing information lectern, and iii) the excavation of a trench to replace an existing grave marker.

**PROJECT CODE:** HSCO-90119-2015-01

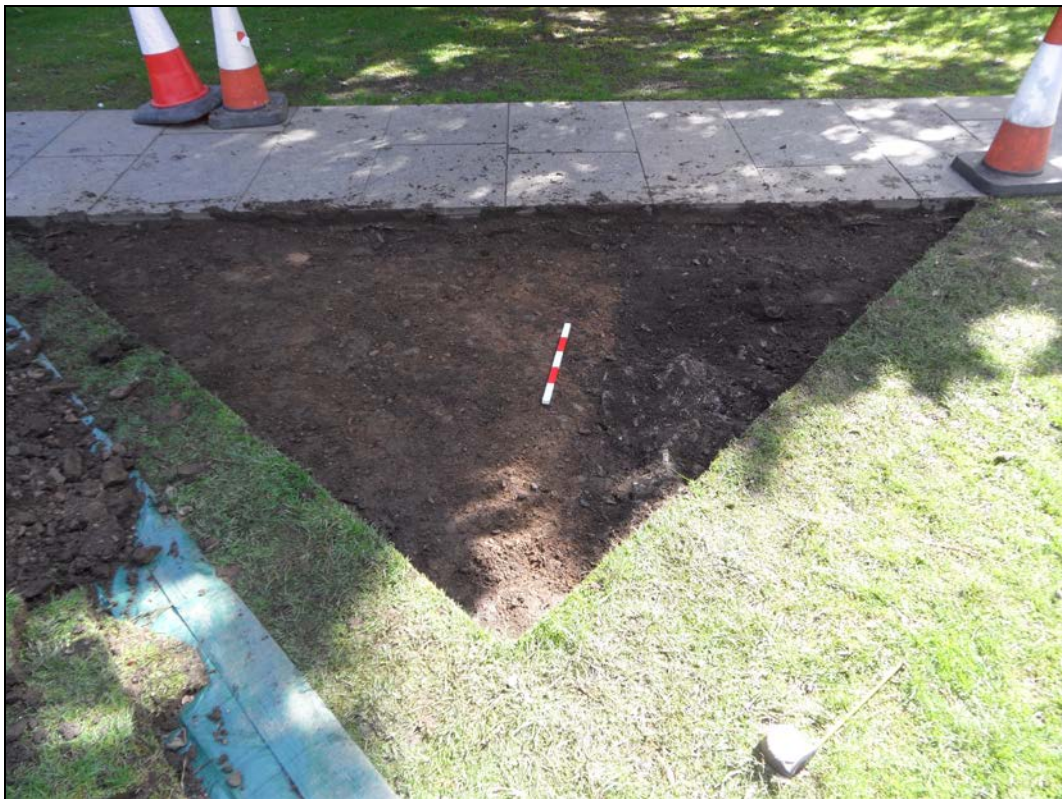
**Plate 1:** Context **102** (left) truncated by cut **103** (central) which is backfilled by **104** (right). Context **104** appeared to be a relatively modern demolition layer, and was preserved *in-situ*, with terram used to protect it before backfilling.

Nothing of archaeological interest was recovered during the works inside the cathedral nave. Externally, Trench 1 indicated that the area has been subject to modern landscaping. It is likely that the feature encountered in Trench 1 (**104**) represents a demolition episode whereby an upstanding masonry structure was reduced. The presence of modern glass and pottery within this layer (not retained) suggests that this may have taken place within the last century. The area should be considered to be one of elevated archaeological sensitivity, and it is therefore recommended that any further ground-breaking work be accompanied by an archaeological watching brief.

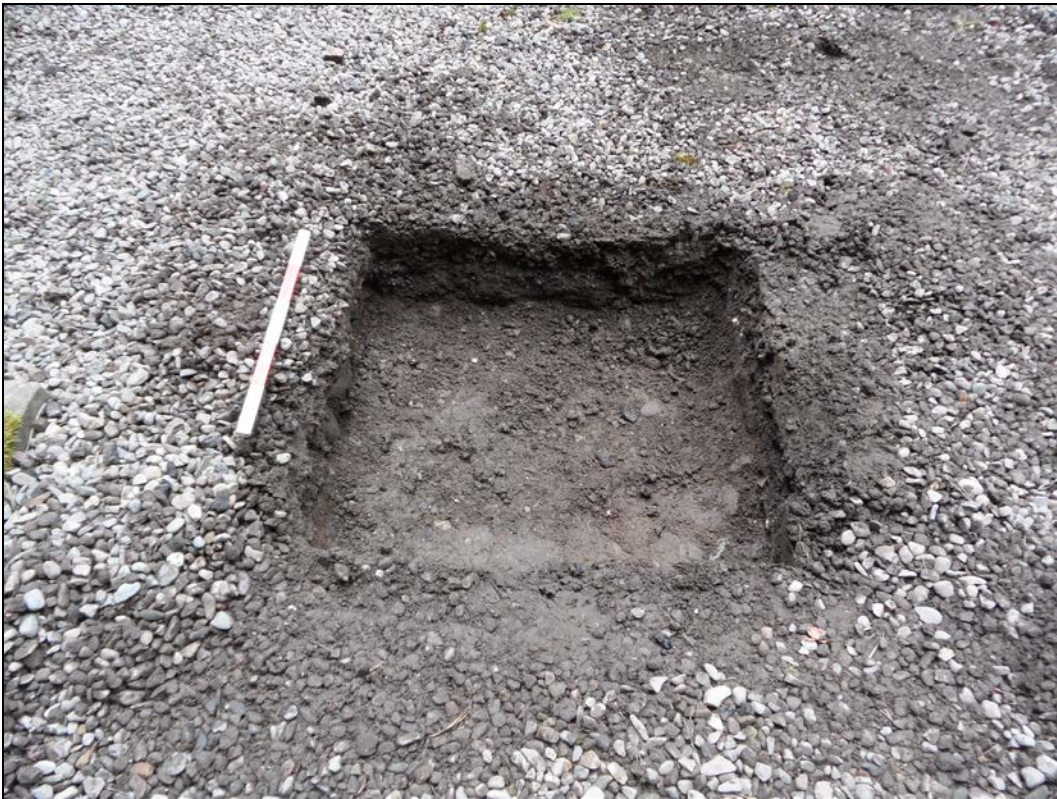
**Plate 2:** Post-excitation view of Trench 2, from the west.

Trench 2 was excavated in order to facilitate the replacement of the existing grave marker to Colonel Cleland within the cathedral nave. This process involved the removal of the existing marker and the expansion of this footprint to the east, to form a trench 0.75m E/W x 0.75m N/S with a total depth of 0.27m.

The upper layer of gravel chips **201** was cleared away to a total depth of 0.1m. The existing marker was excavated down its eastern face, rocked out and removed. The gravel was bedded on a mixed re-deposited layer of greyish-brown clay and gravel **202**, some 0.1m deep (the installation of the gravel path

may have required spreading/levelling works creating this layer with a level surface above). Below **202**, two layers were revealed. To the west was a compact layer of clean greyish-brown clay **203** which, given its position and depth at the western end of the nave, must have been clay introduced when the floor deposits of the nave were replaced by deposits appropriate for internments. This deposit stretched eastwards for 0.22m and was exposed to a depth of 0.1m. It was truncated to the east by a sloping cut **204** which had been backfilled with a mixture of industrial-looking gravelly shale and silt, **205**, containing two water-rolled pebbles (not *in-situ* cobbles). This layer again highlighted modern disturbance/levelling within the nave.
