**HISTORIC SCOTLAND PROPERTIES IN CARE
MINOR ARCHAEOLOGICAL WORKS 2015/2016**

Iona Abbey • Watching Brief • August 2015

SITE: Iona Abbey, Iona.

DESCRIPTION: Archaeological watching brief during the removal of two existing gates, and the excavation of trenches to receive the foundations of replacement ones.

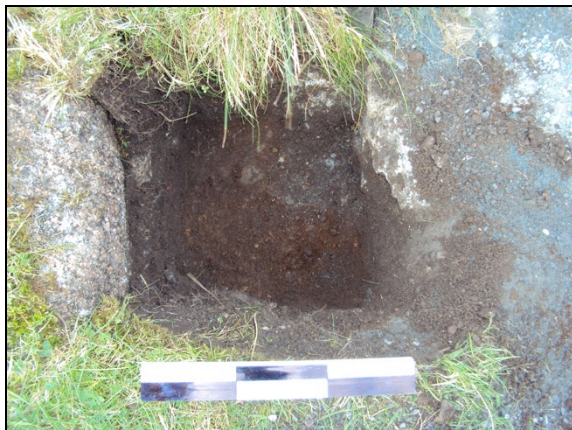
This was located on the southern side of the path. Beneath the 7.5cm thick layer of turf and topsoil, **100**, a layer of concrete, **101**, extended to a depth of 0.32m. Beneath this, a silty mid-brown deposit **102**, 0.12m thick, containing concrete fragments and small rounded stones was visible. Nothing of archaeological interest was revealed, and the finished trench measured 0.64m N/S x 0.66m E/W x 0.44m deep.

Plates 1 and 2: Trench 1, post-excavation photo (left), and Trench 2, post-excavation photo.

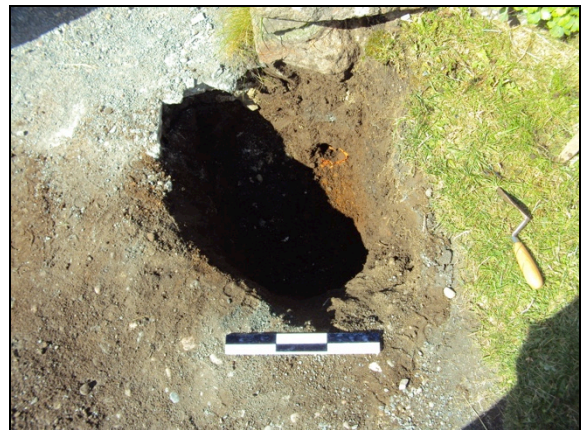
This was located on the northern side of the path. Beneath the 7.5cm thick layer of turf and topsoil, **200**, a layer of concrete, **201**, extended to a depth of 0.28m. Below this was context **202**, some 0.2m thick, containing an assorted array of rubble containing brick fragments, large angular stones, occasional pieces of modern wire and fragments of broken ceramic pipe. An old, broken ceramic pipe **204**, 0.11m in diameter, was visible in the E-facing section. Below this was the natural gravel, **203**, a thickness of 0.05m of which was excavated before the required trench depth was reached. Nothing of archaeological interest was revealed, and the irregularly sized finished trench measured a maximum of 0.4m N/S x 0.4m E/W x 0.53m deep.

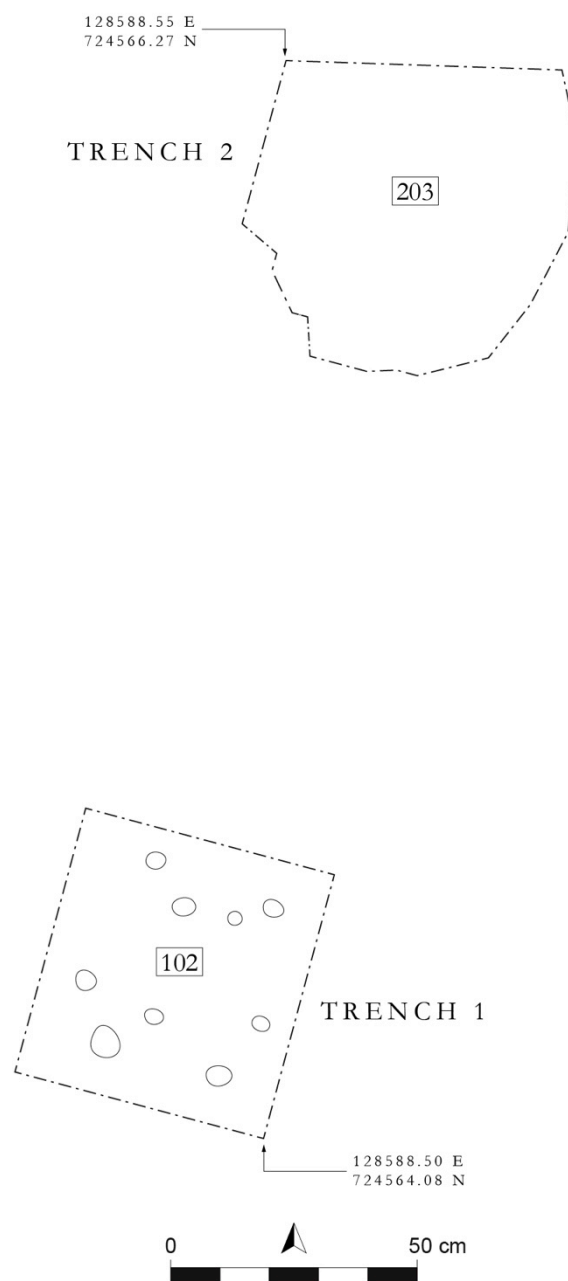
Figure 2: Post-excavation plan of trenches 1 and 2.

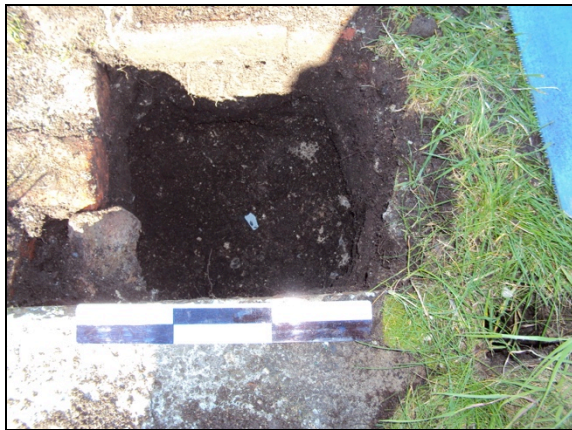
This was located to the north. Following the removal of the 5cm thick turf and topsoil **300**, the hinge-post was revealed to be sitting atop a layer of regularly arranged red bricks, **301**, one course thick (0.1m). Beneath this was **302**, a 0.18m thick layer of dark, stone-free material containing mortar fragments. This in turn lay over **303**, a 0.13m thick layer of loosely packed mortar fragments. The finished trench measured 0.43m N/S x 0.43m E/W x 0.46m deep.

Plates 3 and 4: Trench 3, post-excavation photo (left), and Trench 4, post-excavation photo.

Other than the layer of red bricks (**301**) encountered in Trench 3 (possibly part of a larger arrangement), little of archaeological interest was revealed. Within trenches 3 and 4, the deposits probably indicate an episode of levelling, possibly during the 1930s restoration works.

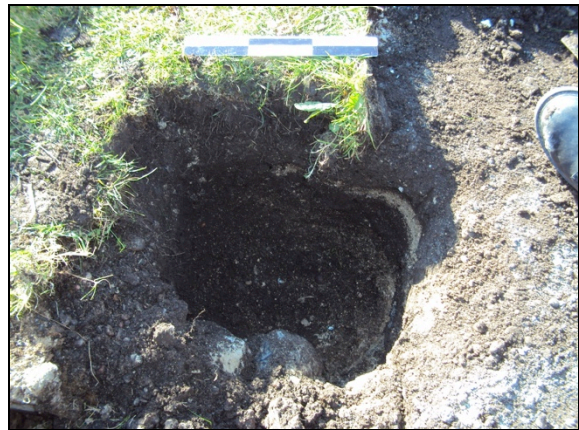
This was located to the south. Following the removal of the 6cm thick turf and topsoil **400**, the locking-post was revealed to be sitting within **401**, a 0.35m thick deposit similar in nature to **302** - i.e. a layer of dark, stone-free material containing mortar fragments. Within **401**, was a 5cm (on average) thick lens of clean sand, **402**. Nothing of archaeological interest was revealed, and the finished trench measured 0.43m N/S x 0.43m E/W x 0.41m deep.
