**HISTORIC SCOTLAND PROPERTIES IN CARE
MINOR ARCHAEOLOGICAL WORKS 2014/2015**

Linlithgow Palace • Watching Brief • January 2015

DESCRIPTION: Archaeological watching brief during the excavation of an evaluation trench ahead of the installation of a new statue depicting Mary, Queen of Scots.

DESCRIPTION: Archaeological watching brief during the excavation of a shallow trench to hold a gravel border surrounding the plinth and base of a new statue depicting Mary, Queen of Scots.

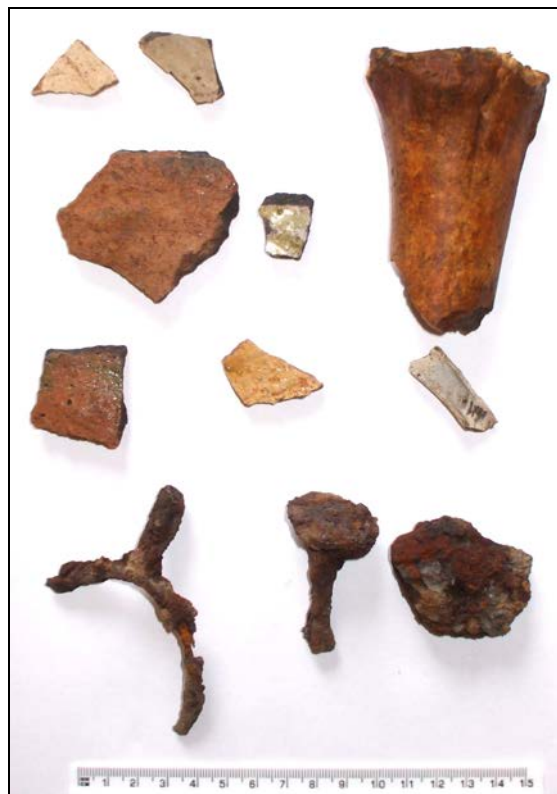
Plate 1: Small finds including barbed wire (bottom, left) from context 103.

The evaluation trench footprint measured 1.7m E/W x 1.7m N/S. It was de-turfed and boards were used to store the turf and spoil. The turf/topsoil **101** was 9 – 10cm thick and was bedded on a layer of silty gravel **102**, some 10cm thick, containing numerous small sub-rounded water-rolled pebbles. Layer **103** below (12 – 26cm thick) consisted of a mid-greyish brown silt, flecked with charcoal, containing a selection of small finds including animal bone, possible medieval/post-medieval pot sherds, iron and possible iron slag and, tellingly, a piece of corroded barbed wire (Plate 1). Barbed wire was first patented in the 1860s, so this would tend to suggest that this was a probably 19th century (or later) levelling layer, where contemporary objects were being mixed with material derived from kitchen midden deposits, possibly from the flattening of nearby earthworks.

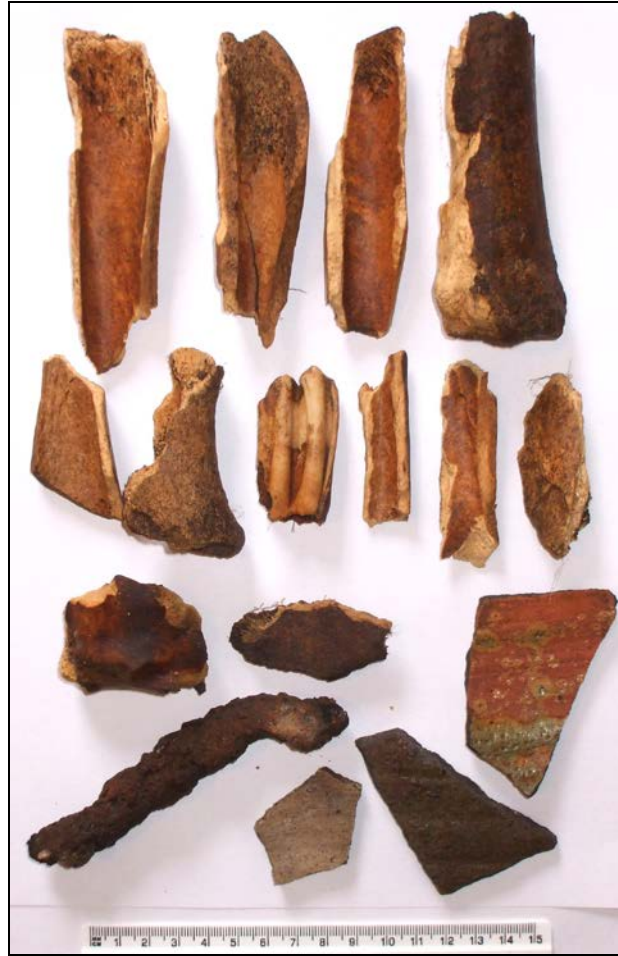
Plate 2: The small finds from layer 105.

An undulating layer of silty gravel **104** (4 – 15cm thick) lay below **103**, which was flecked with charcoal. Upon its removal, a deposit of compact mid-greyish brown silt **105** was revealed, heavily flecked with charcoal and containing numerous pieces of animal bone, as well as green glaze pottery (Plate 2).

Layer **105** varied in depth from 4 – 20cm, but was generally not bottomed as the required trench depth of 60cm had been met. In the north-east corner of the trench, layer **105** gave way to a layer of mid-orangey brown sandy gravel **106**, although this was barely exposed. The compaction, high charcoal and bone content and colour of layer **105**, allied to the lack of modern finds, suggests that it was an *in-situ* historic levelling layer comprising a large amount of kitchen midden material.

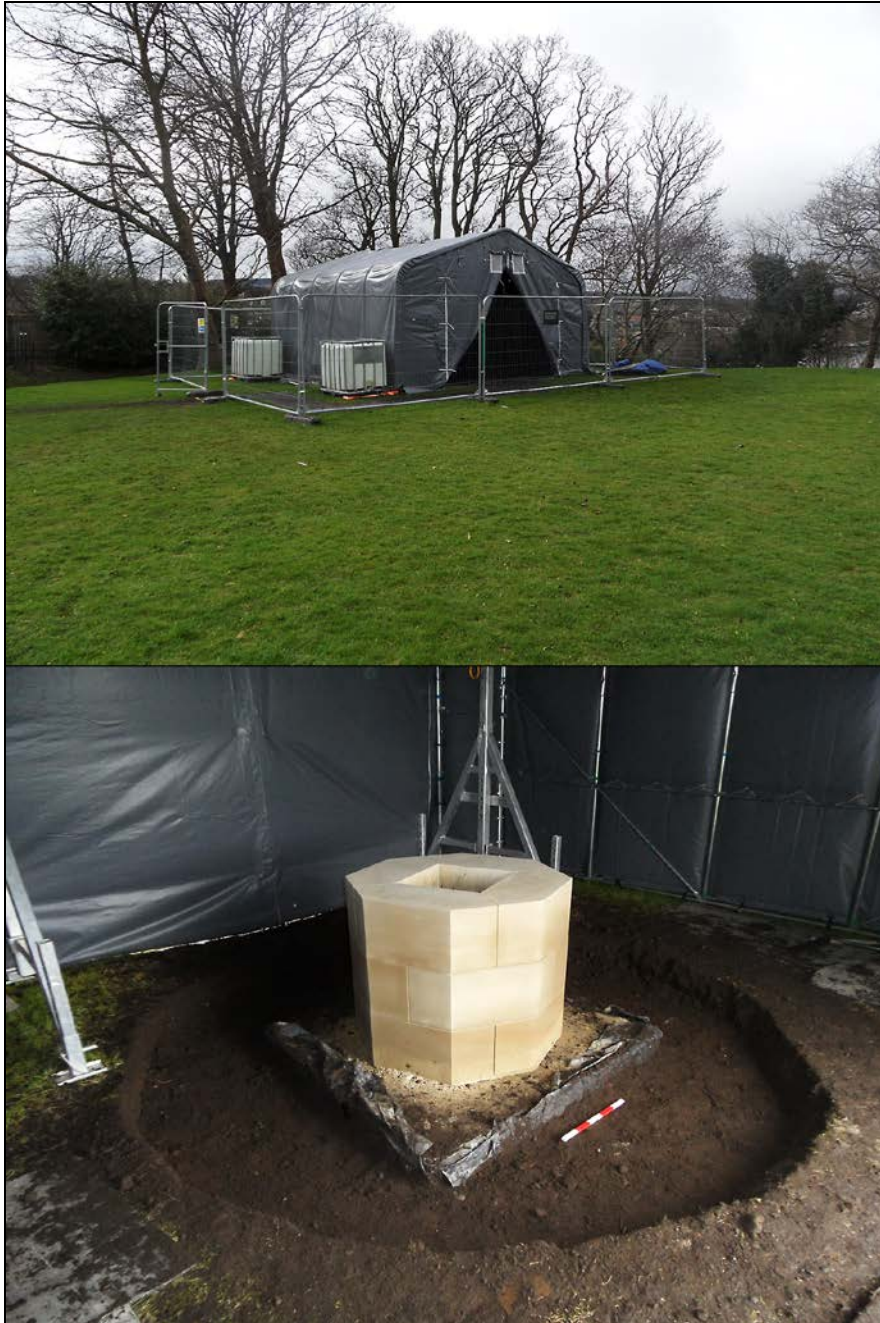
Plate 1: The protective tent over the trench (top) and a view of the trench, as excavated.

Prior to commencement of the work, a tent was erected over the area so that the statue could be emplaced under cover. The poured concrete base was set within the previous evaluation trench and an

octagonal ashlar plinth was erected over it. The gravel border required an excavation depth of $\approx 15\text{cm}$ (measured from the top of the statue base). A further $\approx 5\text{cm}$ depth of gravel was then spread over the base, which was itself lower than the surrounding turf by up to $\approx 10\text{cm}$.

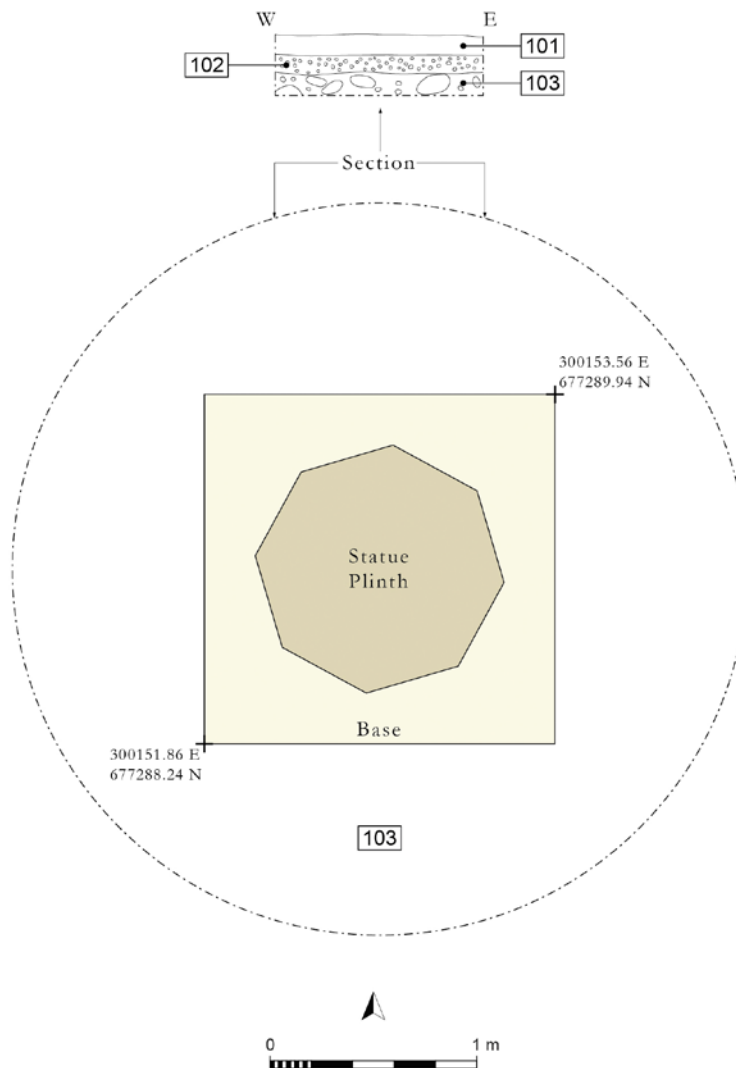
Figure 2: S-facing section (top) and post-excavation trench plan.

The trench for the gravel border was de-turfed and boards were used to store the turf; the spoil was removed in wheelbarrows. The edges of the trench were located 1.2m away from the ashlar faces of the statue plinth. The turf/topsoil **101** was \approx 9-10cm thick and was bedded on a layer of silty gravel **102**, some \approx 10cm thick. It contained numerous small sub-rounded water-rolled pebbles. Layer **103** lay immediately below, and consisted of a mid-greyish brown silt flecked with charcoal. This was partially excavated to a depth of \approx 10cm. This was the layer which, during the initial evaluation in January, had yielded a selection of small finds including animal bone, possible medieval/post-medieval post sherds, iron and possible iron slag and, tellingly, a piece of corroded barbed wire. Barbed wire was first patented in the 1860s which would tend to suggest that this was probably a 19th century levelling layer, where contemporary objects were being mixed with material derived from historic kitchen midden deposits, possibly as a result of flattening the surrounding earthworks. In contrast, there were no artefacts recovered during this period of work, although the trench was a lot shallower.

No.	Type	Description	Scale
1	Plan	Post-excavation.	1:20
1	Section	S-facing,	1:20
