**HISTORIC SCOTLAND PROPERTIES IN CARE
MINOR ARCHAEOLOGICAL WORKS 2015/2016**

Tantallon Castle • Watching Brief • July 2015

SITE: Tantallon Castle, East Lothian.

DESCRIPTION: Archaeological watching brief during the installation of new signage, along with the replacement of some older interpretation panels.

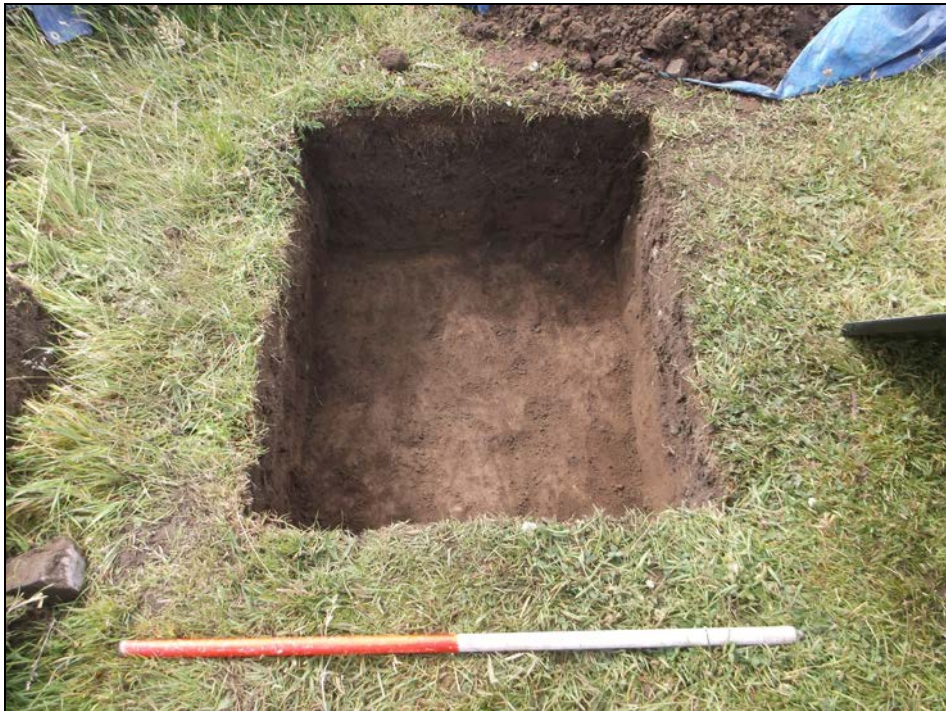
Trench 1 was located at the edge of the Outer Defences to the south of the gate along the access path. This location is part of an earthwork pathway **003**, leading to the bridge **004** over the ravine **005**, through a sandstone entranceway and to the north of the river **011**. The cut for the trench, **027**, measured 1.03m N/S x 0.81m E/W x 0.44m deep.

Within the area opened for the sign only two stratigraphic layers were revealed. The top layer, **001**, was comprised of turf and dark grey/brown sandy topsoil to a depth of 0.1m. The lower deposit, **002**, was a mid-greyish/brown loose silty-sandy soil containing some small and medium red and grey sandstone fragments (c.10cm x 15cm x 8cm), along with fragments of the local green conglomerate stone and a few small river pebbles. The material of **002** was relatively homogenous and turf-like with some possible flecks of charcoal.

Plate 1: Post-excitation view of Trench 1.

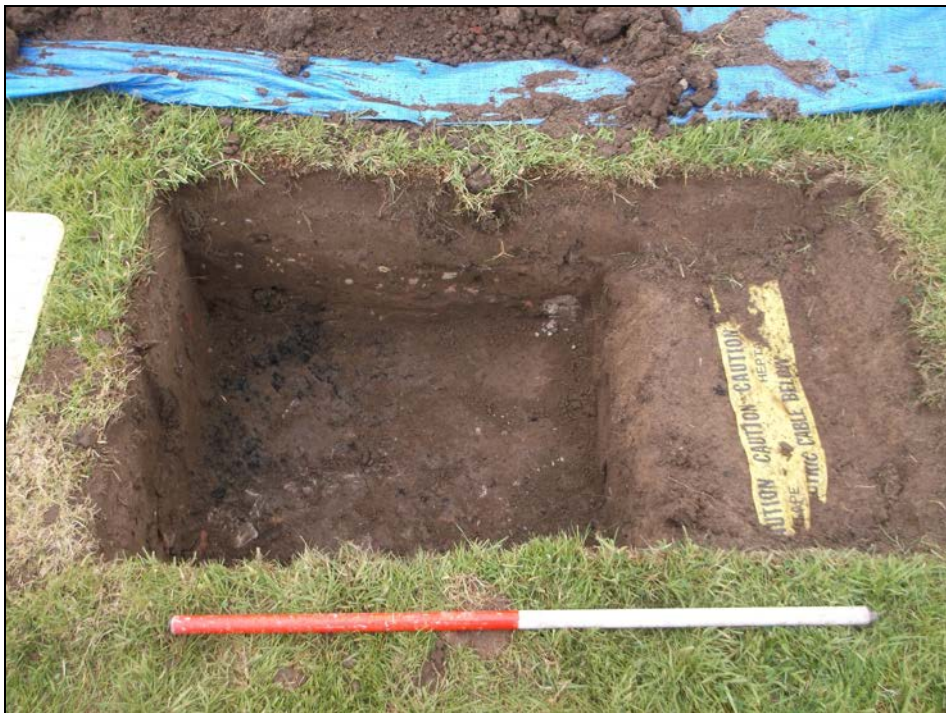
Trench 2 was located towards the western edge of the Outer Close **026**. When the cut **029** for the trench was made, a strip of electric cable warning tape, **022**, was located 0.2m below the surface and 0.12m from the western edge of the trench. The trench was therefore extended 0.35m to the east to avoid the services. Overall the final trench measured 1.45m NW/SE x 0.78m NE/SW x 0.45m deep, with a 0.3m strip along the western edge to a depth of 0.2m.

Within the trench, **020** was a turf and dark brown silty-sandy topsoil \approx 0.1m deep. Immediately below was deposit **021**, a sandy silty clean brown soil 0.15m in depth, which carried the electric cable warning tape **022**. No cut was visible around the location of the warning tape and **021**. Beneath **021** was a silty clay rich brown/grey soil **023** with frequent stone inclusions (red/pink sandstone fragments). This stony layer may be related to the anthropomorphic surfaces found below and included animal bone. With the partial removal of **023** the base of the excavated area was revealed. Towards the northeast corner of the trench was a collection of black, charcoal-like material (0.43m x 0.2m in plan, broadly triangular in shape) with a stony layer extending from amongst the charcoal towards the southeast corner. This surface, **024**, seems likely to be anthropomorphic in origin and may be related to some of the stony material of **023** above; it was suitably protected with a semi-permeable membrane sheet prior to the insertion of the lectern panel.

Plate 2: Post-excitation view of Trench 2.

Towards the bottom of **029** (Trench 2) a small part of a surface with anthropomorphic origins was revealed. This surface was covered and protected prior to the installation of the sign. While Trench 3 revealed no structural remains, finds suggest the lowest stratigraphic layer **014** is of archaeological interest.

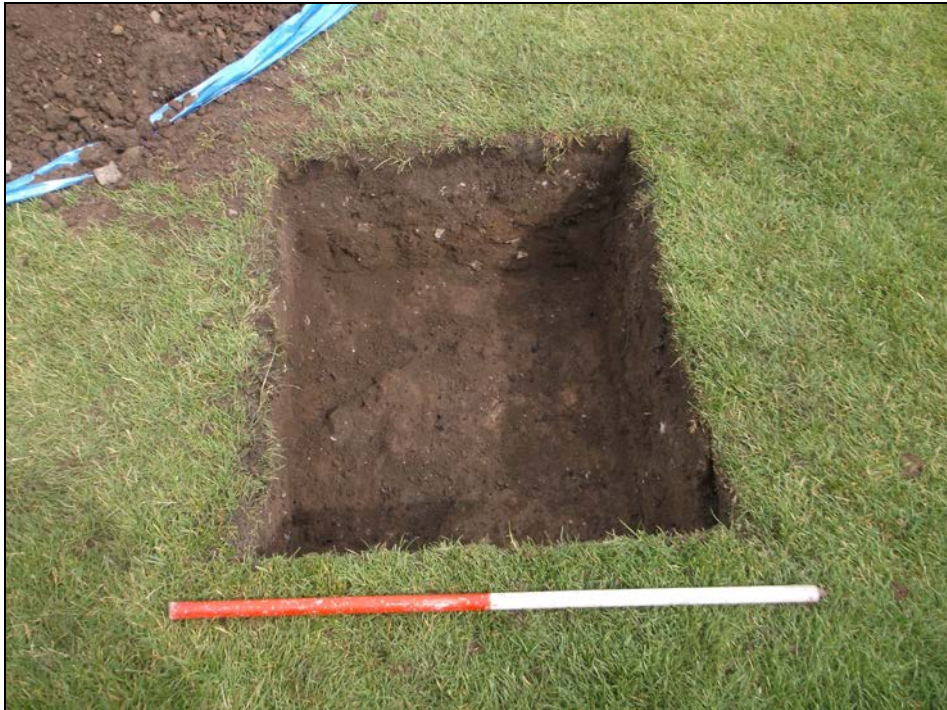
Trench 3 was located towards the eastern corner of the Inner Close, **017**, placed to the southwest of the observation telescope **016**, and to the east of a stone wall foundation **015**, which makes up part of the sea gate.

Within the trench cut **028**, the turf and topsoil **012** were removed to expose the layers below. The topsoil was a dark loose sandy brown soil and extended to a depth of 0.15m. Below the layer of turf lay **013**, a band of dark brown silty soil with a large collection of pebbles and stony inclusions ranging from 4 – 6cm deep. This in turn lay over **014**, a mixed brown/orange clay rich soil with small fragments of red sandstone and natural green conglomerate stone, c.0.25m in depth. The bottom of the cut did not reach the base of this stratigraphic layer; finds including animal bones and clay pipe stem were found within **014**.

Plate 3: Post-excavation view of Trench 3.
