LOCAL AUTHORITY:	West Lothian
PROJECT TITLE/SITE NAME:	Torphichen Preceptory
PROJECT CODE:	HSCO-90305-2015-01
PARISH:	Torphichen
NAME OF CONTRIBUTOR:	Paul Fox
NAME OF ORGANISATION:	Kirkdale Archaeology
TYPE(S) OF PROJECT:	Watching brief
NMRS NO(S):	NS97SE 7
SITE/MONUMENT TYPE(S):	Preceptory
SIGNIFICANT FINDS:	
NGR (2 letters, 8 or 10 figures)	NS 9685 7252
START DATE (this season)	19 March 2015
END DATE (this season)	20 March 2015
PREVIOUS WORK (incl. <i>DES</i> ref.)	
MAIN (NARRATIVE) DESCRIPTION: (May include information from other fields)	An archaeological watching brief was maintained during the excavation of three trenches to house new signage at Torphichen Preceptory. Nothing of archaeological interest was recovered during the works, with the trenches indicating that the area has been subject to modern landscaping.
PROPOSED FUTURE WORK:	
CAPTION(S) FOR ILLUSTRS:	
SPONSOR OR FUNDING BODY:	Historic Environment Scotland

**HISTORIC SCOTLAND PROPERTIES IN CARE
MINOR ARCHAEOLOGICAL WORKS 2015/2016**

Torphichen Preceptory • Watching Brief • March 2015

DESCRIPTION: Archaeological watching brief during the removal of an existing entrance pole sign, and the excavation of three trench

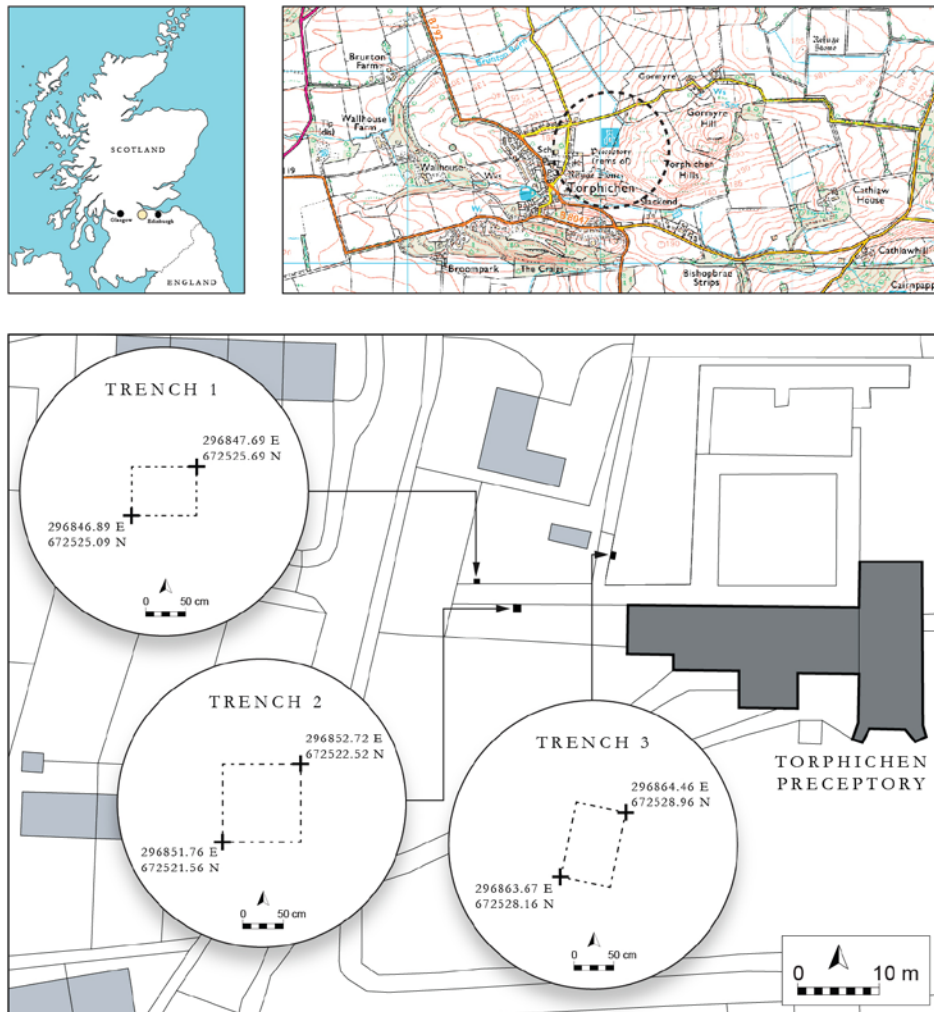
Figure 1: Plan showing the location of the three trenches.

Under the terms of its PIC contract with Historic Scotland, Kirkdale Archaeology was asked to carry out an archaeological watching brief during the excavation of three trenches to house new signage at Torphichen Preceptory near Bathgate in West Lothian. The sign in Trench 1 would replace an existing pole sign on the north side of the path at the entrance gate, the one in Trench 2 was located on the grass on the south side of the path to the south-west of the flag pole outside the Custodian's hut, while the sign in Trench 3 was located on the eastern side of the path to the south-east of the Custodian's hut (see Figure 1).

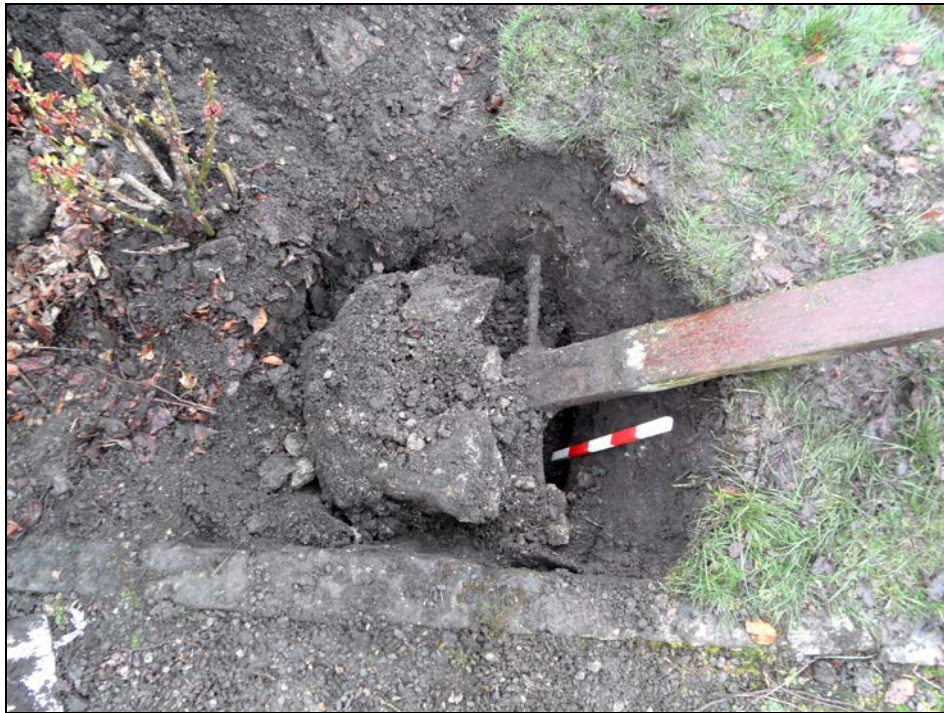
Plate 1: The existing pole sign at the Trench 1 location during removal.

The sign intended for Trench 1 would replace an existing pole sign on the north side of the path at the entrance gate to the church yard. The existing sign was partially excavated then 'rocked' out as it had a sizeable concrete base. The resultant trench measured 0.6m N/S x 0.8m E/W x 0.6m deep. Its south-western edge was located 2m east of the north side of the main entrance gate on the north side of the main path to the church. The turf **101** was 13cm deep and overlay a layer of mid-brown silty garden soil **102** flecked with charcoal. The trench was levelled with excavated soil to provide the required depth of 0.25m.

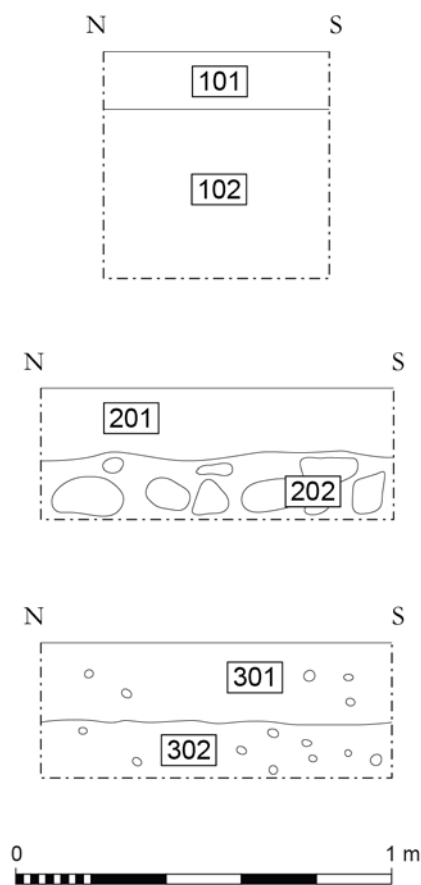
Figure 2: S-facing sections of trenches 1 (top), 2 (centre) and 3.

Trench 2 measured 0.94m N/S x 0.94m E/W x 0.35m deep¹. The western side of Trench 2 was located 7.45m east of the south side of the main entrance gate on the south side of the main path to the church. The turf and mid-brown silty stony topsoil **201** was 0.16m – 0.20m deep and had been introduced (probably at some point in the late 19th/20th century) to cap a mixed levelling layer **202** of partially voided angular rubble mixed with silt flecked with charcoal; this layer was only partially excavated to a depth of 0.15m. The finds from both of these layers (bottle glass/transfer printed pottery/barbed wire) indicated the date suggested above, with layer **202** representing a levelling layer used to landscape the approach to the church.

Trench 3 measured 0.94m N/S x 0.62m E/W x 0.35m deep. Its southern edge was located 3.3m north of the angle of the grassed area south of the main path to the church. The turf and mid-brown silty stony topsoil **301** was 0.2m deep and had been introduced (probably at some point in the late 19th/20th century) to cap a mixed levelling layer **302** of silt flecked with charcoal and mortar containing angular pieces of sandstone and pieces of slate; again, it was only necessary to partially excavate this layer, to a depth of 0.15m. The modern finds (bottle glass/transfer printed pottery/barbed wire) from both of these layers indicated the date suggested above, with layer **302** representing a levelling layer consisting of a large amount of demolition debris.

Nothing of archaeological interest was recovered during the works, with the trenches indicating that the area has been subject to modern landscaping. However, *in-situ* archaeological deposits could still survive at greater depths, so it is recommended that any further ground-breaking activities be accompanied by an archaeological watching brief.
