HISTORIC SCOTLAND PROPERTIES IN CARE MINOR ARCHAEOLOGICAL WORKS 2013

Bothwell Castle • Monitoring • January / February 2013

SITE:	Bothwell Castle, Uddingston	
N.G.R.:	NS 6878 5936	
DESCRIPTION:	An occasional archaeological watching brief during the racking' and other recent repairs at the wall head of the	O .
PROJECT CODE:	HSCO-90038-2013-01	
CONTENTS:	Introduction	1
	Description	2
	Conclusions	3
	List of Digital Photographs	4

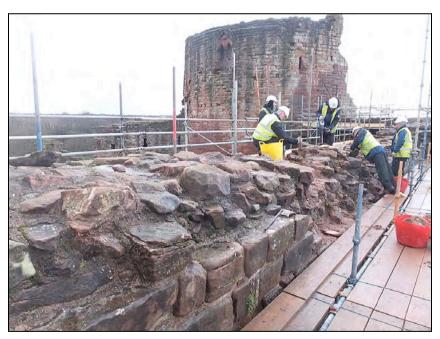
The main focus of the repair programme was the western half of the 14th Century N rampart, built against a reduced section of residual curtain wall, running up to the circular *donjon*. The new build comprised well-shaped rectangular red sandstone blocks as facing stones for the surviving upper 1m, with more random rubble as wall core. The recent rough racking consisted of a jumble of large blocks of red sandstone with copious amounts of cement, creating a random rubble wall core (Plate 1). It was noticeably deeper (£1m) towards the middle area of the wall and was easily distinguished from the whitish mortar of the historic wall fabric by the use of hard grey cement (Plate 2). Once mostly removed, the rough racking was replaced by soft clay (Plate 3).

Plate 1: The exposed wall core

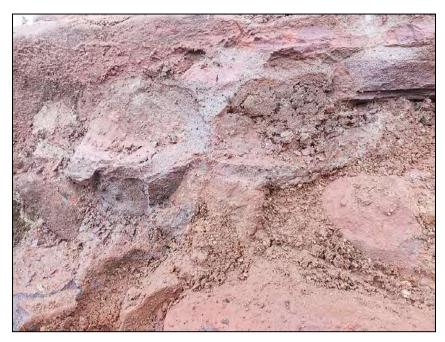
Plate 2: The hard grey cement atop the historic wall fabric

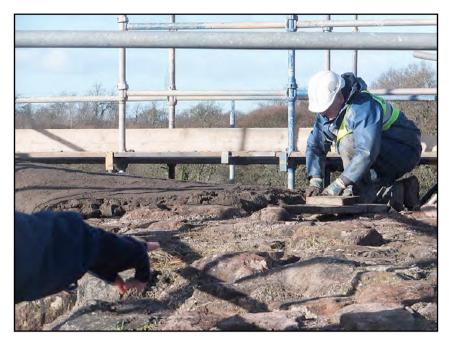
Plate 3: The installation of the soft clay

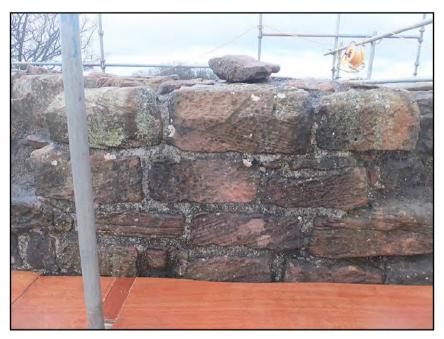
In addition to these general observations, it was noted that three stones at the top of extreme E end of the N rampart featured a weathered chamfer on their upper edges (Plate 4), not matched at the W end by stones at same height, confirming the two phased nature of the surviving masonry.

$\textbf{Plate 4:} \ Chamfered \ stones \ at \ the \ E \ end \ of \ the \ N \ rampart$
