**HISTORIC SCOTLAND PROPERTIES IN CARE
MINOR ARCHAEOLOGICAL WORKS 2013**

Clackmannan Tower • Watching Brief • March 2013

SITE:	Clackmannan Tower, Clackmannan
N.G.R.:	NS 906 919
DESCRIPTION:	Watching Brief during the alteration of three existing gates in order to provide wheelchair access to the property
PROJECT CODE:	HSCO-90073-2013-01
CONTENTS:	
	Introduction.....1
	Description.....2
	Conclusions.....4
	List of Contexts.....6
	List of Drawings.....6
	List of Digital Photographs.....6

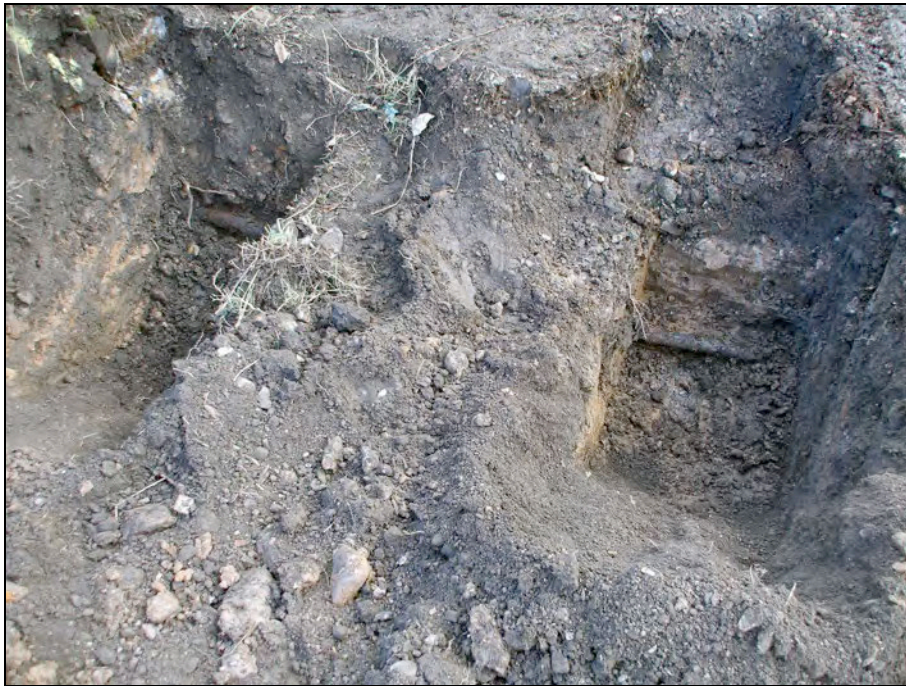
Plate 1: Trench 1, post-excavation shot

The existing gate was removed and an area 2.15m N/S x (up to) 2.9m E/W was reduced by 0.1m to the E, and graded gently up to the W. Two gatepost trenches were then excavated. The N gatepost trench measured 0.6m N/S x 0.95m E/W x 0.7m deep. The S gatepost trench measured 0.7m N/S x 0.9m E/W x 0.7m deep. The sections consisted of introduced topsoil **101**, 0.25m thick, overlying a compact gravelly surface **102**, 0.15m thick, possibly representing a hard surfacing related to the access road for the Clackmannan Water Works (now demolished). This overlay the mottled orange-brown clay natural **103** containing some small sub-rounded stones. Layers **102** and **103** had been truncated to the E by a sloping cut **104**, at least 0.25m wide, within which was a 0.05m diameter metal water pipe **105**, at a depth of 0.7m. The pipe trench had been backfilled with **106**, a re-deposited mixture of layers **102** and **103**.

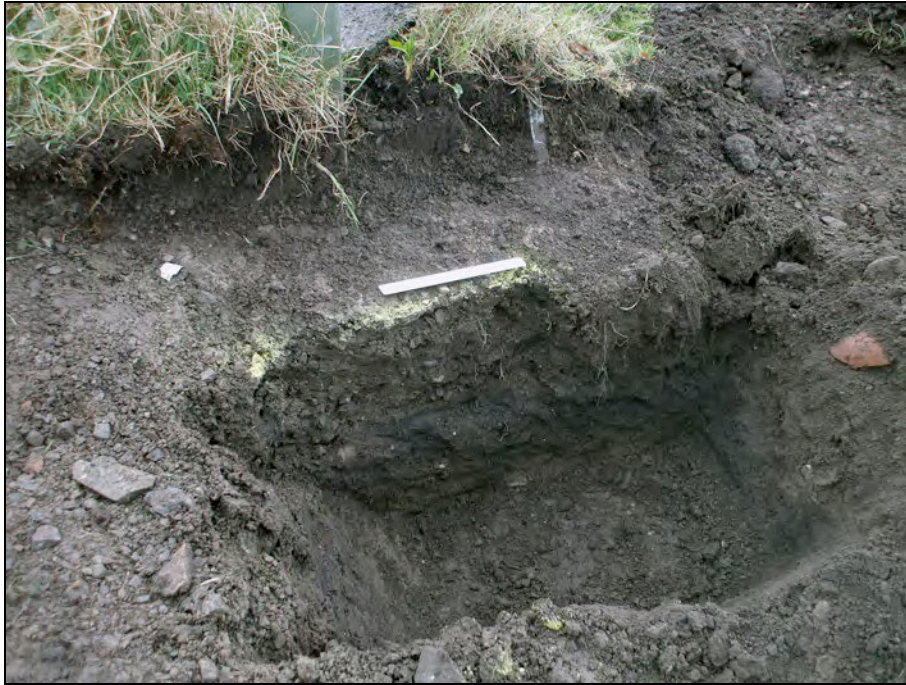
Plate 2: Trench 2, E-facing section

The existing post-and-wire fence was disconnected from the upright of the bow yett and peeled back. One of the metal fence posts then had to be removed. An area 2.2m N/S x 2.7m E/W was then reduced by 0.1m-0.15m. Two gatepost trenches were then excavated by a further 0.65m. The W trench measured 0.64m E/W x 1.3m N/S, while the slightly skewed E trench (due to the working space available for the mini digger) measured 1.25m NE/SW x (up to) 0.9m NW/SE. The sections consisted of modern made-up ground overlying possible buried topsoil. The turf and introduced topsoil **201** was 0.45m thick and overlay a 0.1m thick layer of mid-greyish brown silty clay, **202**. A further mid-brown silty topsoil **203** lay below this and was exposed to a depth of 0.1m.

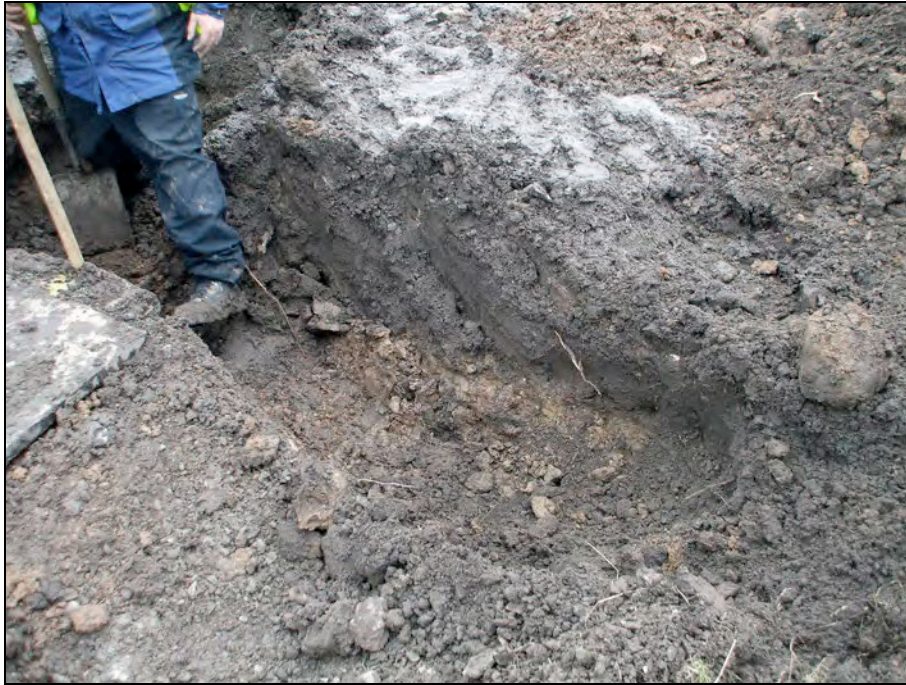
Plate 3: Trench 3, work in progress

The existing post-and-wire fence was disconnected from its round post and peeled back. The post itself was then removed. The bow yett was held in place by deep concrete foundation, which was removed by the mini digger. The removal of the gate exposed a large slab over a manhole containing an electricity cable. The area around the fence was badly waterlogged and churned up due to livestock. To the E of the post-and-wire fence, the upper 0.4m was a layer **301** of muddy turf over mid-brown silt 0.4m thick. The remaining 0.3m below consisted of a layer **302** of mottled orange-brown clay natural containing some small sub-rounded stones. To the W of the post-and-wire fence, at a depth of 0.1m, a layer of compacted type 1 stone, **303**, lay below the turf - once the hard stand for a car park. Truncating **302** was a 0.35m wide cut **304** for the electricity cable, which had been backfilled with a re-deposited mixture of layers **301** and **302**. To the W of the post-and-wire fence, the ground level was reduced by 0.1m in an area 2.40m N/S x (up to) 0.9m E/W. To the E of the post-and-wire fence, an L-shaped trench 2.40m N/S x 0.6m-1.3m E/W x 0.7m was dug. Nothing of archaeological interest was uncovered.
