**HISTORIC SCOTLAND PROPERTIES IN CARE
MINOR ARCHAEOLOGICAL WORKS 2013**

Dumbarton Castle • Monitoring • March 2013

SITE: Dumbarton Castle, Dumbarton

DESCRIPTION: Monitoring the excavation of one of a series of investigative trenches excavated in order to expose existing drains in advance of new drainage measures

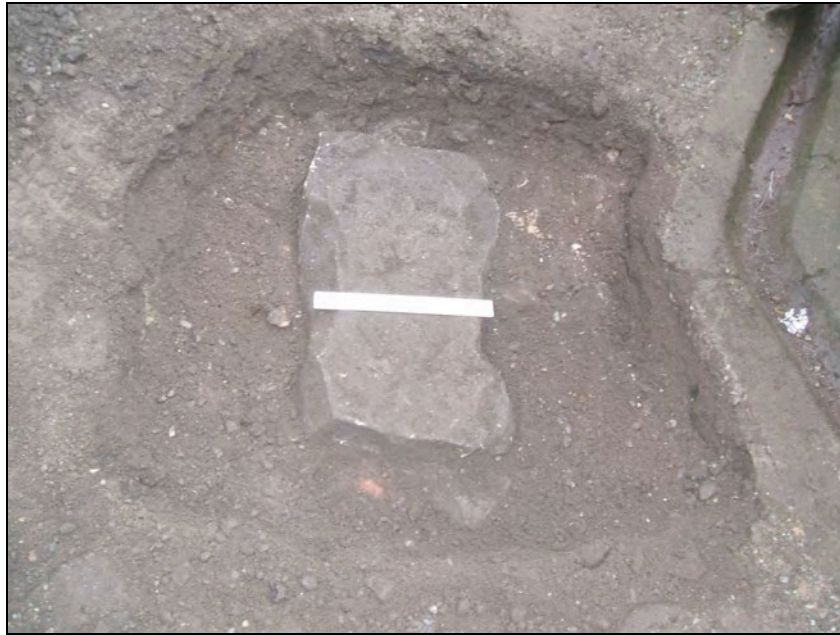
After the successive removal of gravel (001) and a mixed deposit of stones and dark silt (002), a large single stone (003) - the remains of an earlier wall - was revealed. Further excavation revealed a wall face

Plate 1: Context 002

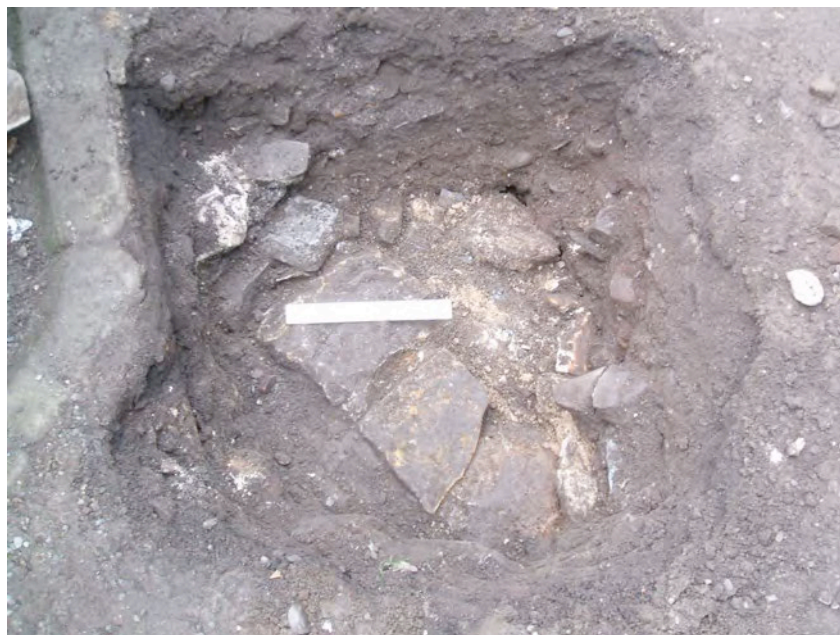
(006) with associated wall core (007), apparently reflecting a wall aligned NE/SW. This was truncated by the footings (008) for the present drainage channel (005) at its S end.

Plate 2: Contexts 002, 006 and 008

This wall appears to represent an earlier version of the southern defences of the castle, predating the 1735 building campaign. Although only revealed in a small trench, it appears to show the upper limits of a wall on a different alignment from the 18th Century layout. The masonry, in turn, lies beyond the assumed limits of the 17th Century plan, and as such is most likely part of the medieval defences associated with other known residual elements such as the medieval gatehouse. Significantly, the platform occupied by the gatehouse and its successor, the Governors House, and that which was projected by both 17th and 18th Century batteries, was not seen in the trench, on the basis of **006** defining the outer face of a free standing wall. On this basis **006/007** could represent a wall rising up from the beach/shoreline levels, with the natural terrace exploited by the gatehouse on its N side.

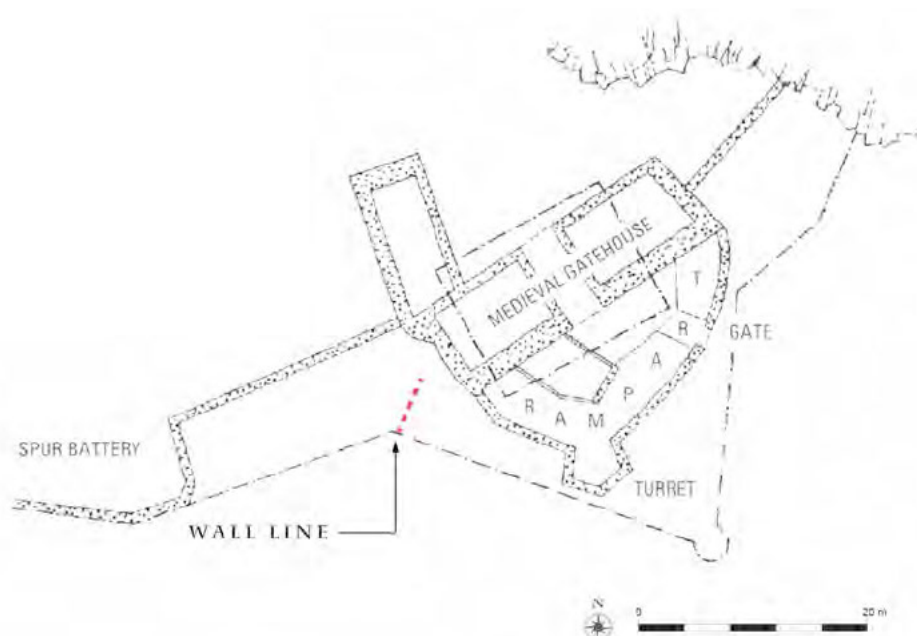
Figure 3: Alignment of wall 006
