**HISTORIC SCOTLAND PROPERTIES IN CARE  
MINOR ARCHAEOLOGICAL WORKS 2013**

**Noltland Castle • Excavations • February 2013**

**SITE:** Noltland Castle, Westray, Orkney Islands

**DESCRIPTION:** Excavation of trenches to assess the impact of a new car park and associated access upgrade

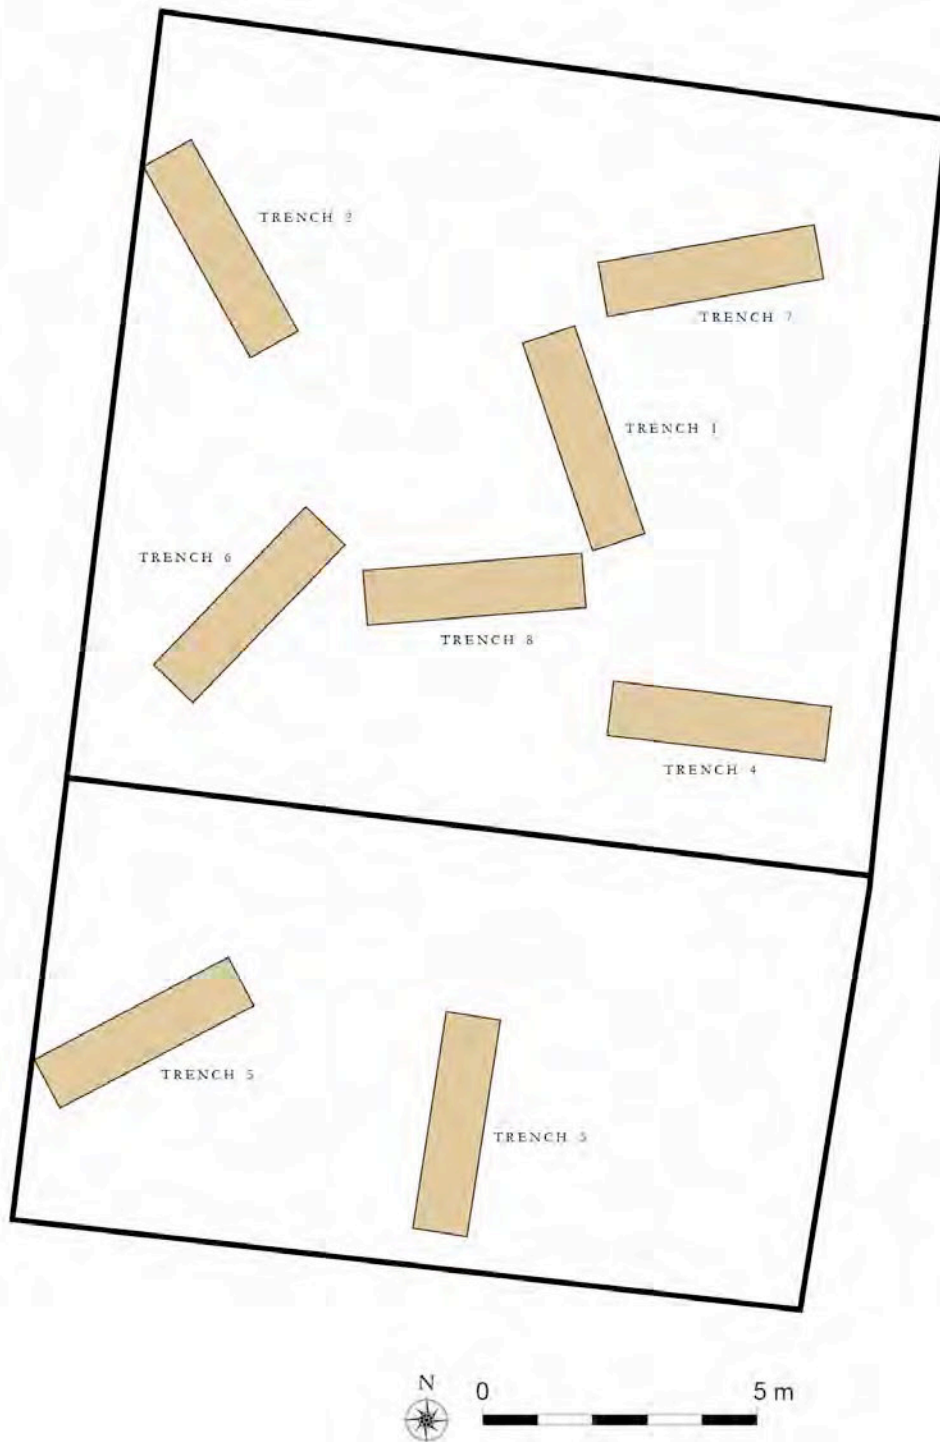
**Figure 2:** Plan showing the trench locations.

The trenching scheme is shown on Fig. 2 and corresponds with that submitted as part of the planning application. The trenches provide a sample size of approximately 10%. All trenches were excavated by hand.

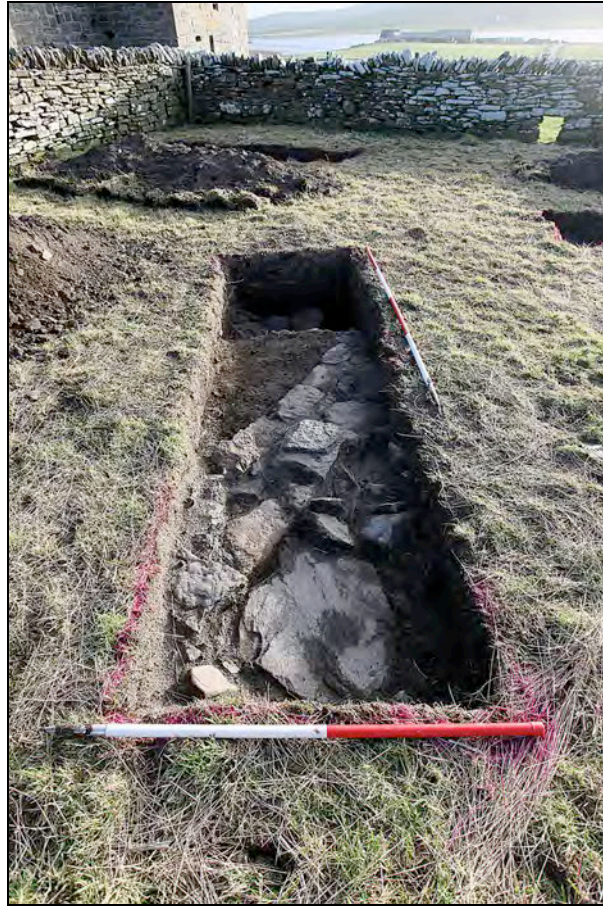
**Plate 1:** Post-excavation photograph of Trench 1.

This trench measured 4m by 1m and was excavated to a maximum depth of 0.62m. Structural remains of unknown archaeological potential were identified within this trench. These comprised a 1.65m segment of drystone walling and associated rough stone surfaces. Further assessment is required in order to more fully characterise these remains. They lie within the depth required for the new car park base and would be entirely removed or substantially altered by the proposed development.

It is recommended that a further programme of pre-development excavation is undertaken and that this is specifically targeted to investigate the structural remains seen in Trenches 1, 4, 8 and 6.

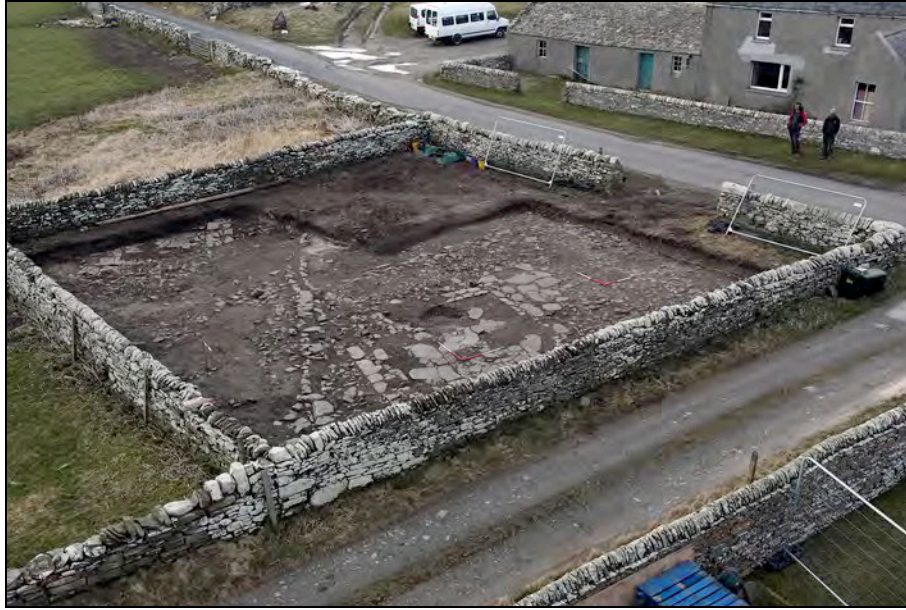
**Plate 2:** A later view of the work

The features collectively grouped as Structure C comprise two walls (**111** and **113**), two flagstone surfaces (**110** and **112**) and a spread of rubble **114**. A 2.7m long segment of the most substantial wall (**113**) was exposed. This well-built wall extended on a NW/SE alignment. There were topographic indications that it

continued SE for a further 3.5m – 4m below the level reached by excavation. It was built from a mixture of quarried stone and fieldstone and was founded on a basal plinth that survived to a height of approximately 0.25m. It varied between 0.75m and 0.9m in width. There was no evidence for the use of clay bonding, plaster or render in association with this feature.

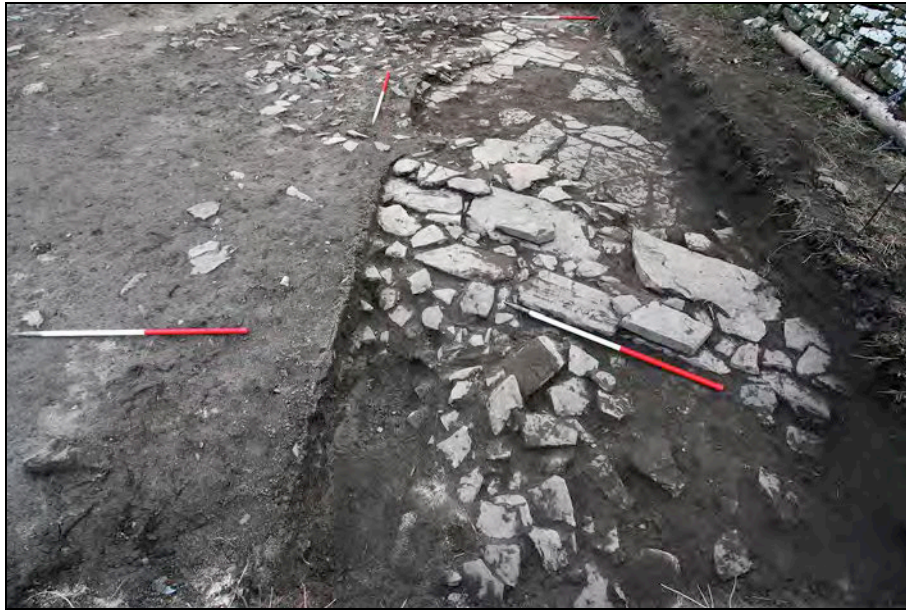
Plate 3: Details of the wall 113 and paved area to the S (112)

To the S side of wall 113, two fragments of flagstone paving were found in association with a possible internal wall base. One of the flagged surfaces (112) was closely butted up against the face of wall 113. The most complete of the large flags measured some 0.8m x 0.8m in plan but the majority had been smashed into small fragments. The condition of these stones may be indicative of an act of deliberate demolition rather than the gradual decay of the building. From the limited investigation possible within this structure, it appeared that the floor was comprised of two or perhaps three separate layers of flagstones, suggesting that it had been repaired over its lifetime.

A second area of flagstones (110) was identified within Structure C. This lay to the E side of wall 111 and probably represents a continuation of surface 112. These flagstones were also neatly laid. They had been

smashed *in situ* and it was impossible to determine the original size of any of the individual stones. At least two layers of paving were in evidence here.

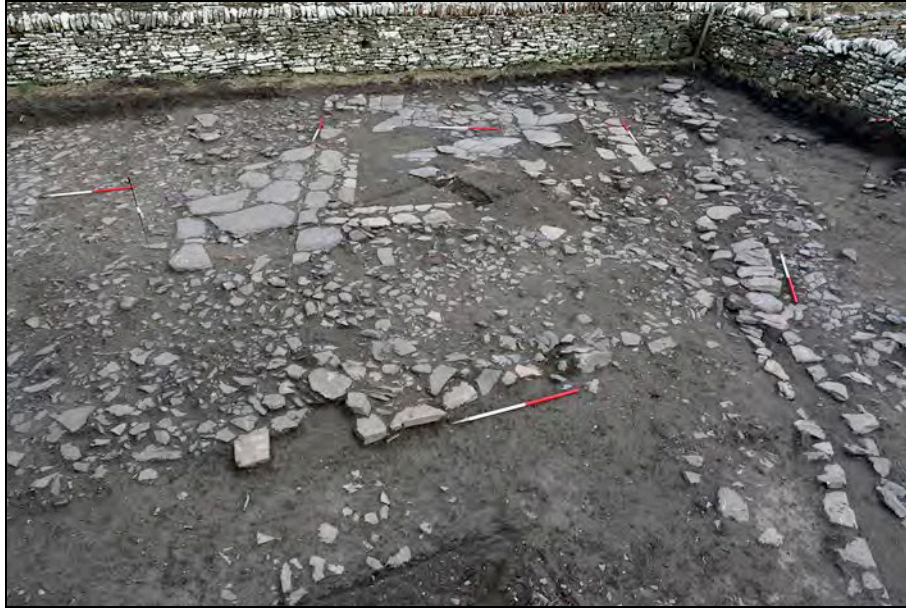
**Plate 4:** View of the central part of the trench showing the drain 103, walling 116, 117 *etc.*

The surviving segment of the N wall of Structure A (**116**) measured 6.1m long x 0.6m wide. It had been reduced to its basal course (0.15m - 0.2m high), and was of double-faced construction with a rubble and clay core, and appears to have been clay-bonded. The exterior face was constructed from larger stones, with examples measuring 0.6m x 0.3m x 0.2m and 0.45m x 0.6m x 0.15m. The interior face utilised smaller stone, the average size being 0.3m x 0.2m x 0.15m. The interior face retained traces of a gritty, cream coloured plaster.

A wall (**117**) extended across the western side of Structure A. This appears to have formed either an internal partition within the building or a secondary addition to it. At its N end, this wall was keyed into wall **116**. No traces of plaster were noted in association with this wall. That it did not form the original W side of the building was evidenced by the fact that wall **116** projected beyond it. Wall **117** extended for 1.6m and was 0.5m wide. It was constructed from stones of average size, typically 0.3m x 0.3m x 0.1m, which were smaller than those used in walls **115** and **116**. Between the southern end of wall **117** and the S wall of the building there was a 2.1m gap. The presence of a doorway here is suggested by a post-setting (**119**). This stood at the centre of the gap and may have held a doorpost. The cut was set into deposits underlying the floor of the building. It measured 0.1m x 0.2m (E/W) and was lined with stone. Traces of an earlier wall (*see* **118**, Phase 1) were also present in this area, and it is possible that parts of it had been repurposed in the creation of an entrance feature. Since the walls had subsequently been reduced to their foundations however, it was not possible to formulate a more detailed reconstruction.

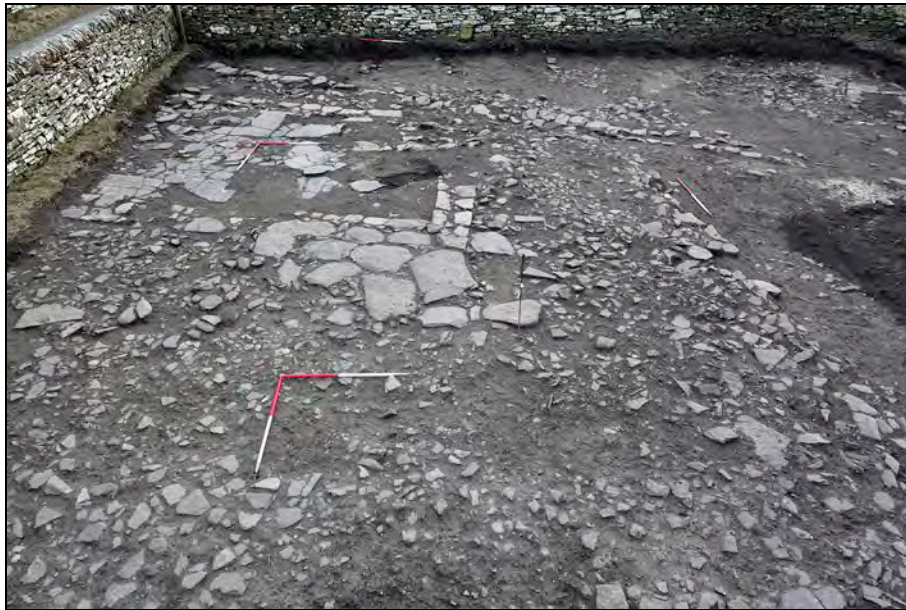
Plate 5: Surfaces 121 and 122

A stony surface containing a group of ten or so large flat slabs (121) surrounded the northern exterior of Structure A. The largest of the slabs measured 0.9m x 0.6m by 0.04m. This surface extended northwards where it melded into a metallised track (122). The track, which was not fully uncovered, appeared to be aligned E/W and is likely to extend beyond the walled enclosure and, possibly, beneath the modern road. It was at least 5m wide (N/S). The surface of the track was very compact and stony. It comprised fist-sized and smaller angular stones in a matrix of sandy silt soil. There was no evidence of a kerb or edge to this feature. Irregular linear depressions in this surface may represent ruts caused by the traffic of cart wheels.

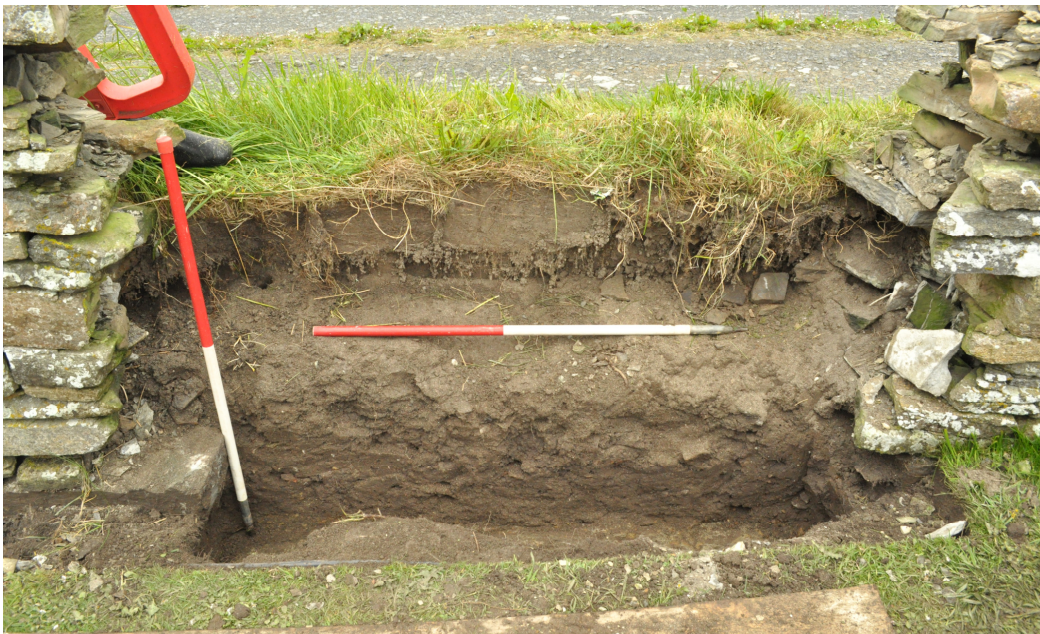
*Plate 1: Excavated area, looking east.*

Excavation was then carried out to determine the nature of the deposits. Up to 400mm of turf and topsoil (001) was removed from the west side of the wall. This was fairly loose, mid-brown, stony, clayey soil. On the east side, the turf (002) was firmer, dark brown, sandy loam up to 120mm thick, just below which an electrical cable in armoured sheathing (007) ran north-south c 200mm east of the wall.

Seen on both sides of the wall (sealed by 004 to the west and by 001 to the east) was a firmer, darker layer of sandy, clayey silt, 005, with abundant charcoal flecks, a few fragments of heat-affected stone and a small fragment of animal bone. This layer had a maximum depth of 340mm and below it was the smooth, level surface of the flagstone bedrock, at c 420mm below the existing ground surface level on the west side of the wall.
