**HISTORIC SCOTLAND PROPERTIES IN CARE  
MINOR ARCHAEOLOGICAL WORKS 2013**

**Rothesay Castle • Excavation • June 2013**

**SITE:** Rothesay Castle, Rothesay, Isle of Bute

**DESCRIPTION:** Excavation of two trenches to house new signage and two test trenches to characterise ground make-up

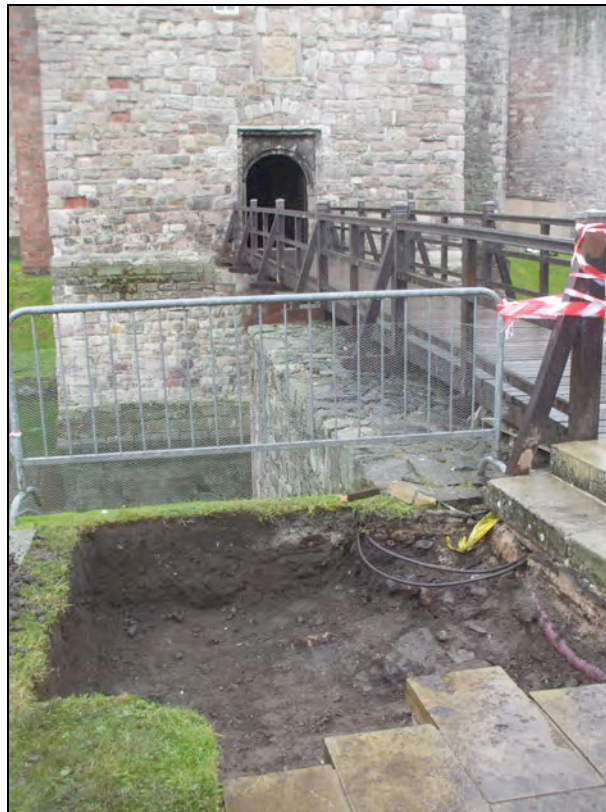
Signage Trench 2 was located on the flat top of the moat embankment E of the Ticket Office at the entrance to the castle drawbridge. The trench measured 2m E/W x 1.5m N/S x 0.46m deep. An area of sandstone paving slabs **200** incorporating an existing information board had to be removed before excavation could begin.

**Plate 1:** Signage Trench 2, from the N

The slabs and bedding sand **201** accounted for the first 15cm depth of the excavation. To the E, a 50cm wide strip of turf **202** some 10cm thick had to be removed. Thereafter, the fill to the required depth was a moderately compact layer of dark brown silt **203** containing a mixture of modern and historic artefacts.

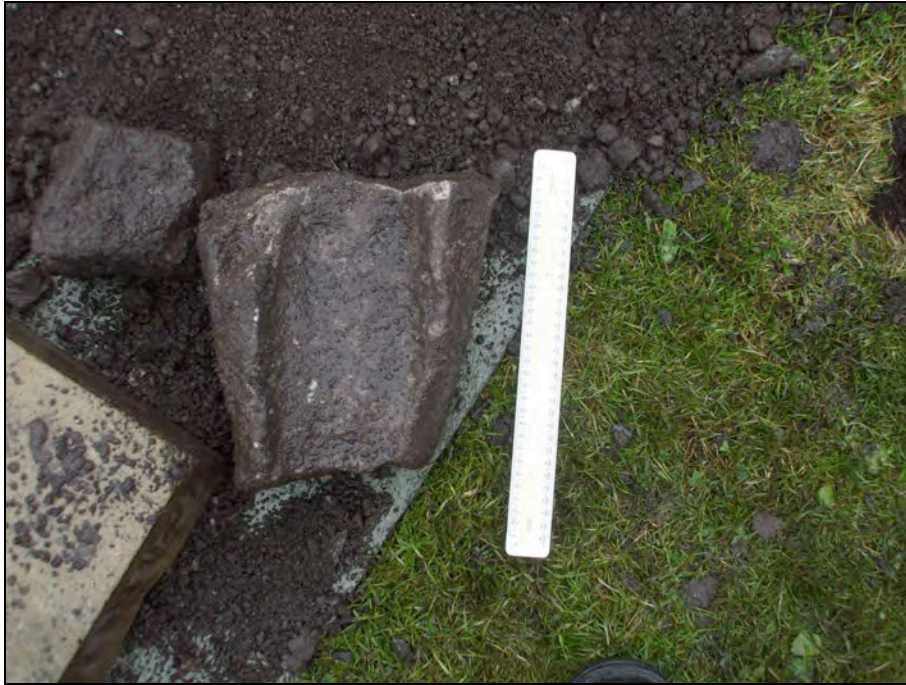
The ceramic assemblage was again a mixture of modern transfer-printed wares and green-glazed pottery. Within **203**, three service cables were exposed. When the required depth was achieved, a layer of voided rubble **204** was found in the western 60cm - 70cm of the trench. It is possible that this represents the backfill of the excavation for the current S drawbridge abutment. Within the rubble was a possible fragment of a sandstone spout (Plate 2).

Plate 2: The possible sandstone spout from 204
