# Dundrennan Abbey: Minor Excavations, September 2008

HS PIC Index number: 90114  
Project code: HSCO-90114-2008-02

15 December 2008  
Kirkdale Archaeology

<b><u>Site</u></b>	Dundrennan Abbey
<b><u>N.G.R</u></b>	Centred on NX 749 474
<b><u>Project Description</u></b>	Minor excavations
<b><u>Project code</u></b>	HSCO-90114-2008-02

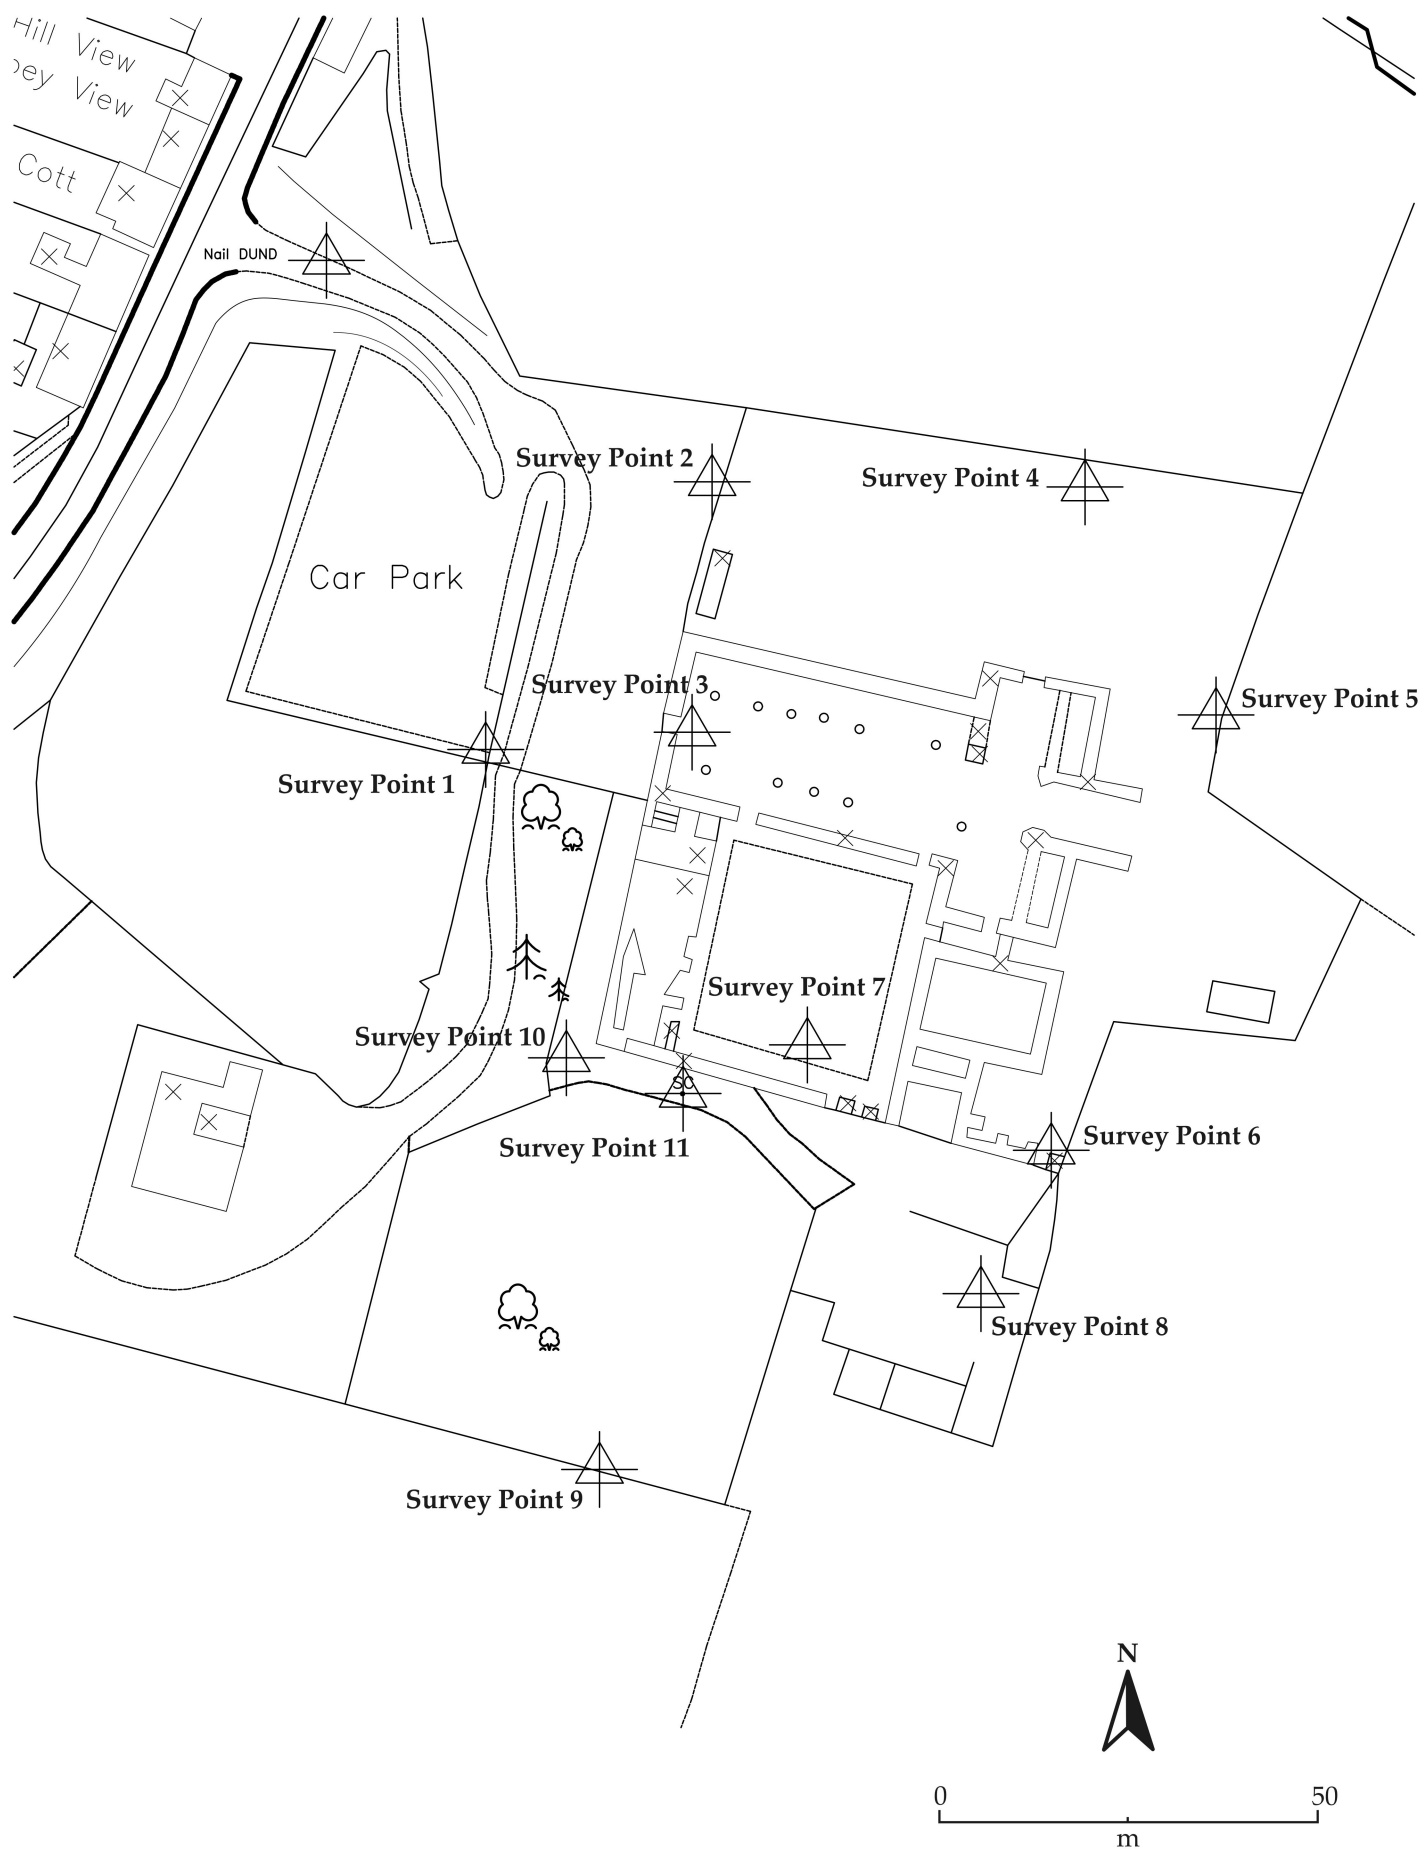
Fig. 1 : Plan (1:1000) showing location of survey points

The following is a description of each of the survey points. This includes details of the excavation if relevant.
